## INSPECTION INSIGHTS

| DATE | 04/02/24 |
| ADDRESS | 1903 Maddox Street,<br>Richmond, VA |

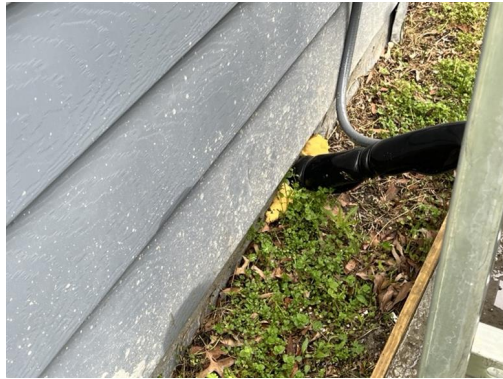
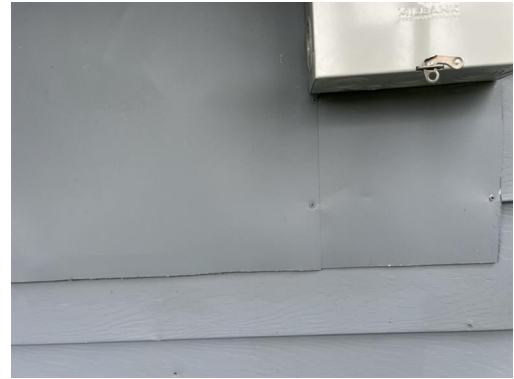
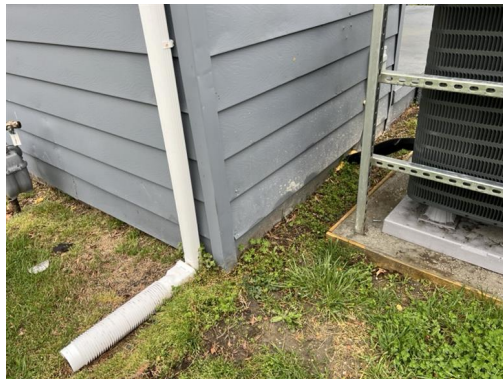
EXTERIOR/EXTERIOR WALLS

| ISSUE | The siding panels have been repaired and penetrations sealed. |
| LOCATION | Multiple Locations |

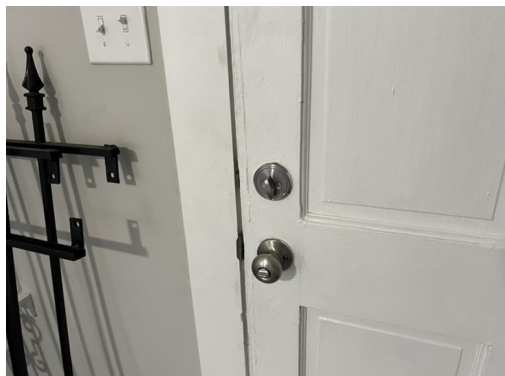
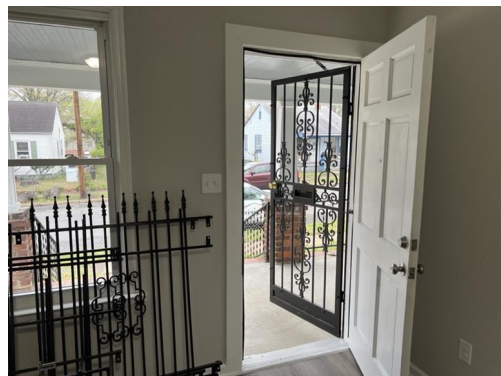
## EXTERIOR/EXTERIOR DOORS

| ISSUE | The door latch/deadbolt has been repaired and the weather stripping installed. |
| LOCATION | Front |

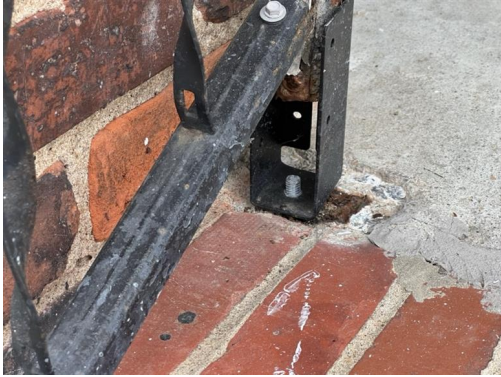
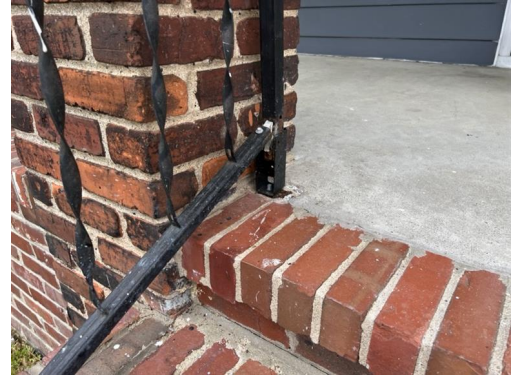
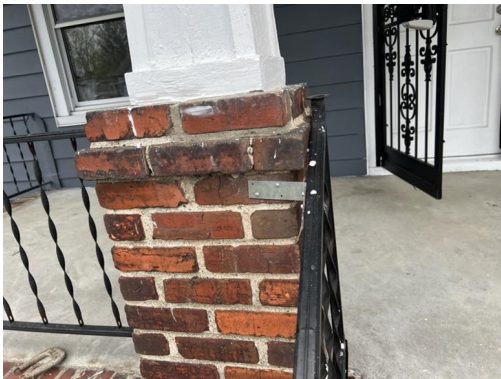
## EXTERIOR/EXTERIOR STAIRS/STEPS

ISSUE The hand railing has been mostly secured, the bottom bolt is missing a nut. Add and secure.  
 LOCATION Front  
 RESOURCE Experienced professional

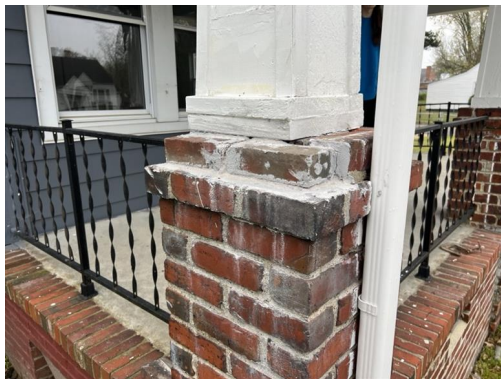
## EXTERIOR/EXTERIOR STAIRS/STEPS

ISSUE The front left porch post has been repaired.  
 LOCATION Front  
 RESOURCE Experienced professional

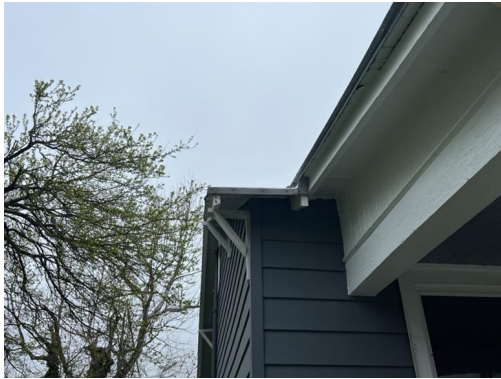
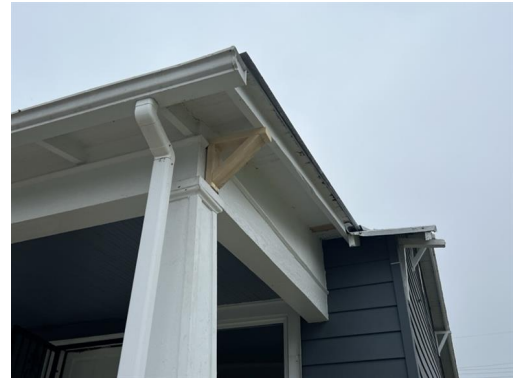
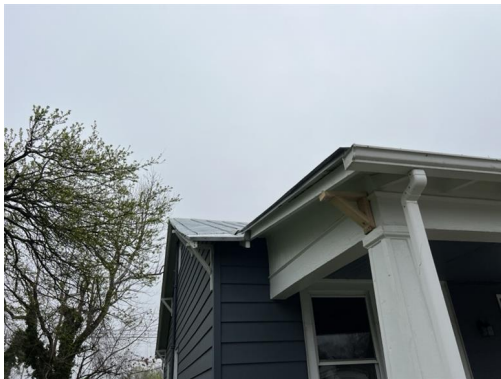
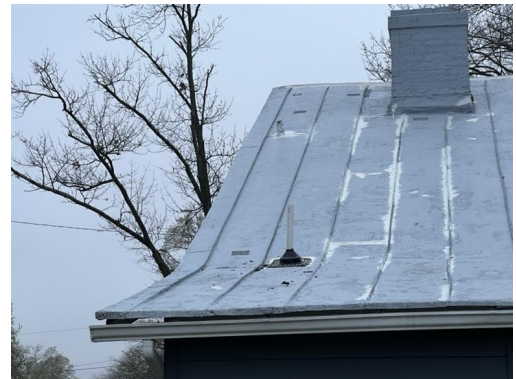
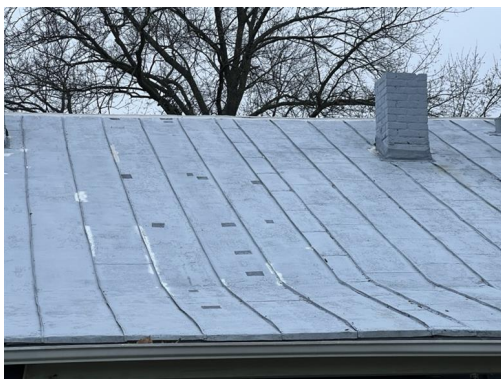
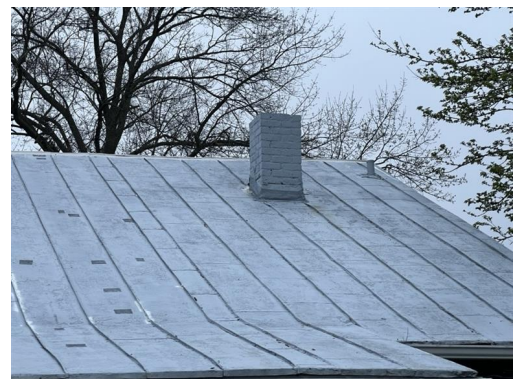
## ROOF/ROOFING

| ISSUE | All of the roofing repairs have been completed. |
| LOCATION | Multiple Locations |

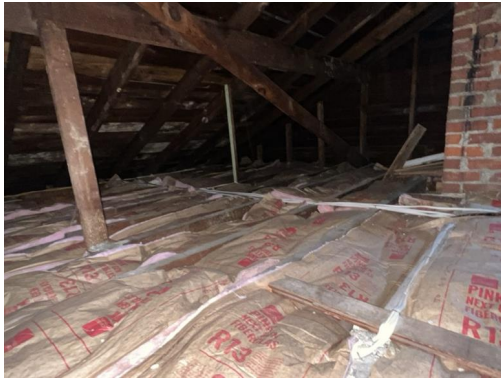
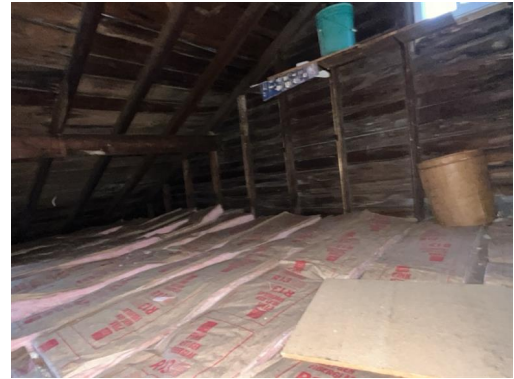
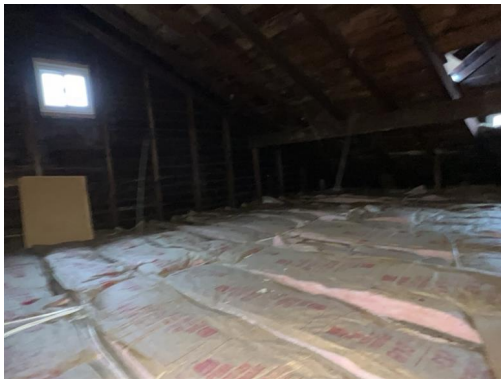
## INSULATION AND VENTILATION/ATTIC INSULATION

| ISSUE | The insulation has not been corrected. |
| LOCATION | Throughout the attic |

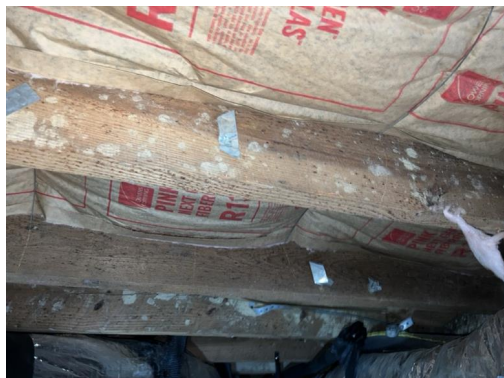
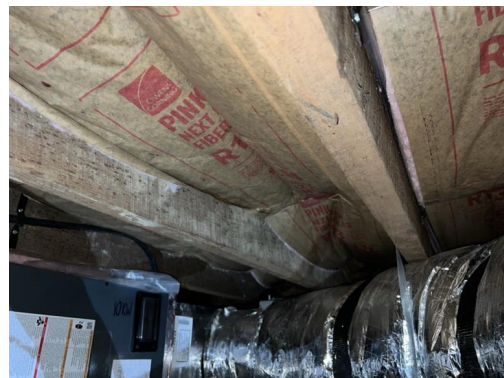
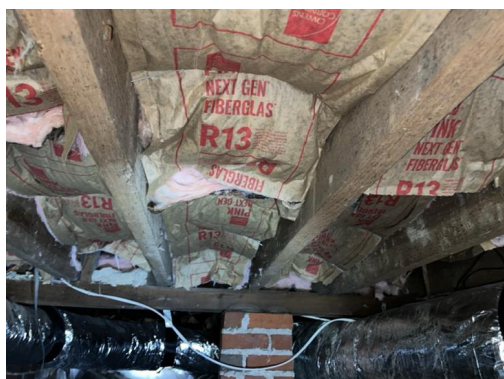
## INSULATION AND VENTILATION/CRAWL SPACE INSULATION

| ISSUE | The insulation has not been corrected. |
| LOCATION | Multiple Locations |

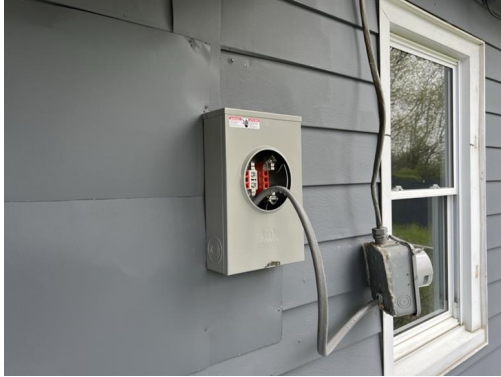
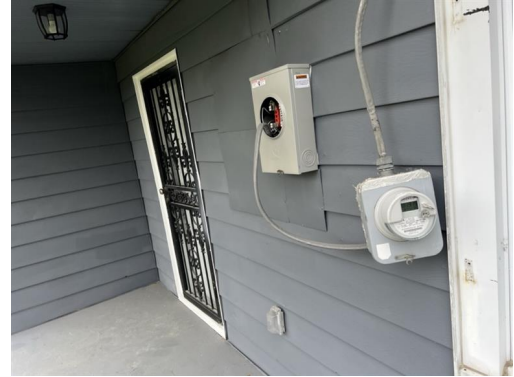
## R ELECTRICAL/ELECTRICAL SERVICE

ISSUE The service meter has not been corrected.  
 LOCATION Rear  
 RESOURCE Electrical contractor

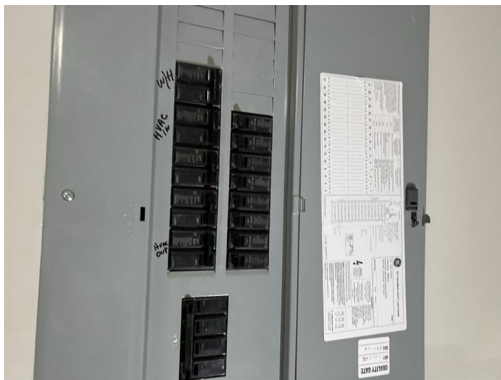
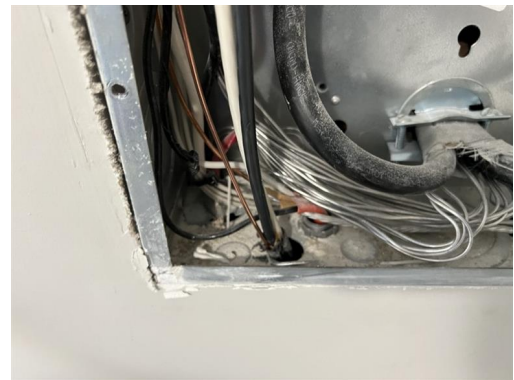
## R ELECTRICAL/ELECTRICAL PANEL

ISSUE The electrical panel has not been labeled, also the connector clamp is missing at the bottom.  
 LOCATION Bedroom  
 RESOURCE Electrical contractor

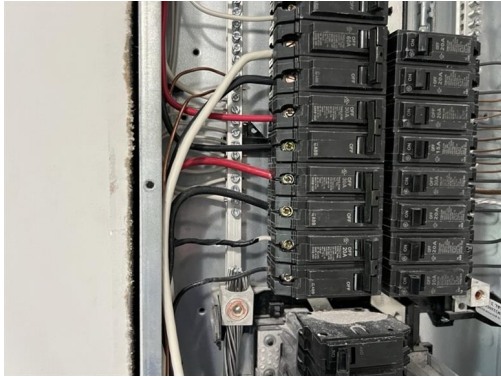
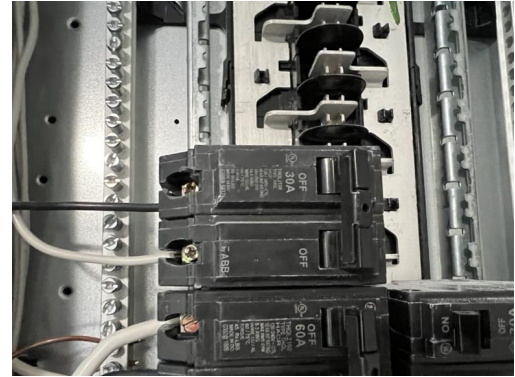
## ELECTRICAL/ELECTRICAL PANEL

| ISSUE | The undersized wiring has been corrected. |
| LOCATION | Bedroom |

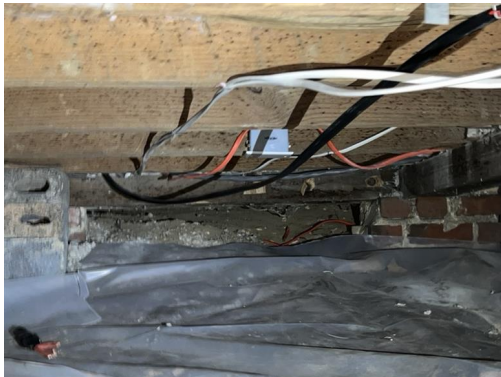
## ELECTRICAL/BRANCH CIRCUITS

| ISSUE | The exposed wiring has been corrected. |
| LOCATION | Multiple Locations |

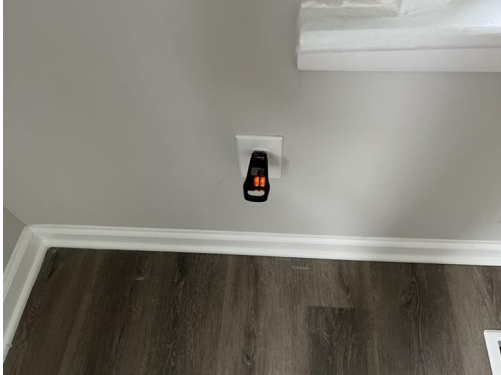
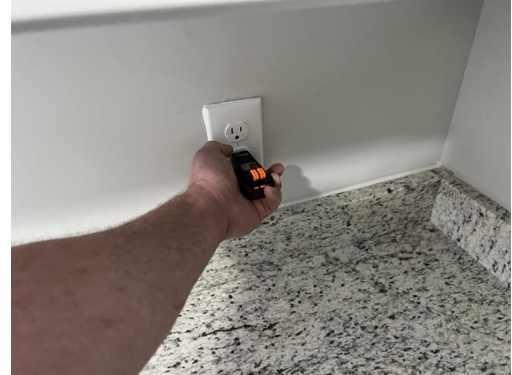
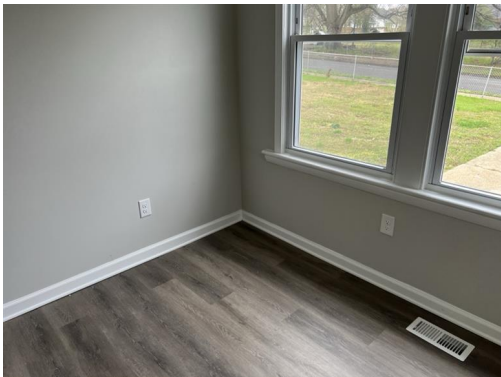
## ELECTRICAL/RECEPTACLES

ISSUE The outlets have been wired correctly and have power.  
 LOCATION Multiple Locations  
 RESOURCE Electrical contractor

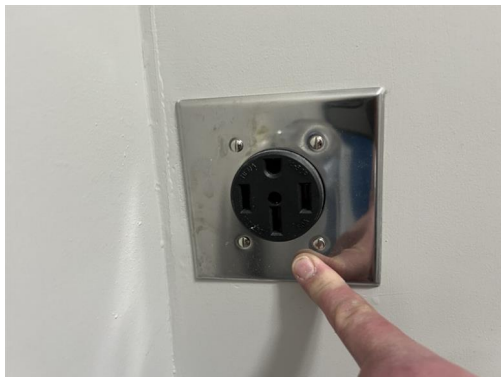
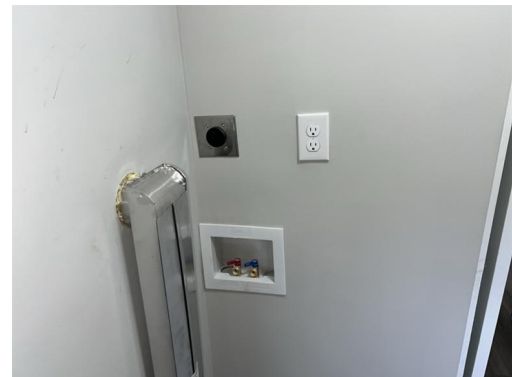
## ELECTRICAL/RECEPTACLES

ISSUE The wrong outlet is used for the clothes dryer, the current receptacle is designed for an electric range. Replace with the correct unit.  
 LOCATION Laundry Room  
 RESOURCE Electrical contractor

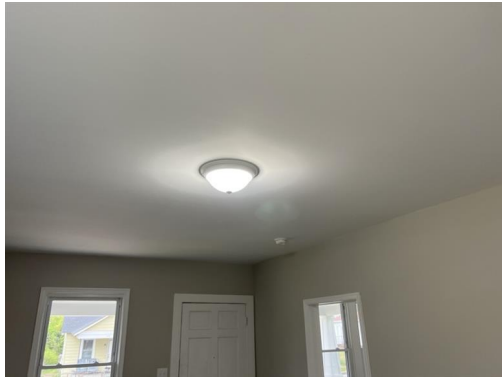
ELECTRICAL/FIXTURES

| ISSUE | The non working light has been corrected. |
| LOCATION | Living Room |

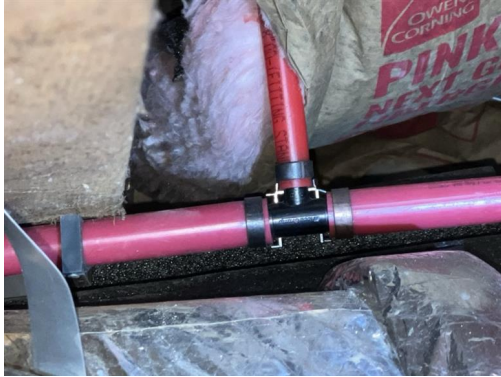
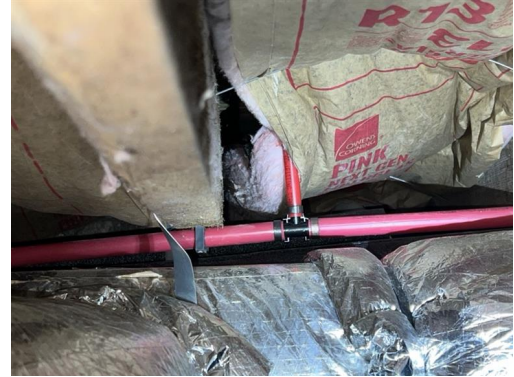
## R PLUMBING/SUPPLY PIPES

| ISSUE | The supply line leak has been corrected. |
| LOCATION | Rear Right of the crawlspace. |

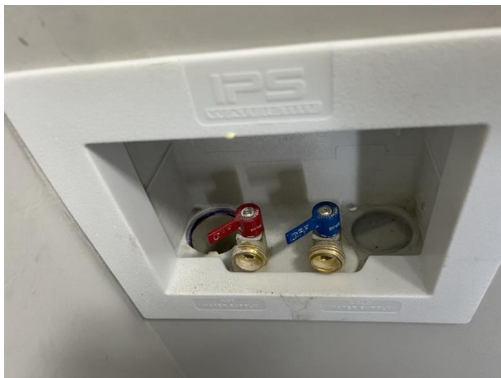
## R PLUMBING/DRAIN, WASTE, VENTS

| ISSUE | The laundry drain has been corrected. |
| LOCATION | Laundry Room |

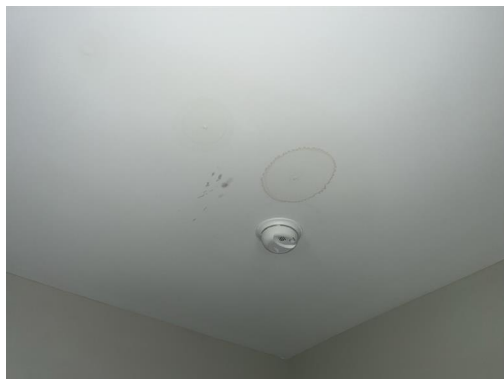
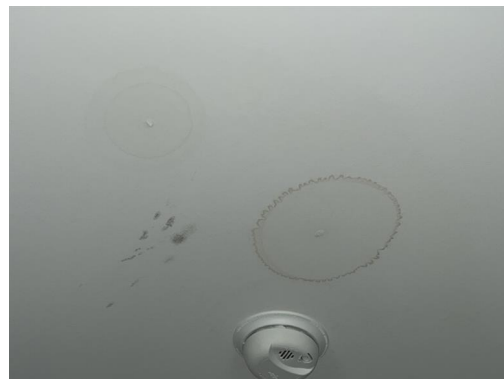
**R** INTERIOR/INTERIOR CEILINGS

| ISSUE | Water staining found on the ceiling at the entrance to the rear bedroom. |
| LOCATION | Bedroom |

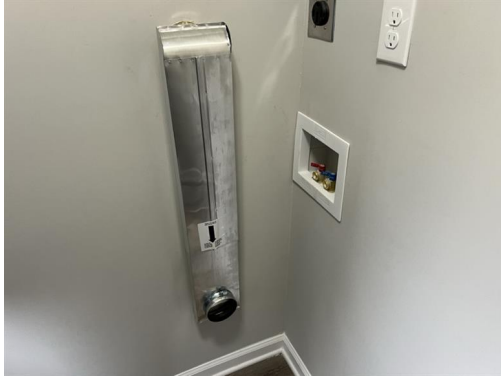
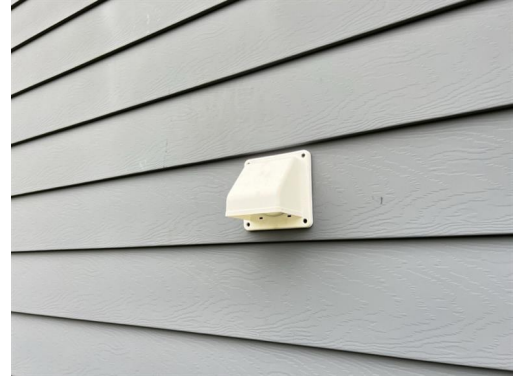
## APPLIANCES/DRYER 1 VENTILATION

| ISSUE | The dryer ducting has been installed. |
| LOCATION | Laundry Room |
