## INSPECTION INSIGHTS

DATE	04/22/24
ADDRESS	608 Mayfair Ave, Richmond, VA
NAME	Lee Henry

TYPE	Single family
YEAR BUILT	1968
APPROXIMATE SQUARE FOOTAGE	5,379
DIRECTION FRONT OF HOUSE FACES	Southeast

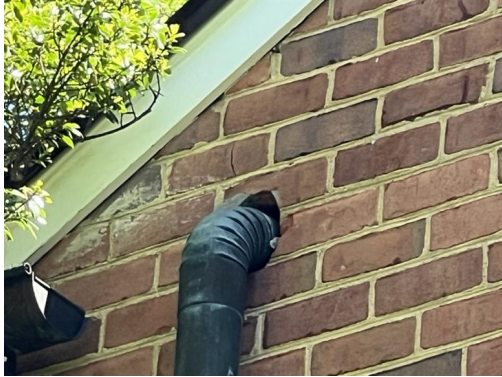
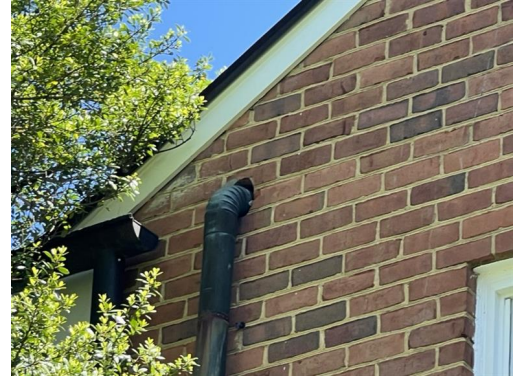
## R EXTERIOR/EXTERIOR WALLS

<b>R</b>	<b>REPAIR/FIX</b>	
1.	<b>Exterior/Exterior Walls</b> There is a gap between the brick and HVAC utilities chase. Replace the siding and repair any damage which may be revealed. LOCATION: Rear Upper Right.	13

ISSUE	There is a gap between the brick and HVAC utilities chase.
LOCATION	Rear Upper Right.
IMPLICATION	May permit water to penetrate the structure.
RECOMMENDATION	Replace the siding and repair any damage which may be revealed.
RESOURCE	Experienced professional

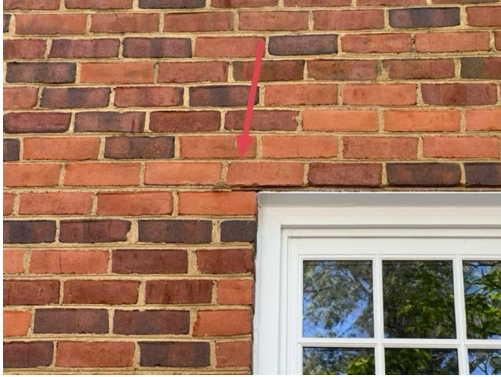
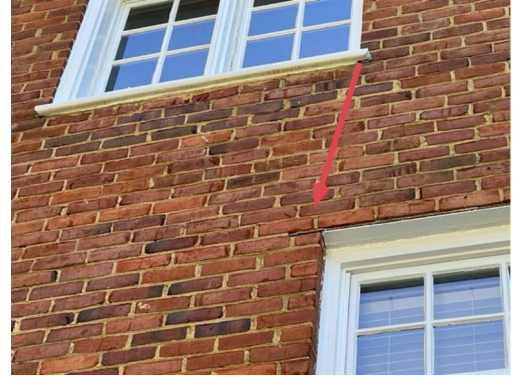
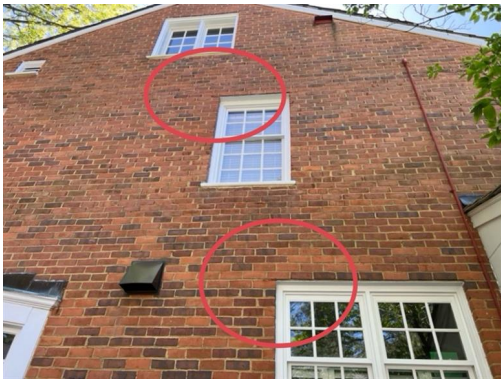
## EXTERIOR/EXTERIOR WALLS

ISSUE	There are minor masonry cracks at the lintels.
LOCATION	Upper left corner of the kitchen window and upper left corner of the second floor right rear window.
IMPLICATION	No visible displacement or evidence of moisture intrusion.
RECOMMENDATION	Seal cracks and monitor for movement.
RESOURCE	Masonry contractor

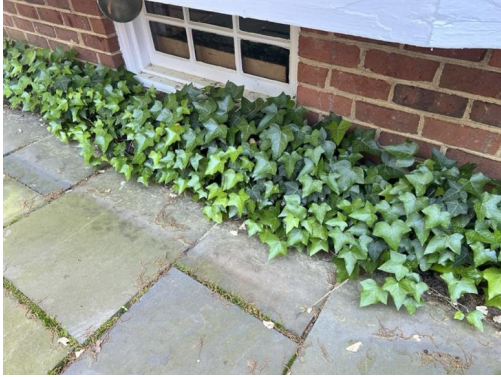
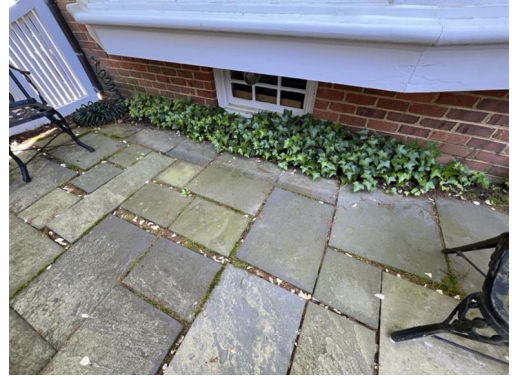
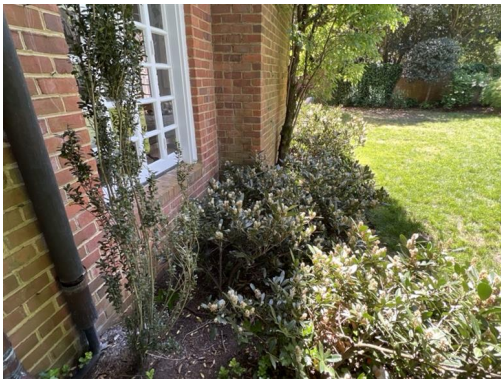
## EXTERIOR/EXTERIOR WALLS

22.	<b>Exterior/Exterior Walls</b> There is vegetation in contact with the exterior wall. Trim or relocate any plants and trees to provide at least a one foot of air space around the house. LOCATION: Multiple Locations.	15

ISSUE	There is vegetation in contact with the exterior wall.
LOCATION	Multiple Locations
IMPLICATION	Causes damage and premature deterioration of the siding.
RECOMMENDATION	Trim or relocate any plants and trees to provide at least a one foot of air space around the house.
RESOURCE	Experienced professional

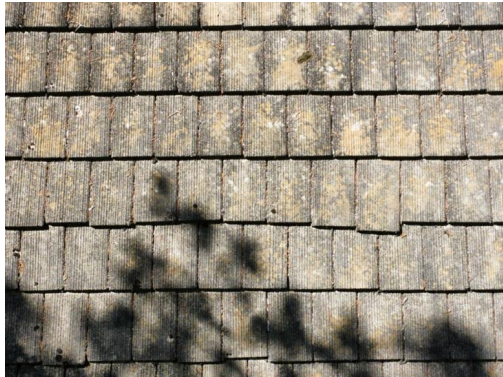
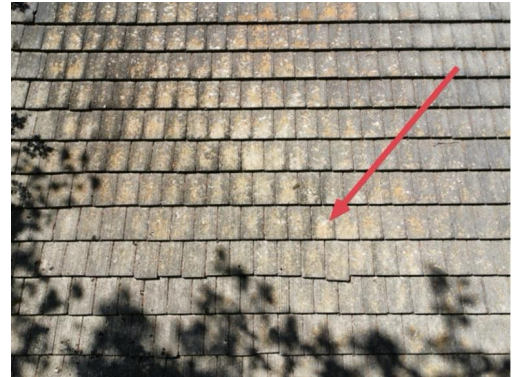
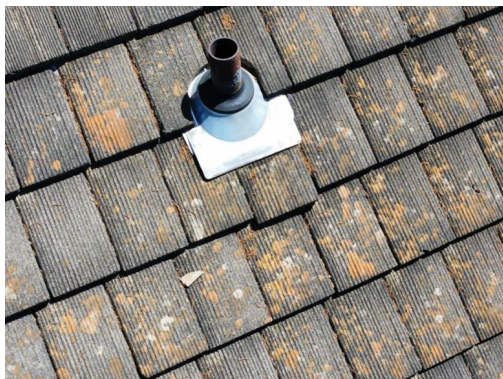
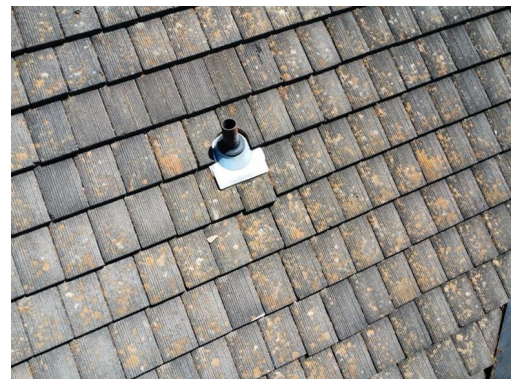
## ROOF/ROOFING

2.	<b>Roof/Roofing</b> The tiles have shifted from their original position. Engage a roofing contractor to make secure or repair the roofing as required to prevent water intrusion and subsequent damage. LOCATION: Front left of the front roof and below the plumbing vent at the rear right of the roof.	19

ISSUE	The tiles have shifted from their original position.
LOCATION	Front left of the front roof and below the plumbing vent at the rear right of the roof.
IMPLICATION	May continue to loosen and fall permitting water to penetrate the structure.
RECOMMENDATION	Engage a roofing contractor to make secure or repair the roofing as required to prevent water intrusion and subsequent damage.
RESOURCE	Roofing contractor

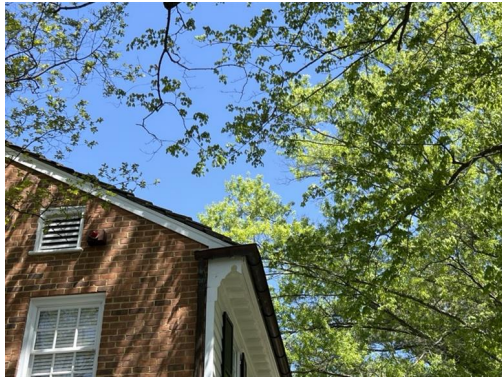
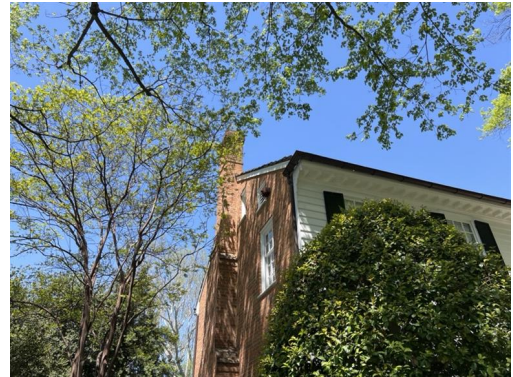
**R** ROOF/ROOFING

ISSUE	The roof covering is in close proximity with tree limbs.
LOCATION	Multiple Locations
IMPLICATION	May damage roofing and permit water penetration and damage to the structure.
RECOMMENDATION	Remove the tree limbs.
RESOURCE	Roofing contractor

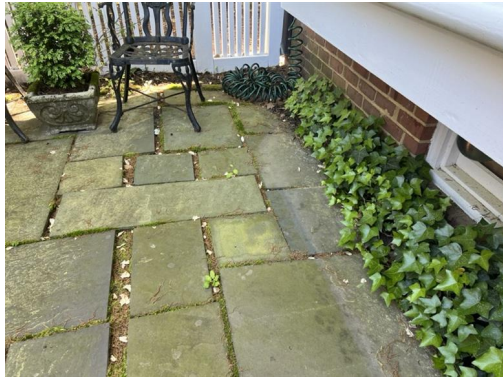
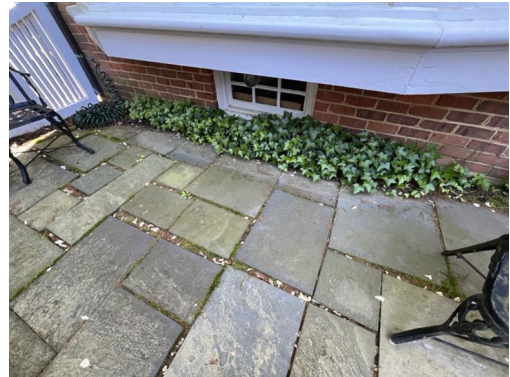
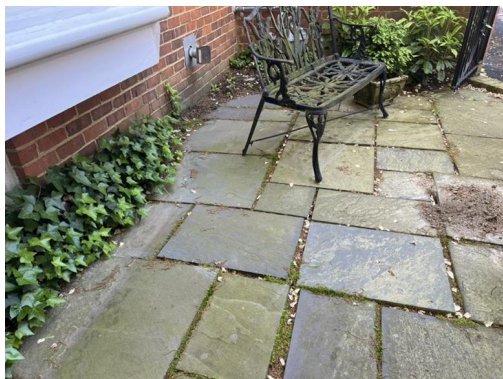
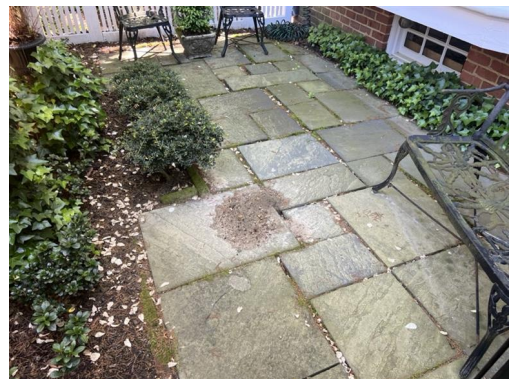
## WATER CONTROL/GRADING

23.	<b>Water Control/Grading</b> The grading is sloping towards the foundation. Regrade to divert surface water away from foundation; grading should be sloped at 1"/foot up to 6' from the house. LOCATION: Right Side (Patio).	23

ISSUE	The grading is sloping towards the foundation.
LOCATION	Right Side (Patio)
IMPLICATION	May permit water to accumulate at the structure; water may penetrate the structure.
RECOMMENDATION	Regrade to divert surface water away from foundation; grading should be sloped at 1"/foot up to 6' from the house.
RESOURCE	Landscaping contractor

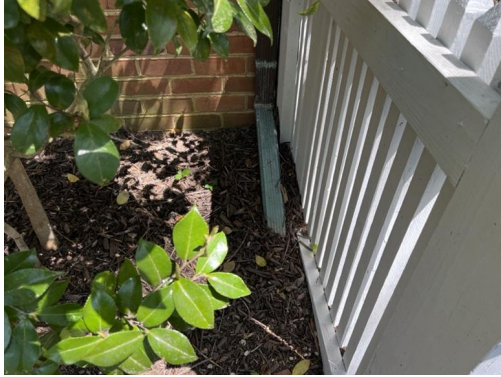
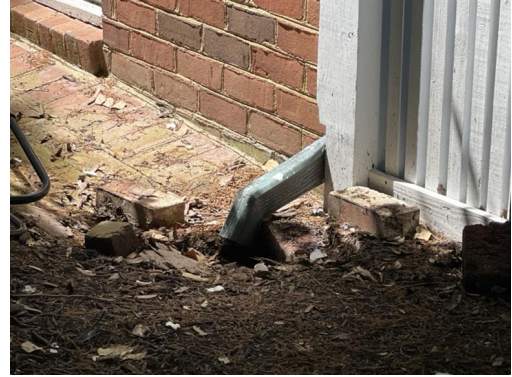
## WATER CONTROL/GUTTERS/DOWNSPOUTS

5.	<b>Water Control/Gutters/Downspouts</b> The downspout exhaust is not visible; displays signs of blockage. Clear the blockage. LOCATION: Multiple Locations. Estimated cost to remedy: \$150 to \$250.	24

ISSUE	The downspout exhaust is not visible; displays signs of blockage.
LOCATION	Multiple Locations
IMPLICATION	May permit water to accumulate adjacent to the structure.
RECOMMENDATION	Clear the blockage.
RESOURCE	Experienced professional
COST TO REMEDY	\$150 to \$250

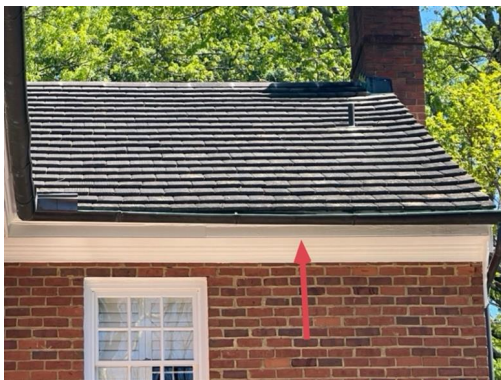
## WATER CONTROL/GUTTERS/DOWNSPOUTS

ISSUE	The gutter is sagging at the center.
LOCATION	Rear Left
IMPLICATION	May permit water to overflow and accumulate at the structure.
RECOMMENDATION	Repair or replace the gutters to carry water away from the structure.
RESOURCE	Gutters contractor

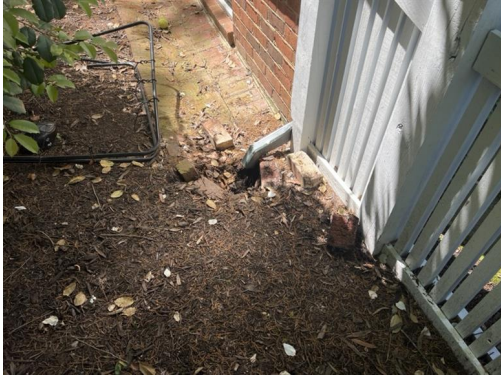
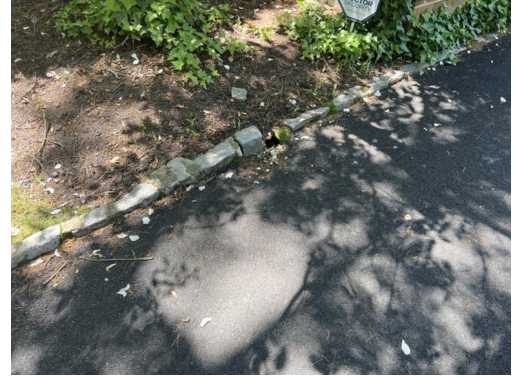
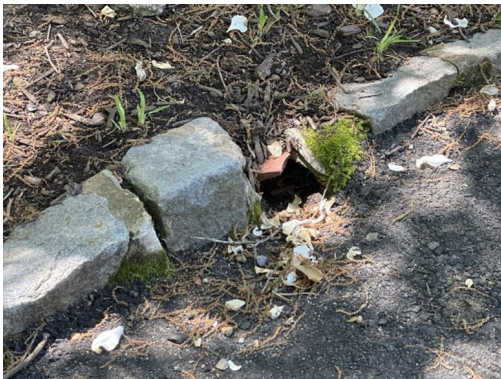
## WATER CONTROL/EXTERIOR DRAINS

6.	<b>Water Control/Exterior Drains</b> The underground drains below the downspouts appear to be blocked, the terracotta drains have a tendency to deteriorate and break over time. Engage a drainage contractor to evaluate for all remedial needs and correct as required. Replacing the current drainpipe may be required. LOCATION: Multiple Locations.	26

ISSUE	The underground drains below the downspouts appear to be blocked, the terracotta drains have a tendency to deteriorate and break over time.
LOCATION	Multiple Locations
IMPLICATION	This may cause water to pool at the foundation.
RECOMMENDATION	Engage a drainage contractor to evaluate for all remedial needs and correct as required. Replacing the current drainpipe may be required.
RESOURCE	Experienced professional

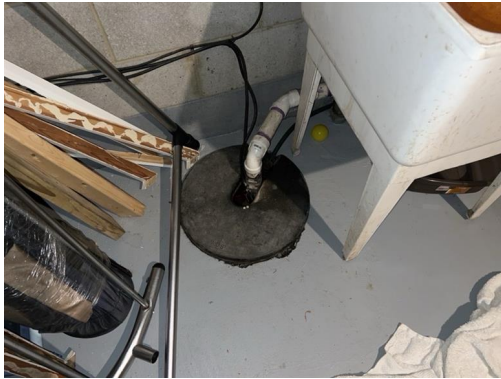
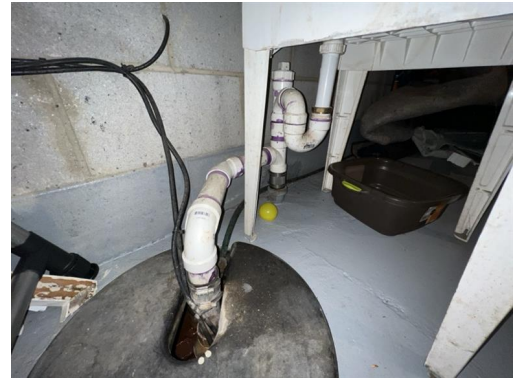
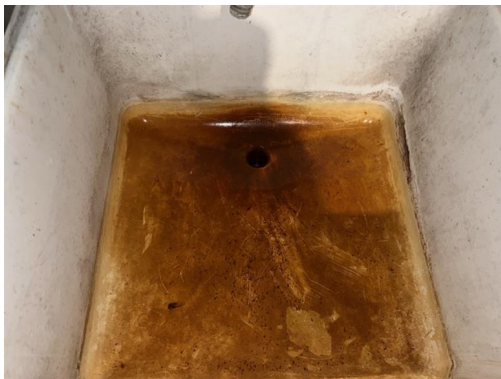
## WATER CONTROL/SUMP PUMP

7.	<b>Water Control/Sump Pump</b> The sump pump drains into the municipal sewer system, also the drain line is not adequately sized for the amount of water discharged, the water backflows into the connected mop sink. Reroute the discharge to the exterior away from the structure. LOCATION: Basement.	27

ISSUE	The sump pump drains into the municipal sewer system, also the drain line is not adequately sized for the amount of water discharged, the water backflows into the connected mop sink.
LOCATION	Basement
IMPLICATION	Not designed to be plumbed in this fashion and may not adequately drain.
RECOMMENDATION	Reroute the discharge to the exterior away from the structure.
RESOURCE	Experienced professional

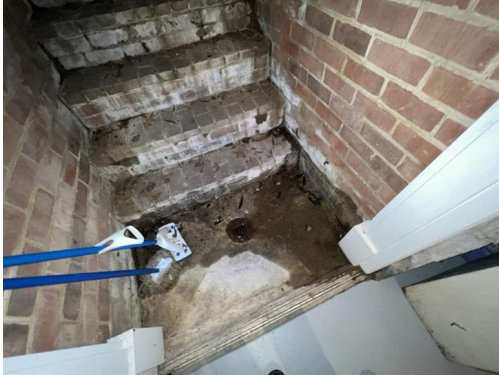
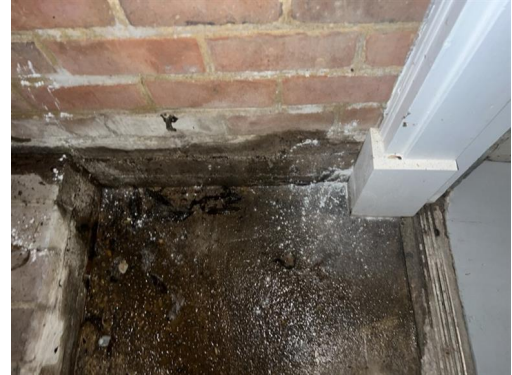
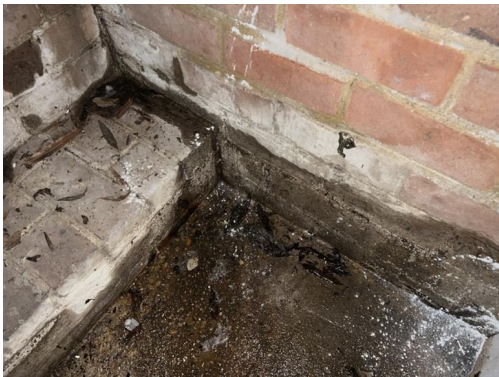
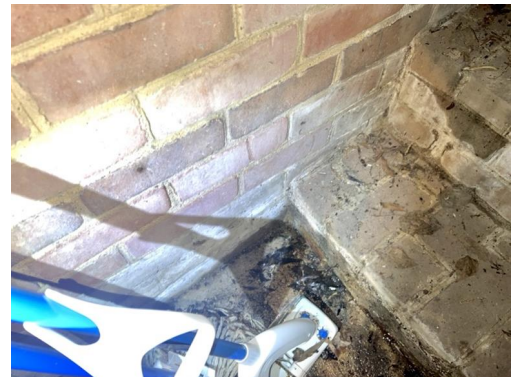
**R** STRUCTURE/FOUNDATION

8.	<b>Structure/Foundation</b> There is evidence of active water intrusion at the right side of the basement below the exterior entry door. Engage a structural contractor to evaluate and to make repairs, as required. LOCATION: Right Side.	30

ISSUE	There is evidence of active water intrusion at the right side of the basement below the exterior entry door.
LOCATION	Right Side
IMPLICATION	Conducive to microbial growth and related damage.
RECOMMENDATION	Engage a structural contractor to evaluate and to make repairs, as required.
RESOURCE	Structural contractor

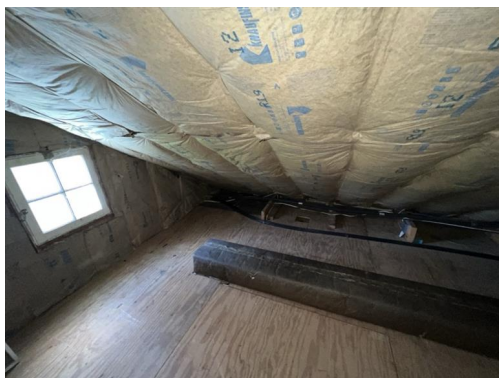
**●** STRUCTURE/ROOF SHEATHING

ISSUE	The attic is finished and covered with insulation; the inspector does not inspect behind walls, above ceilings, or other obstructions which obstruct the inspector's view.
-------	--

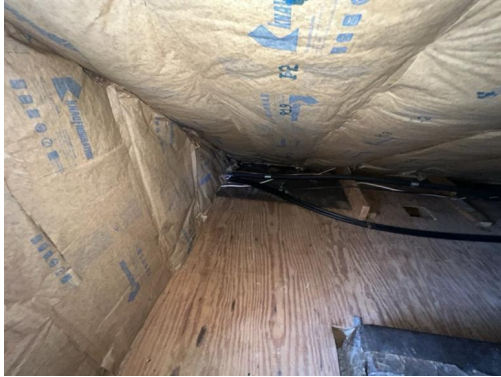
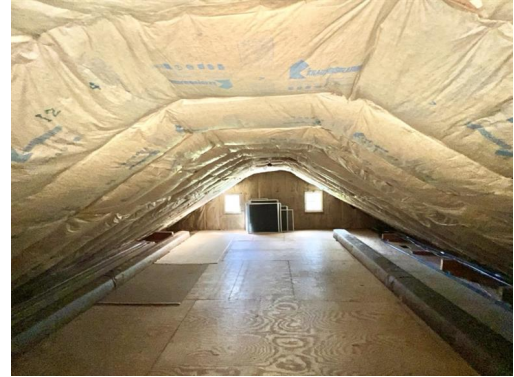
## R INSULATION AND VENTILATION/ATTIC INSULATION

9.	<b>Insulation and Ventilation/Attic Insulation</b> The insulation paper backing is exposed. Engage a contractor to evaluate and to make repairs, as required. LOCATION: Rear.	32

ISSUE	The insulation paper backing is exposed.
LOCATION	Rear
IMPLICATION	The paper is designed to be covered by wallboard/drywall. Insulation must be installed properly with fire-rated materials.
RECOMMENDATION	Engage a contractor to evaluate and to make repairs, as required.
RESOURCE	Insulation contractor

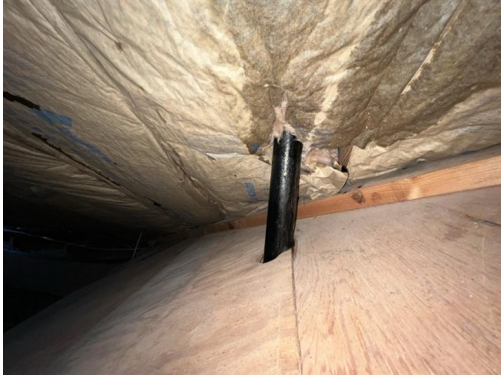
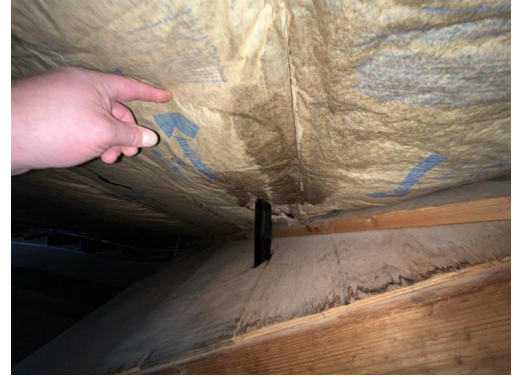
## INSULATION AND VENTILATION/ATTIC INSULATION

24.	<b>Insulation and Ventilation/Attic Insulation</b> There are water stains on the insulation; the insulation is wet. Condensation around the cast iron vent, high humidity. Mitigate the humidity and maintain as required. LOCATION: Rear.	33

ISSUE	There are water stains on the insulation; the insulation is wet. Condensation around the cast iron vent, high humidity.
LOCATION	Rear
IMPLICATION	Active water penetration.
RECOMMENDATION	Mitigate the humidity and maintain as required.
RESOURCE	Roofing contractor

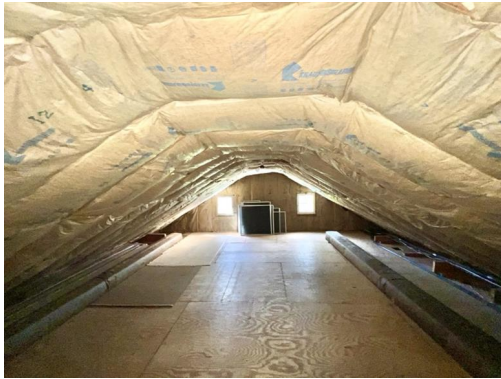
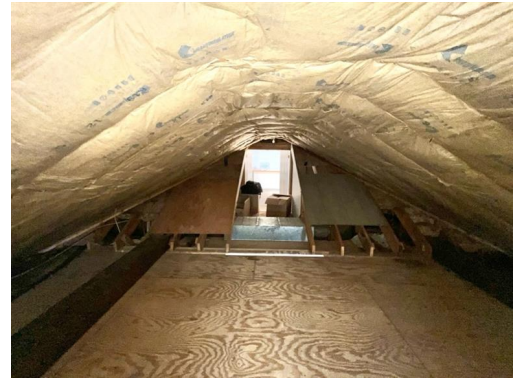
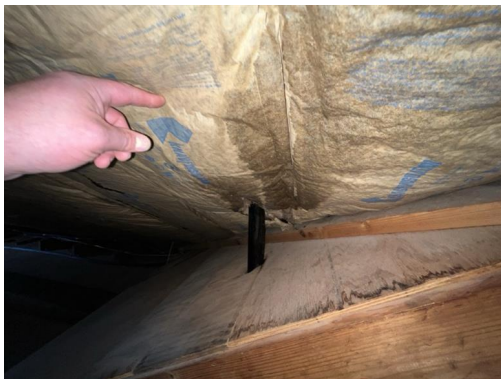
**R** INSULATION AND VENTILATION/ATTIC VENTILATION

10.	<b>Insulation and Ventilation/Attic Ventilation</b> There is no attic ventilation system. Evidence of moisture noted on the access door, around the plumbing vent, and the insulation. High humidity detected when entered. Install an attic ventilation system to maintain proper air circulation. LOCATION: Rear walk-in attic area.	34

ISSUE	There is no attic ventilation system. Evidence of moisture noted on the access door, around the plumbing vent, and the insulation. High humidity detected when entered.
LOCATION	Rear walk-in attic area.
IMPLICATION	Moisture may create conditions conducive to microbial growth.
RECOMMENDATION	Install an attic ventilation system to maintain proper air circulation.
RESOURCE	Experienced professional

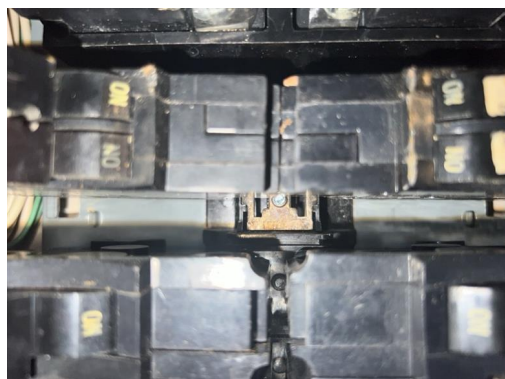
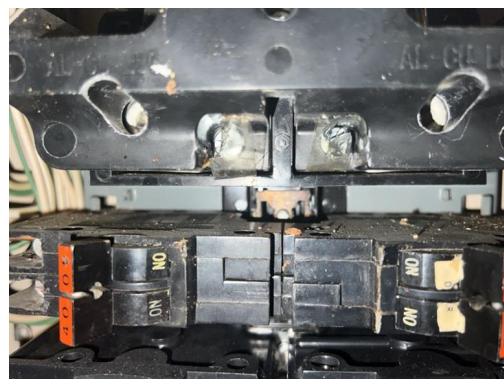
## ELECTRICAL/ELECTRICAL PANEL

25.	<b>Electrical/Electrical Panel</b> Oxidation noted on the terminal bar below the main disconnect. Monitor and maintain as required. LOCATION: Basement.	36

ISSUE	Oxidation noted on the terminal bar below the main disconnect
LOCATION	Basement
IMPLICATION	This may indicate moisture exposure.
RECOMMENDATION	Monitor and maintain as required.
RESOURCE	Electrical contractor

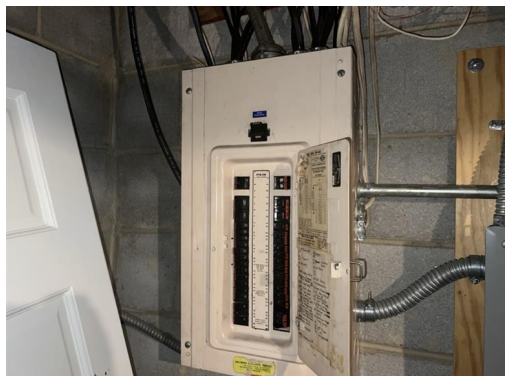
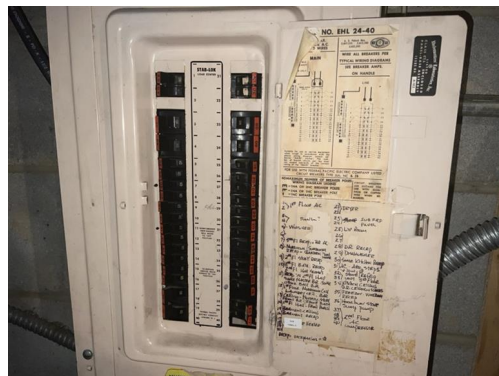
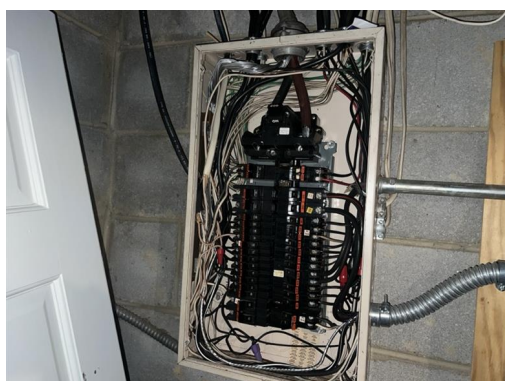
**R** ELECTRICAL/ELECTRICAL PANEL

12.	<b>Electrical/Electrical Panel</b> There is a Federal Pacific Electric breaker panel. Engage an electrical contractor to replace the panel. LOCATION: Basement.	37

ISSUE	There is a Federal Pacific Electric breaker panel.
LOCATION	Basement
IMPLICATION	Established history of overheating and arcing.
RECOMMENDATION	Engage an electrical contractor to replace the panel.
RESOURCE	Electrical contractor

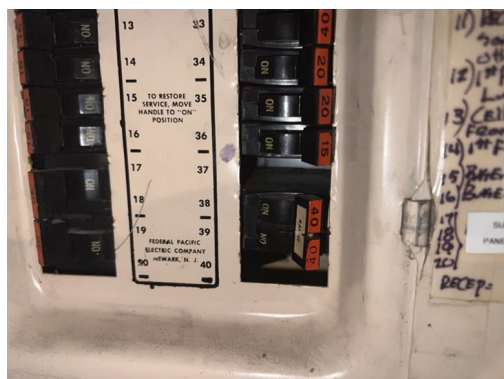
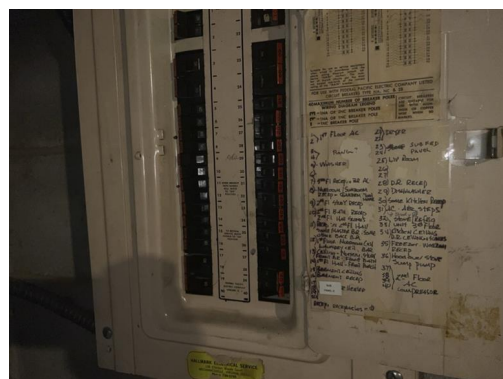
## R ELECTRICAL/ELECTRICAL PANEL

11.	<b>Electrical/Electrical Panel</b> The knockout covers are missing. Engage an electrical contractor to evaluate and to make repairs, as required. LOCATION: Basement.	38

ISSUE	The knockout covers are missing.
LOCATION	Basement
IMPLICATION	Defeats the panel's fire rating and permits contact with energized components.
RECOMMENDATION	Engage an electrical contractor to evaluate and to make repairs, as required.
RESOURCE	Electrical contractor

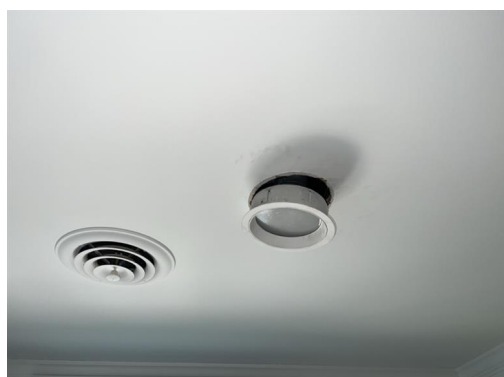
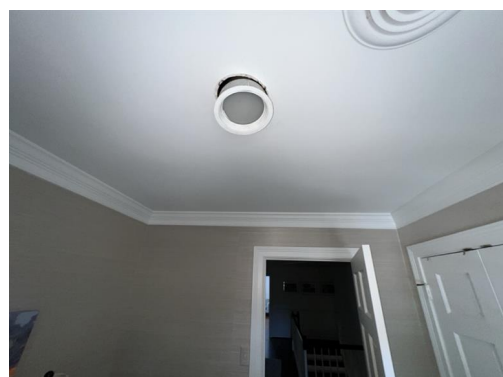
## Y ELECTRICAL/FIXTURES

ISSUE	The light fixture is loose.
LOCATION	Front Office
IMPLICATION	Electrical connections may become damaged.
RECOMMENDATION	Repair or replace the fixture.
RESOURCE	Experienced professional

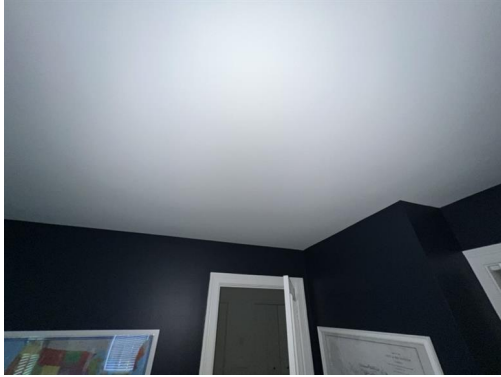
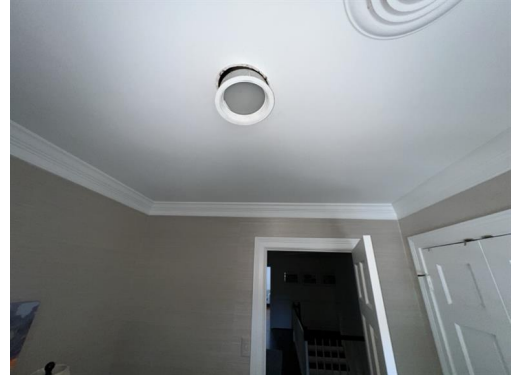
## R ELECTRICAL/SMOKE DETECTORS

13.	<b>Electrical/Smoke Detectors</b> There are missing smoke detectors. Install smoke detectors to comply with local requirements. LOCATION: Multiple Locations. Estimated cost to remedy: \$100 to \$150.	39

ISSUE	There are missing smoke detectors.
LOCATION	Multiple Locations
IMPLICATION	At least one functional smoke detector is required on each level of the house; some jurisdictions require a detector within 15' of, or inside, each bedroom.
RECOMMENDATION	Install smoke detectors to comply with local requirements.
RESOURCE	Experienced professional
COST TO REMEDY	\$100 to \$150

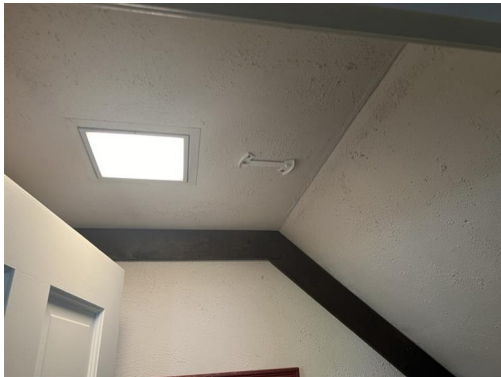
## R ELECTRICAL/CO DETECTORS

ISSUE	There are missing carbon monoxide detectors.
LOCATION	Multiple Locations
IMPLICATION	Fuel-burning appliances may emit CO in their exhaust gases or an attached garage with door(s) connected to the living space.
RECOMMENDATION	Install carbon monoxide detectors.
RESOURCE	Experienced professional

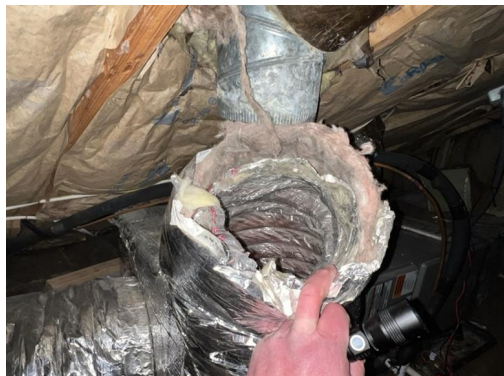
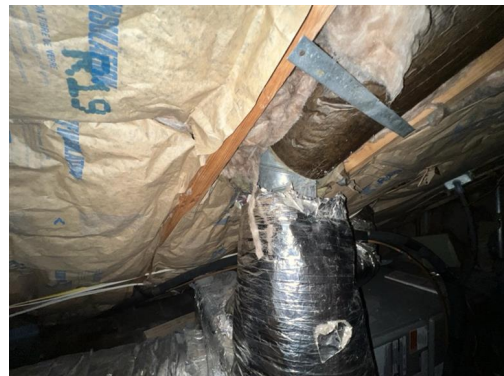
**R** HVAC/DISTRIBUTION

ISSUE	The ductwork is separated from the trunk line.
LOCATION	Attic Kneewall
IMPLICATION	Reduces system efficiency.
RECOMMENDATION	Engage an HVAC contractor to make repairs, as required.
RESOURCE	Experienced professional

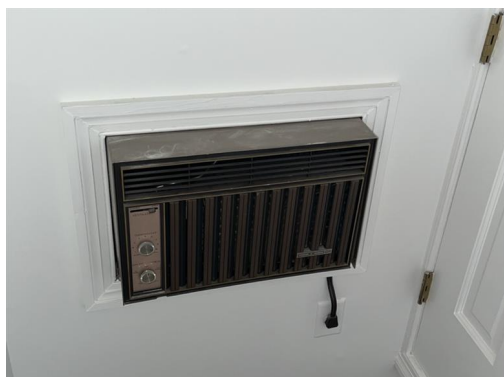
**●** HVAC/HVAC OTHER

ISSUE	The wall units are not longer in use.
-------	---------------------------------------

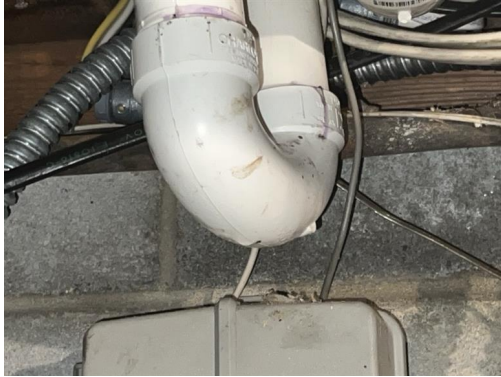
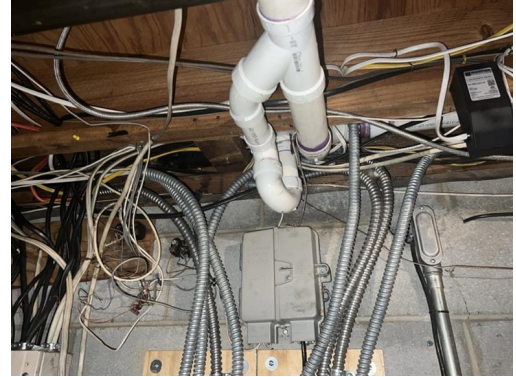
## R PLUMBING/DRAIN, WASTE, VENTS

17.	<b>Plumbing/Drain, Waste, Vents</b> The drainpipe is dripping at the rear right of the basement, the moisture appears to be condensation due to the proximity to the furnace and water heater. Consider insulating the piping to prevent moisture buildup. LOCATION: Basement.	45

ISSUE	The drainpipe is dripping at the rear right of the basement, the moisture appears to be condensation due to the proximity to the furnace and water heater.
LOCATION	Basement
IMPLICATION	Moisture buildup can damage framing, systems, and cause microbial issues.
RECOMMENDATION	Consider insulating the piping to prevent moisture buildup.
RESOURCE	Plumbing contractor

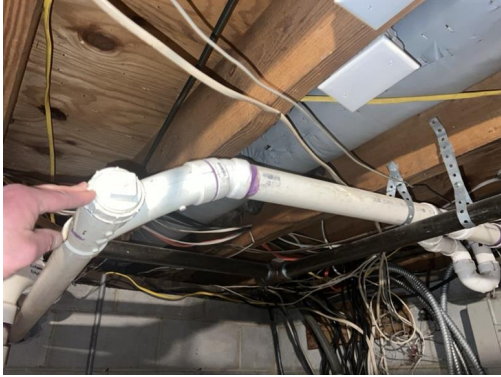
## PLUMBING/DRAIN, WASTE, VENTS

16.	<b>Plumbing/Drain, Waste, Vents</b> The drain pipe is inadequately secured. Engage a plumbing contractor to secure the pipe. LOCATION: Basement.	46

ISSUE	The drain pipe is inadequately secured.
LOCATION	Basement
IMPLICATION	Pipe may become loose or fall; exhaust may be released into the house.
RECOMMENDATION	Engage a plumbing contractor to secure the pipe.
RESOURCE	Plumbing contractor

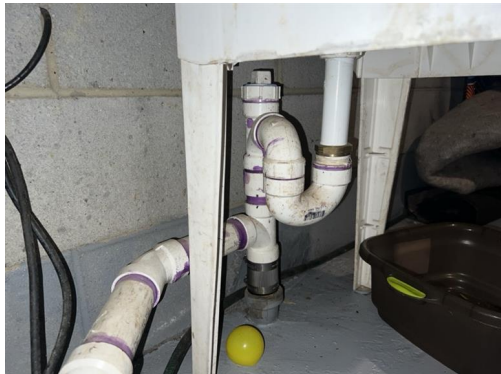
## PLUMBING/DRAIN, WASTE, VENTS

ISSUE	The mop sink drain pipe has an "s trap" installed.
LOCATION	Basement
IMPLICATION	Trap may remain empty and permit waste gases to enter the house.
RECOMMENDATION	Engage a plumbing contractor to make repairs, as required.
RESOURCE	Plumbing contractor

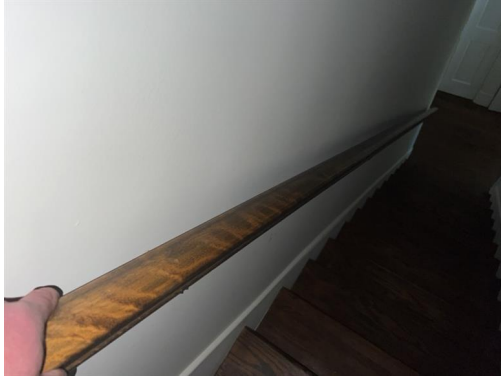
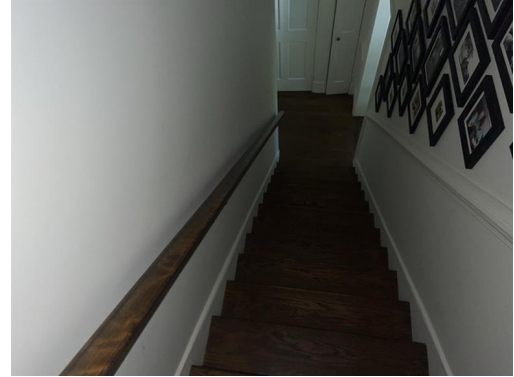
## R INTERIOR/INTERIOR STAIRS/STEPS

18.	<b>Interior/Interior Stairs/Steps</b> The railing is loose along the butlers staircase. Secure the railing as required for safety. LOCATION: Main Level.	48

ISSUE	The railing is loose along the butlers staircase.
LOCATION	Main Level
IMPLICATION	This may pose a safety issue.
RECOMMENDATION	Secure the railing as required for safety.
RESOURCE	Stairs contractor

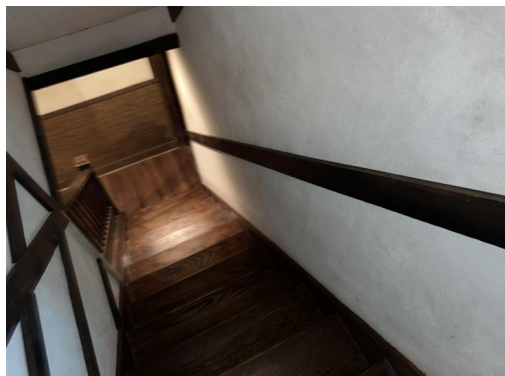
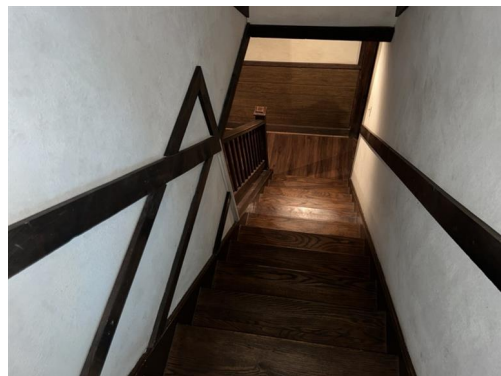
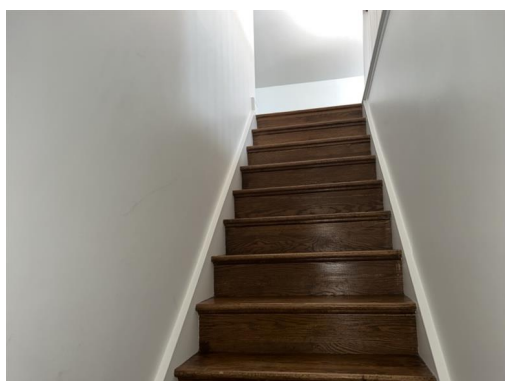
**R** INTERIOR/INTERIOR STAIRS/STEPS

19.	<b>Interior/Interior Stairs/Steps</b> The graspable handrail is not continuous along the basement and loft stairs. Install a railing where missing. LOCATION: Basement and Loft.	49

ISSUE	The graspable handrailing is not continuous along the basement and loft stairs.
LOCATION	Basement and Loft
IMPLICATION	This may pose a safety issue.
RECOMMENDATION	Install a railing where missing.
RESOURCE	Stairs contractor

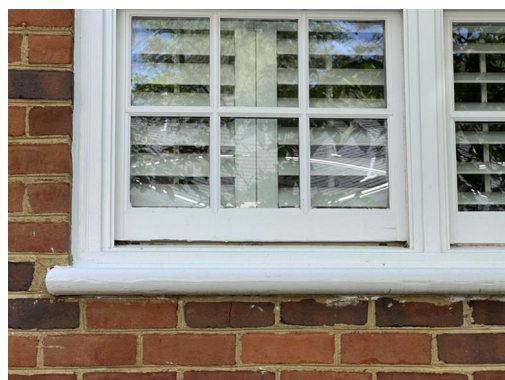
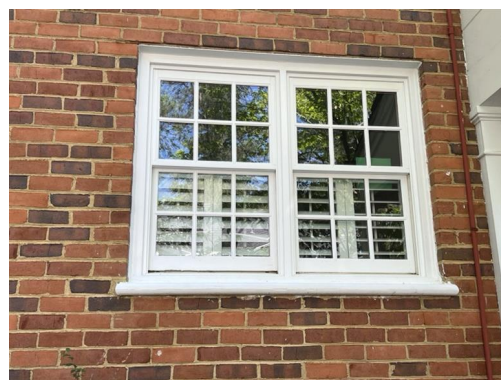
**R** INTERIOR/WINDOWS

ISSUE	Weather stripping missing.
LOCATION	Kitchen
RESOURCE	Windows contractor
