## INSPECTION INSIGHTS

| DATE | 02/01/24 |
| ADDRESS | 13200 Court Ridge Road,<br>Midlothian, VA |

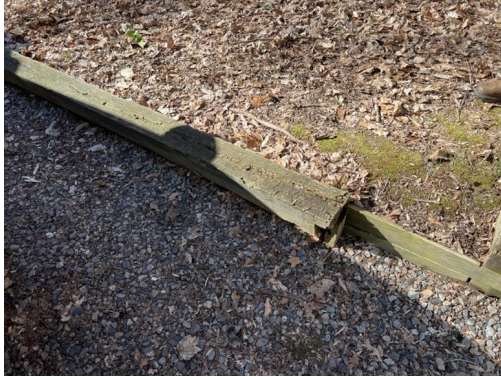
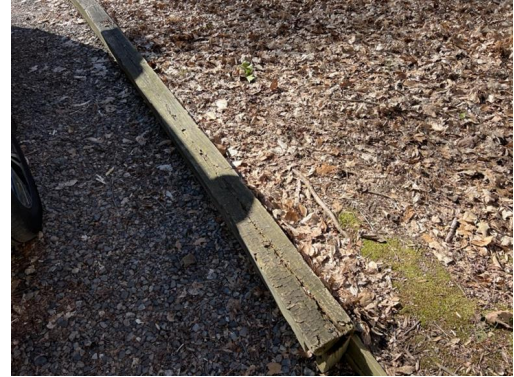
## EXTERIOR/DRIVEWAY

| ISSUE | The timber borders are rotting/deteriorating. |
| LOCATION | Front |
| IMPLICATION | The timbers will fail and prevent soil retention. |

| RECOMMENDATION | Remove all damaged materials and replace as required. |

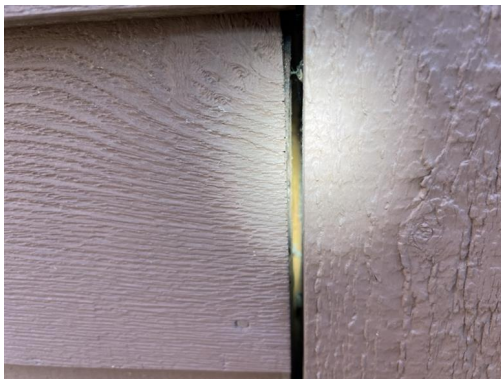
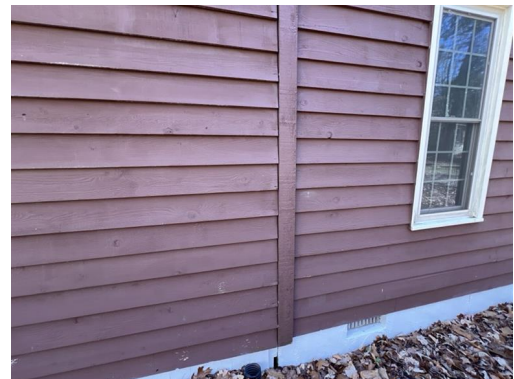
## EXTERIOR/EXTERIOR WALLS

| ISSUE | There are gaps in the siding between the home and the shed. |
| LOCATION | Left Side |

| RECOMMENDATION | Replace the siding and repair any damage which may be revealed. |

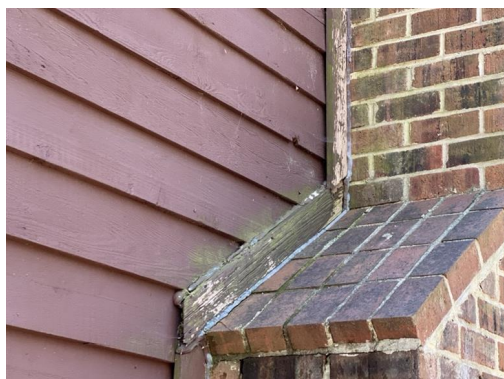
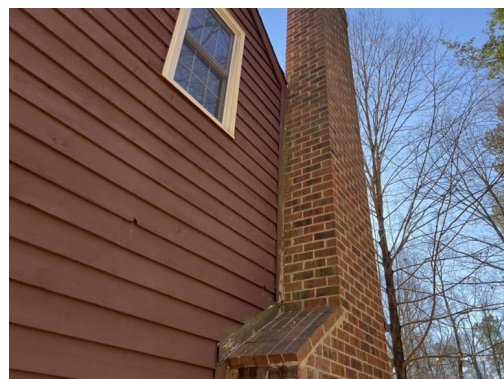
**R** EXTERIOR/EXTERIOR TRIM

| ISSUE | The trim is behind the chimney is deteriorated from moisture exposure. |
| LOCATION | Left side. |

| RECOMMENDATION | Replace the trim and repair any damage which may be revealed. |

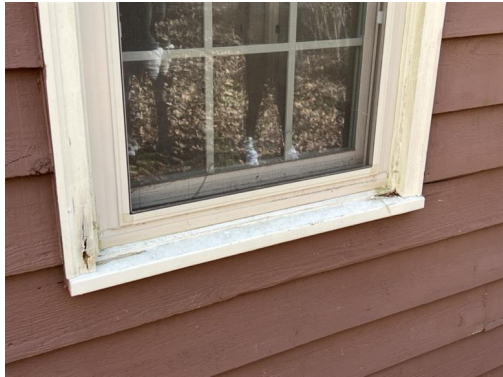
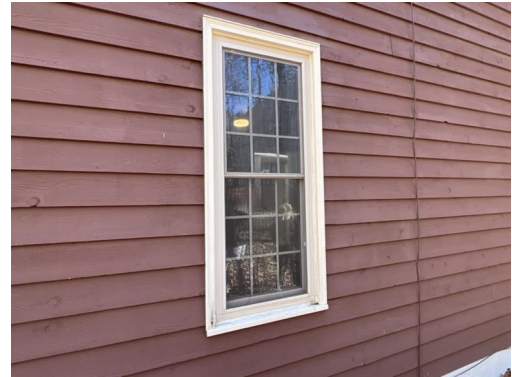
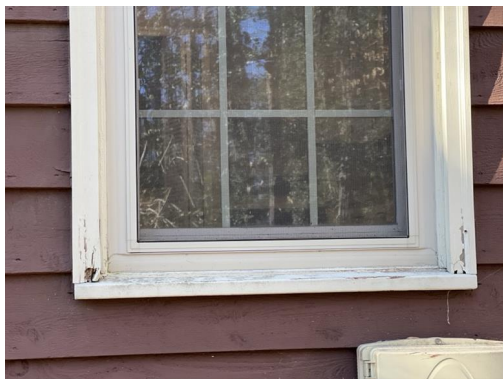
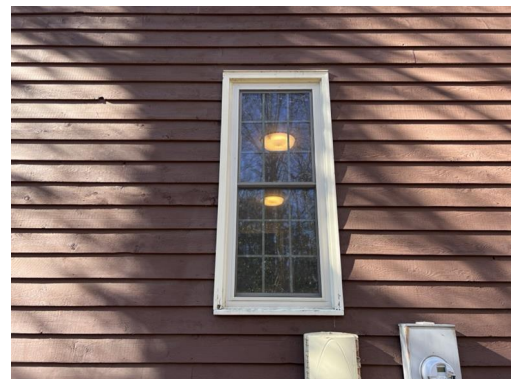
**R** EXTERIOR/EXTERIOR TRIM

| ISSUE | There is rotted/damaged trim around the window. |
| LOCATION | Left side lower window and right rear lower window. |

| RECOMMENDATION | Replace the trim and repair any damage which may be revealed. |

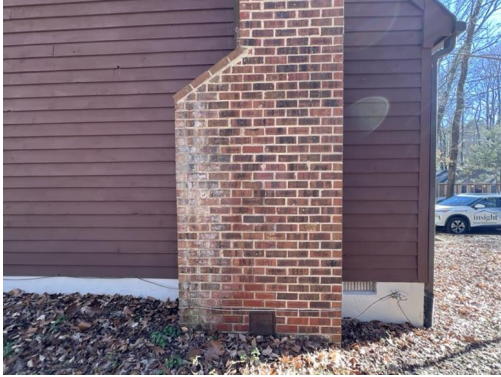
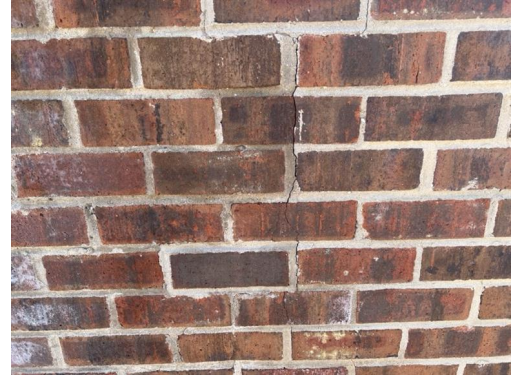
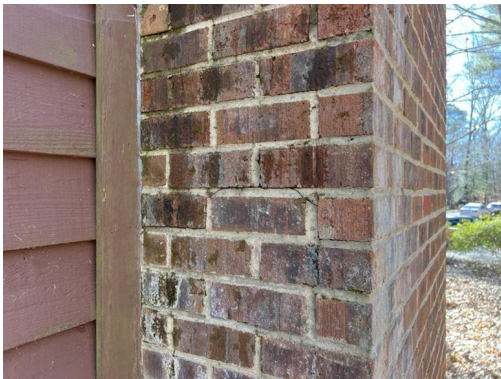
**R** EXTERIOR/CHIMNEY

| ISSUE | There are cracks in the exterior bricks of the chimney chase; there is no discernible movement. |
| LOCATION | Left Side |

| RECOMMENDATION | Fill and seal the cracks, as required. |

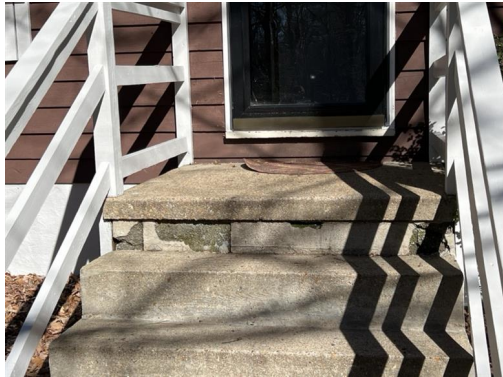
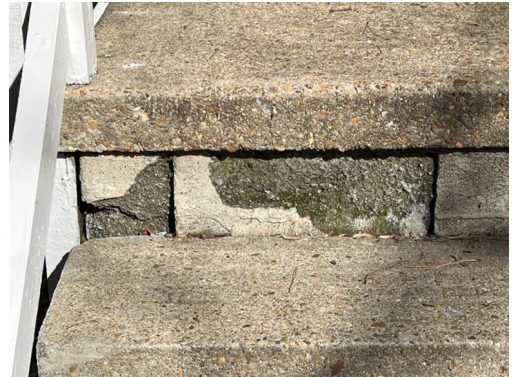
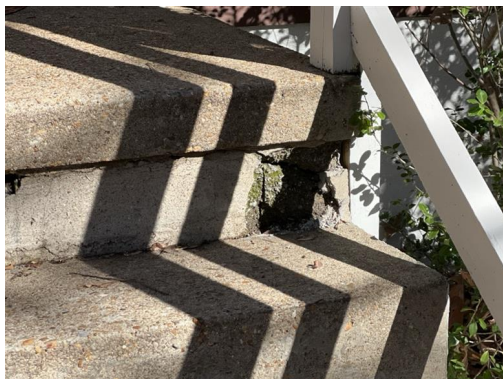
| ISSUE | The top concrete riser is beginning to scale/spall. |
| LOCATION | Front |
| IMPLICATION | The deterioration will continue unless corrected. |

| RECOMMENDATION | Patch and maintain as required. |

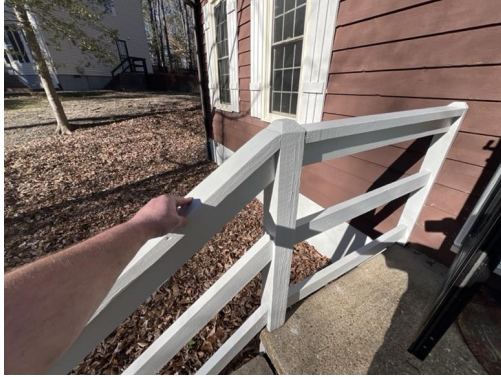
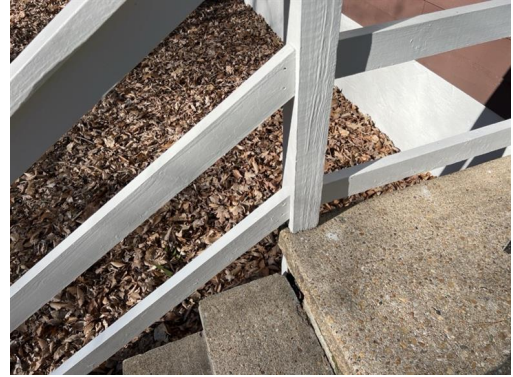
| ISSUE | The handrail is loose at the left side of the landing. |
| LOCATION | Front |

| RECOMMENDATION | Secure or replace the handrail as required for safety. |

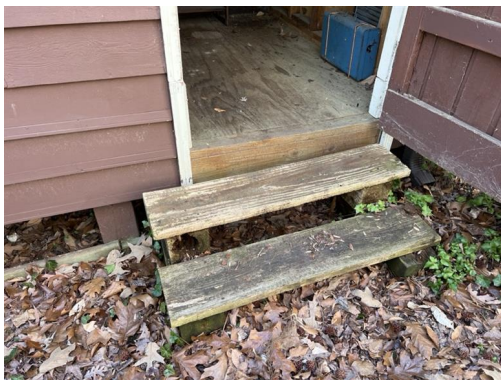
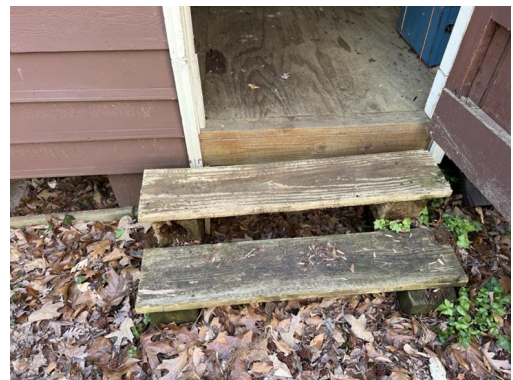
| ISSUE | There are rotted/damaged treads and framing. |
| LOCATION | Rear attached storage |

| RECOMMENDATION | Replace the stairs as required for safety. |

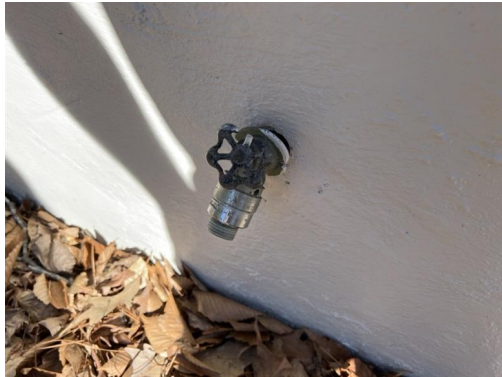
**R** EXTERIOR/HOSE FAUCETS

| ISSUE | The hose faucet handle is broken. |
| LOCATION | Front |

| RECOMMENDATION | Replace the faucet handle. |

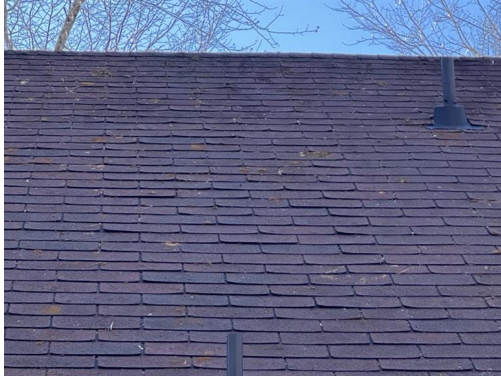
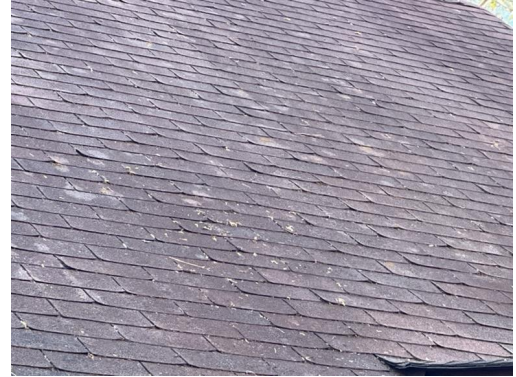
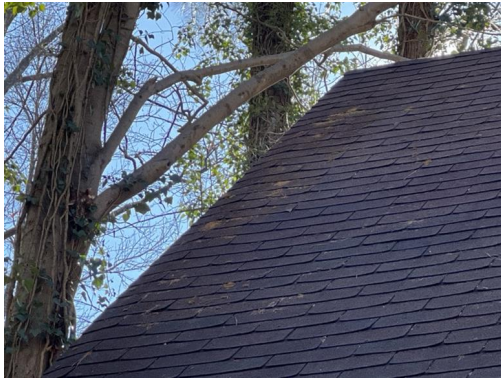
## ROOF/ROOFING

| ISSUE | The shingles are lifted at the corners. |
| LOCATION | Multiple Locations |

| RECOMMENDATION | Engage a roofing contractor to make repairs or replace the roofing. |

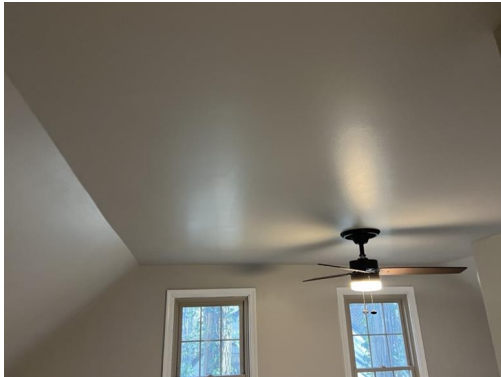
## STRUCTURE/ROOF STRUCTURE

The roof structure is not accessible.

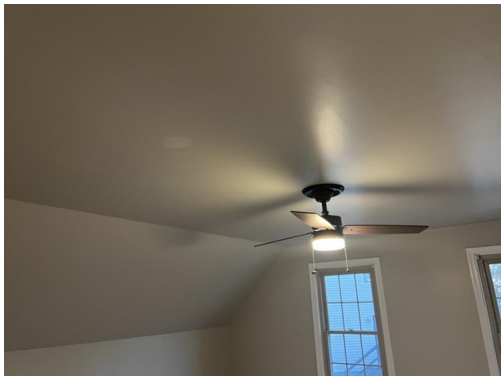
## STRUCTURE/ROOF SHEATHING

The attic is finished; the inspector does not inspect behind walls, above ceilings, or other obstructions which obstruct the inspector's view.

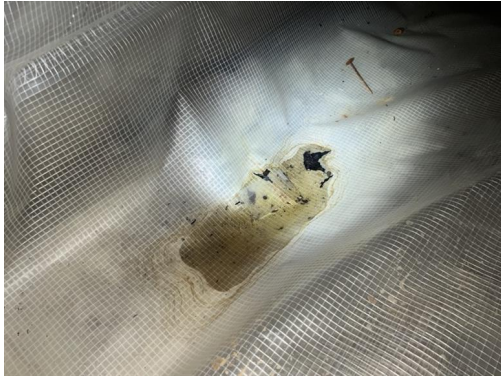
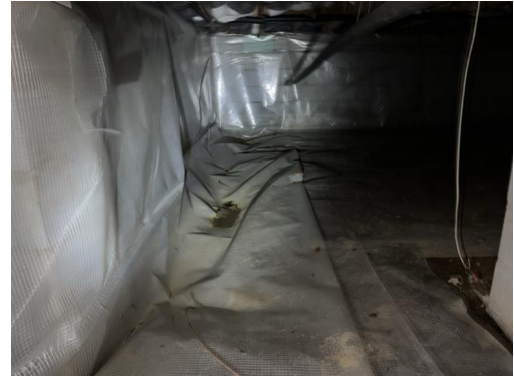
| ISSUE | There is standing water in the crawl space. The moisture appears to be originating from below the vapor barrier seam. |
| LOCATION | The front right corner of the crawlspace. |
| IMPLICATION | Conducive to microbial growth and related deterioration. |

| RECOMMENDATION | Identify and mitigate the source of water penetration. Seal the center seams as required. |

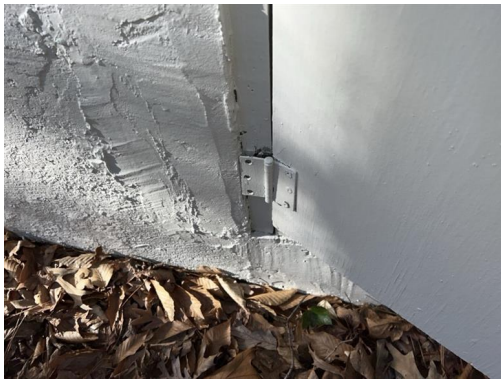
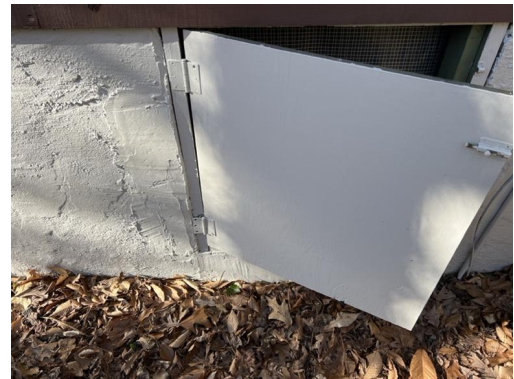
| ISSUE | The access cover hinge is not connected. |
| LOCATION | Right Side |
| IMPLICATION | This affects energy efficiency and may permit water to enter and damage the structure. |

| RECOMMENDATION | Repair or replace the cover. |

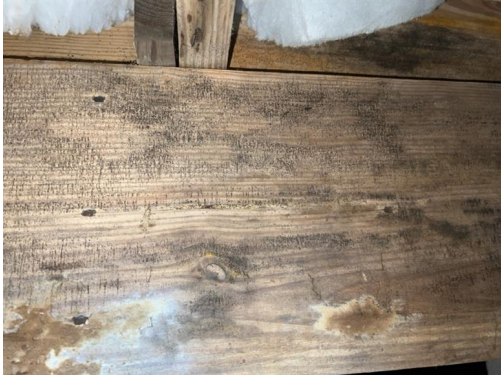
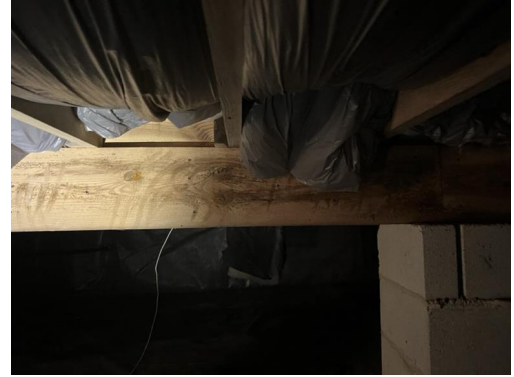
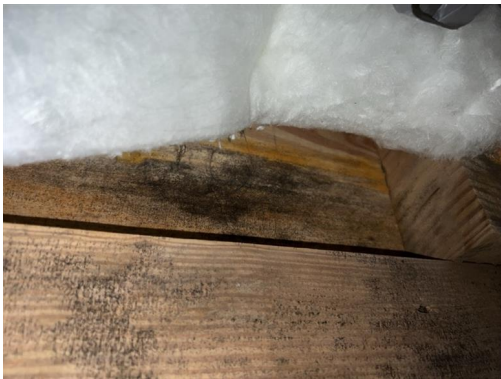
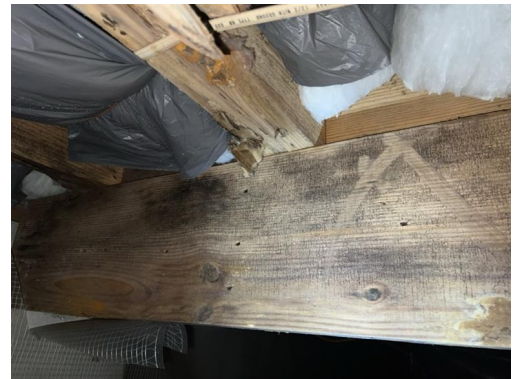
| ISSUE | There is suspected microbial growth on the framing in the crawlspace. |
| LOCATION | Crawlspace |
| IMPLICATION | Microbial growth may cause health issues and lead to deterioration of underlying components. The inspector doesn't determine the extent of the activity or related damage during an inspection. |

| RECOMMENDATION | Engage an environmental contractor to evaluate and treat as required. |

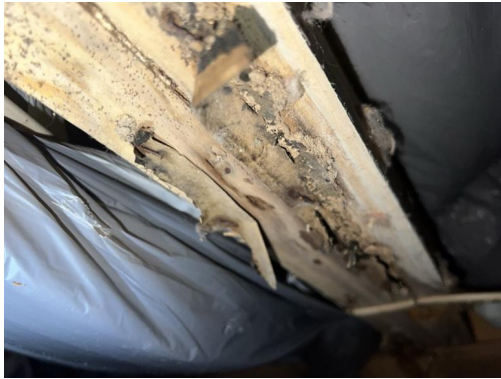
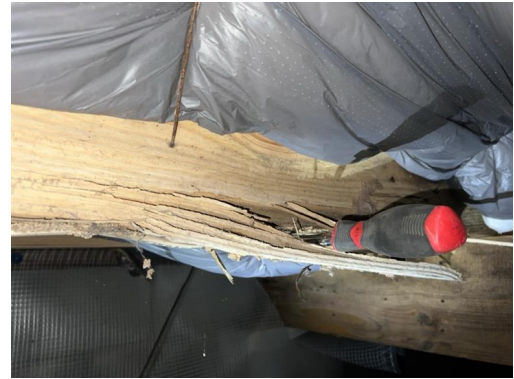
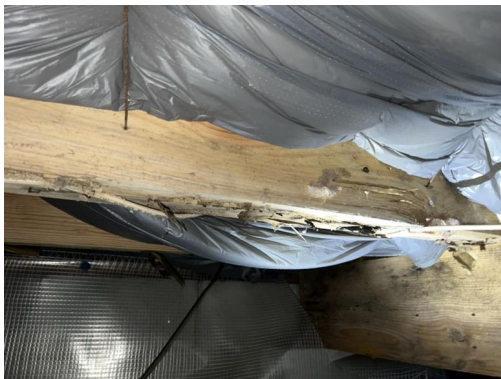
| ISSUE | There is evidence of possible wood-destroying insect activity. Damaged joist observed resting on the center beam. |
| LOCATION | Left center of the crawlspace. |
| IMPLICATION | The inspector doesn't determine the extent of the activity or any damage during a home inspection. |

| RECOMMENDATION | Engage a pest control technician to evaluate and treat as required. Following treatment repair all damaged framing, recommend sistering the damaged joist full span. |

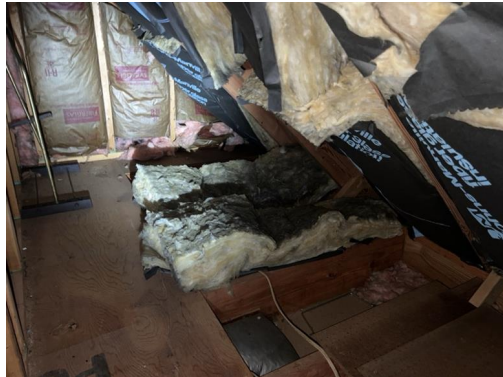
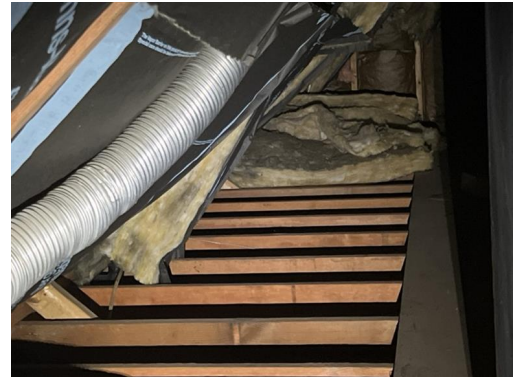
## INSULATION AND VENTILATION/ATTIC INSULATION

| ISSUE | The insulation has fallen from the rafters bays. |
| LOCATION | Left side and right sides of the rear kneewall attic. |

| RECOMMENDATION | Install insulation in accordance with local guidelines. |

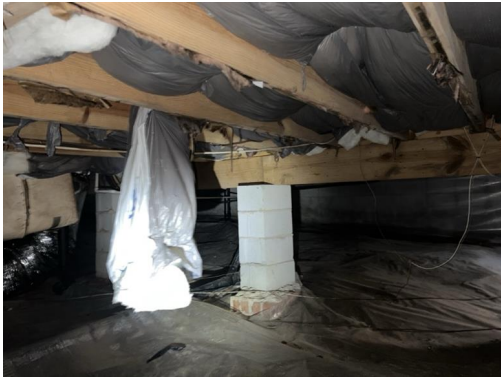
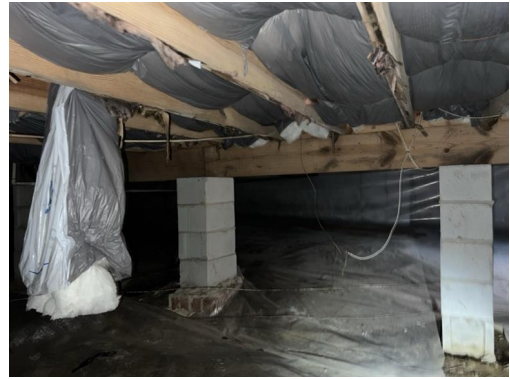
INSULATION AND VENTILATION/CRAWL SPACE INSULATION

| ISSUE | The insulation is loose or falling. |
| LOCATION | The front right of the crawlspace. |

| RECOMMENDATION | Install insulation in accordance with local guidelines. |

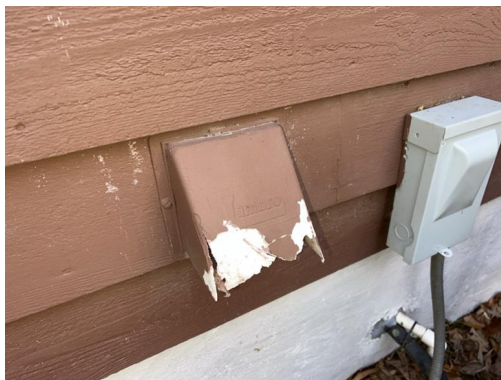
INSULATION AND VENTILATION/EXHAUST VENTILATION

| ISSUE | The exterior hood is damaged or deteriorated. |
| LOCATION | Rear |

| RECOMMENDATION | Replace the hood. |

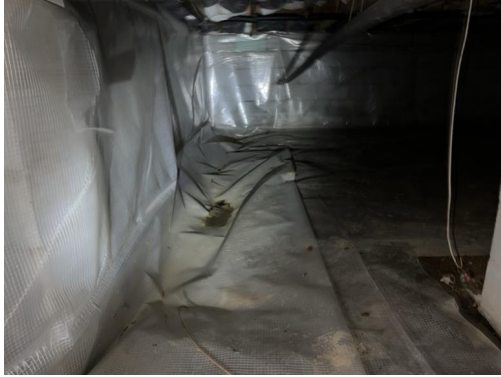
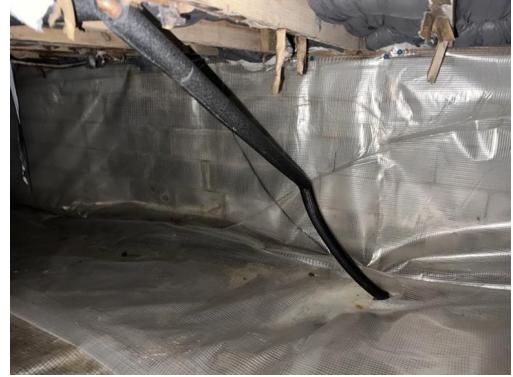
## INSULATION AND VENTILATION/CRAWL SPACE VENTILATION

| ISSUE | The crawl space is mostly encapsulated (sealed vents and vapor barrier) with no source of air circulation or humidity control. |
| LOCATION | Crawlspace |
| IMPLICATION | Seal areas with no air movement may allow moisture to accumulate and create conditions conducive to microbial growth. |

| RECOMMENDATION | Engage a crawlspace contractor to install a dehumidifier or air circulation system. |

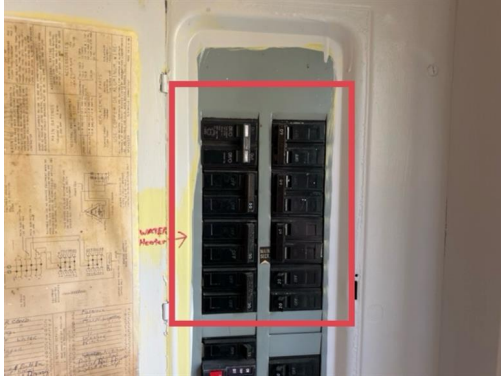
| ISSUE | There is no main breaker on the "split bus" panel. |
| LOCATION | Kitchen |

| RECOMMENDATION | Maintain as required, consider upgrading to a single throw if other electrical work is being done. |

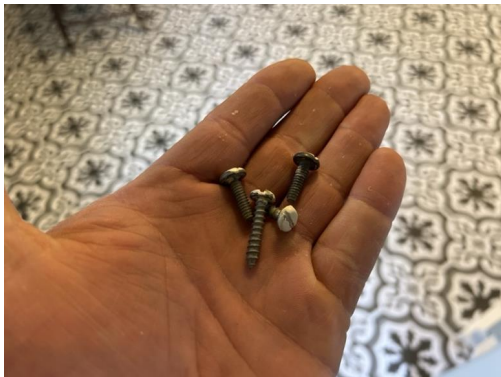
| ISSUE | There are pointed screws securing the cover. |
| LOCATION | Kitchen |

| RECOMMENDATION | Engage an electrical contractor to replace the screws. |

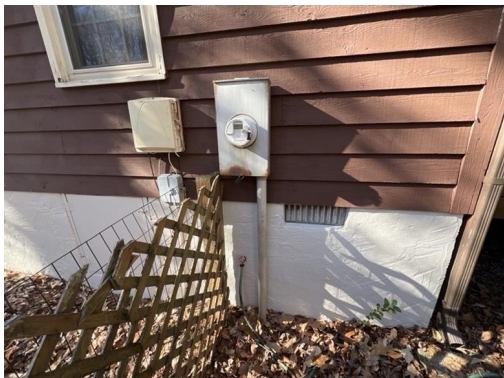
ELECTRICAL/GROUNDING/BONDING

ISSUE                      The grounding/bonding location can't be identified.

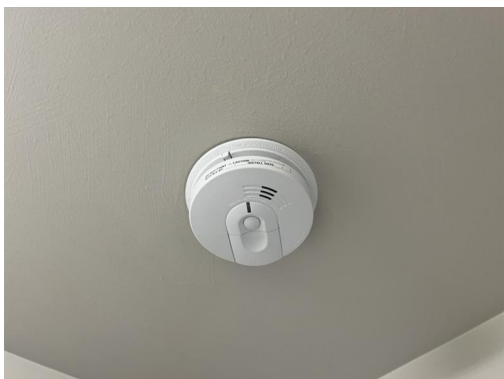
ELECTRICAL/CO DETECTORS

| ISSUE | There are missing carbon monoxide detectors. No gas fueled appliances present. |
| LOCATION | Multiple Locations |
| IMPLICATION | Fuel-burning appliances may emit CO in their exhaust gases or an attached garage with door(s) connected to the living space. |

| RECOMMENDATION | Install carbon monoxide detectors. |

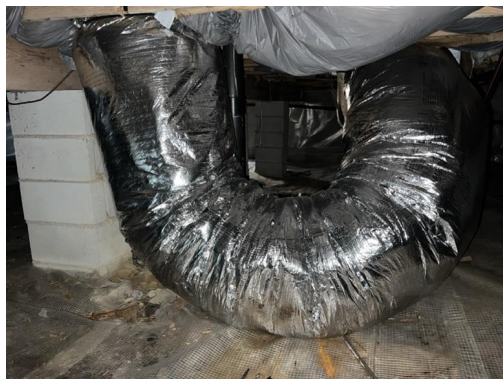
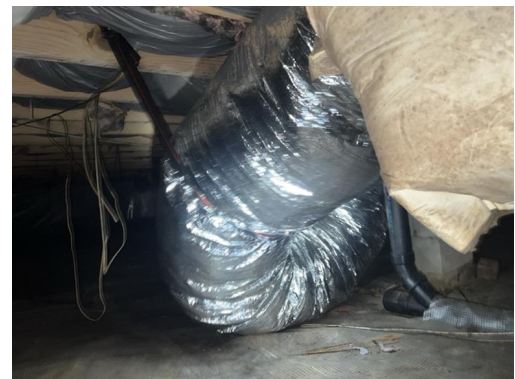
## HVAC/DISTRIBUTION

| ISSUE | The main trunk line is inadequately supported and laying on the ground. |
| LOCATION | Crawl Space |
| IMPLICATION | Reduces system efficiency, restricts air flow, and may cause damage to the ducting. |

| RECOMMENDATION | Secure the ductwork to the framing above. |

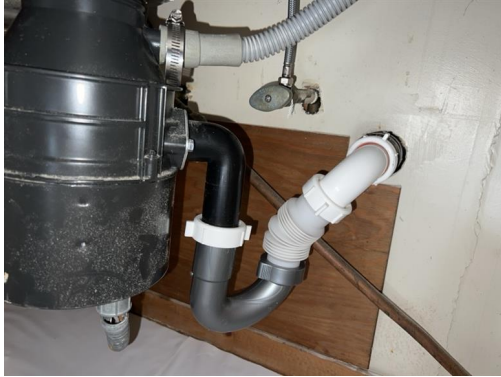
| ISSUE | The drain pipe is a corrugated or accordion style. |
| LOCATION | Kitchen |

| RECOMMENDATION | Engage a plumbing contractor to replace the pipe. |

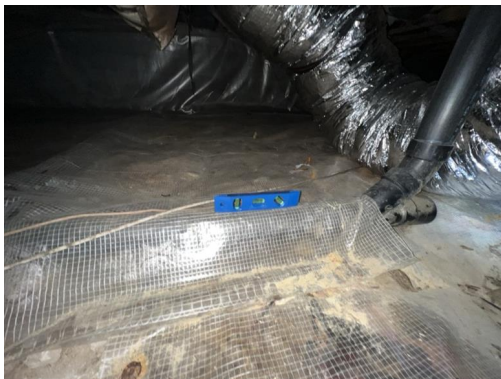
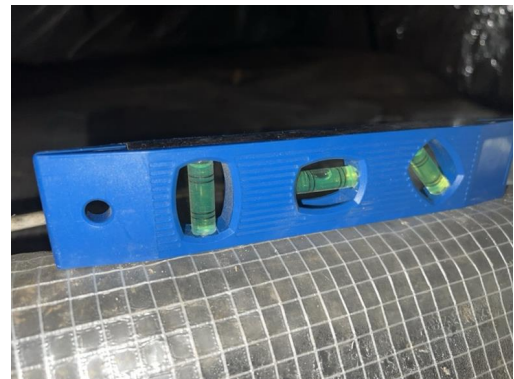
| ISSUE | The drain pipe is improperly sloped and back pitched. |
| LOCATION | Center of the crawlspace below the bathroom. |

| RECOMMENDATION | Engage a plumbing contractor to reinstall the pipe with a proper slope. |

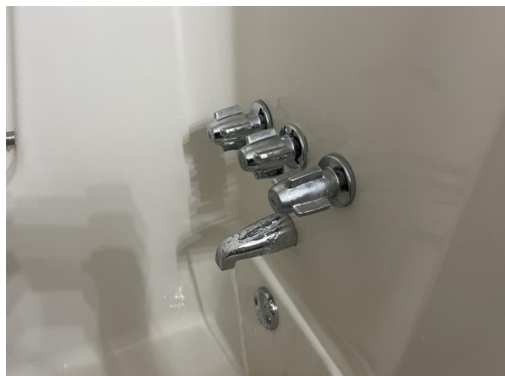
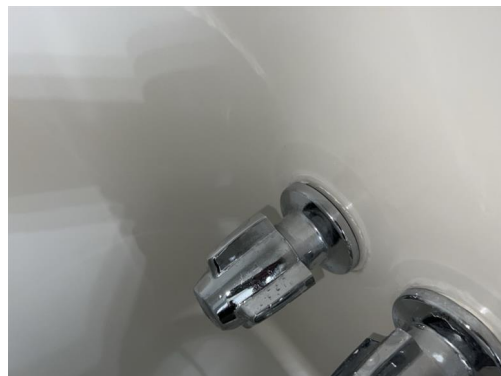
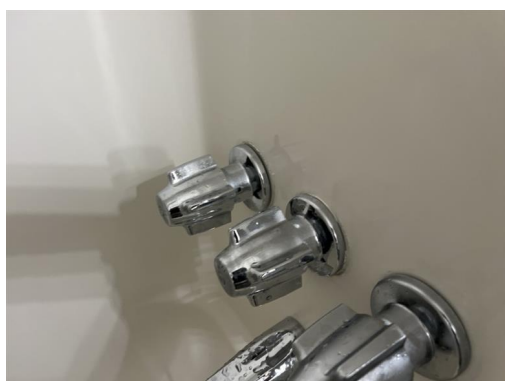
**R** PLUMBING/SHOWERS/TUBS

| ISSUE | The faucet handle leaks when operated, also gaps noted between the handles and the stall. |
| LOCATION | Main floor bathroom |
| IMPLICATION | Water may penetrate and damage the structure; there may be hidden damage. |

| RECOMMENDATION | Repair or replace the faucet to prevent water intrusion. |

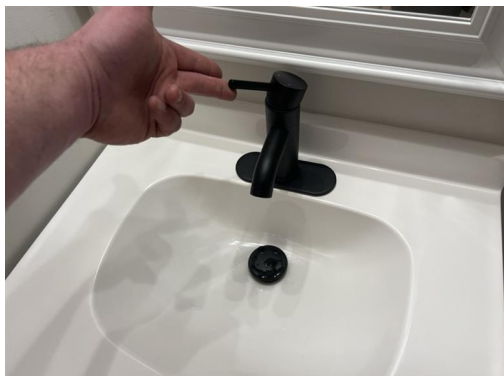
| ISSUE | The sink faucet is not adjusted correctly. The water stops when pressed to the hot water side. |
| LOCATION | Second floor bathroom. |

| RECOMMENDATION | Adjust the faucet cartridge as required to restore proper function. |

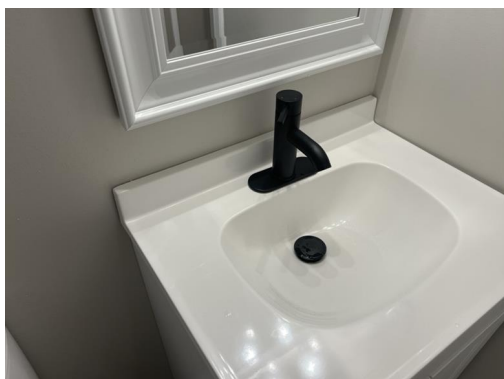
| ISSUE | The faucet is loose. |
| LOCATION | Main floor bathroom |

| RECOMMENDATION | Repair or replace the faucet. |

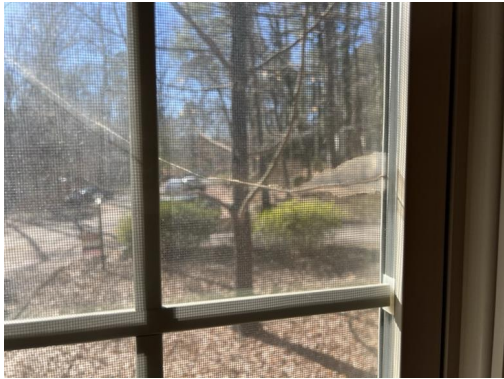
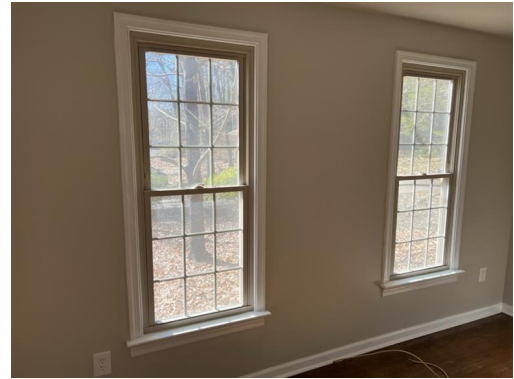
**R** INTERIOR/WINDOWS

| ISSUE | The window pane is broken. |
| LOCATION | The front right family room window. |

| RECOMMENDATION | Replace the window pane. |

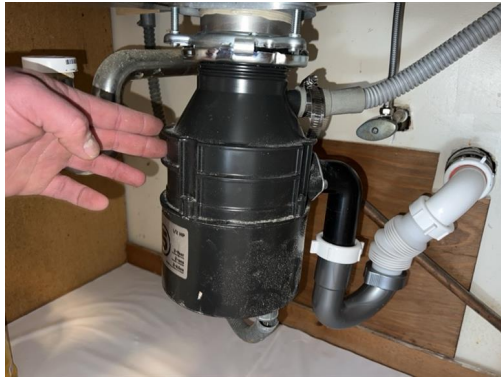
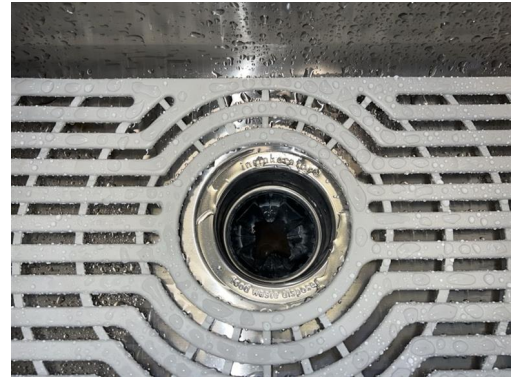
## R APPLIANCES/GARBAGE DISPOSER

| ISSUE | The disposal grind chamber is jammed. |
| LOCATION | Kitchen |

| RECOMMENDATION | Engage a qualified professional to repair/replace as required. |

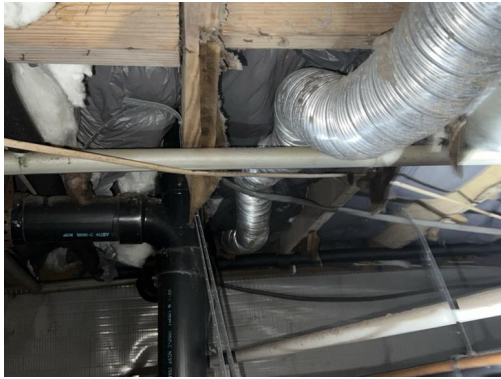
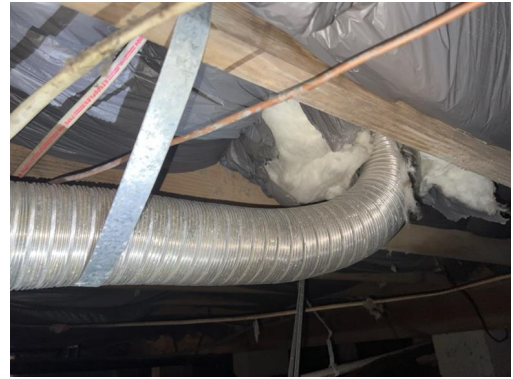
## APPLIANCES/DRYER 1 VENTILATION

| ISSUE | The vent pipe is an improper material. Corrugated ducting collects lint in the ridges and can be easily torn. |
| LOCATION | Center of the crawlspace |
| IMPLICATION | The ducting is easily damaged and humid air may be released under the house. |

| RECOMMENDATION | Replace the vent pipe with a hard smooth walled duct discharging to the exterior. |
