| DATE | 03/17/25 |

| ADDRESS | 2895 Johnsonway Terrace,<br>Powhatan, VA |

| NAME | Pavell Megan |

# TABLE OF CONTENTS

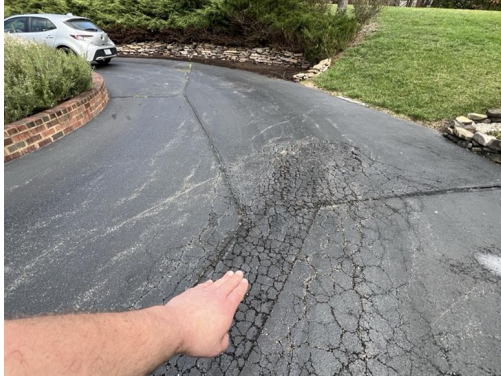
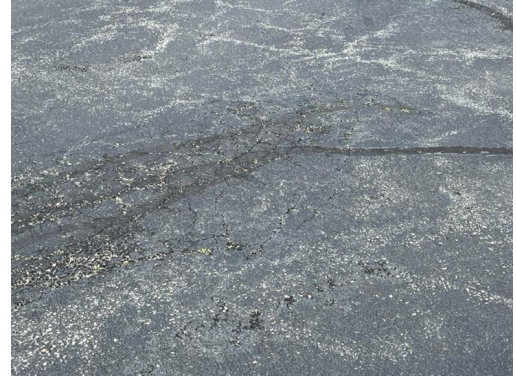
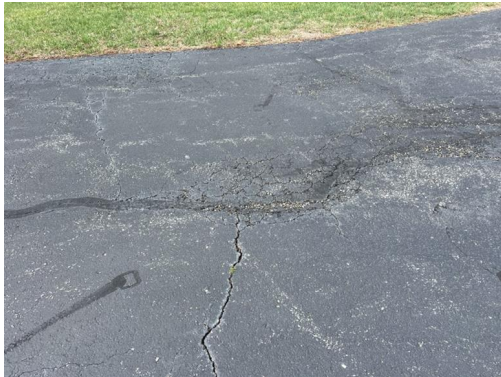
## R EXTERIOR/DRIVEWAY

| 1. | <b>Exterior/Driveway</b> The driveway is significantly deteriorated. Shifting in the asphalt noted. Repair and seal the driveway. LOCATION: Multiple Locations. Estimated cost to remedy: \$2,500 to \$3,000. | 13 | |

| ISSUE | The driveway is significantly deteriorated. Shifting in the asphalt noted. |
| LOCATION | Multiple Locations |
| IMPLICATION | Deterioration may have an impact on function; water may also penetrate the driveway and cause further deterioration. |

| RECOMMENDATION | Repair and seal the driveway. |
| COST TO REMEDY | \$2,500 to \$3,000 |

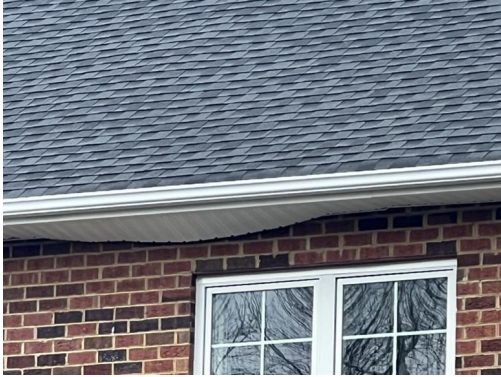
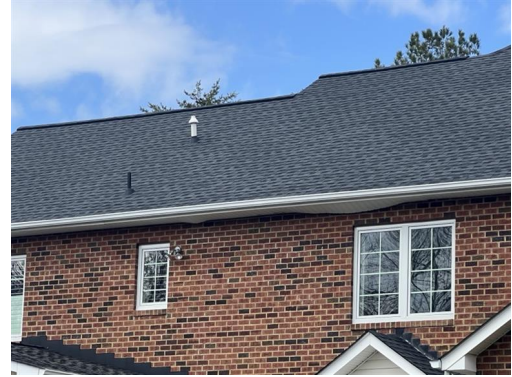
**R** EXTERIOR/EXTERIOR TRIM

| 2. | <b>Exterior/Exterior Trim</b> The soffit cover is loose and has fallen out of position. Replace the soffit and repair any damage which may be revealed. LOCATION: Rear. Estimated cost to remedy: \$350 to \$450. | 14 | |

| ISSUE | The soffit cover is loose and has fallen out of position. |
| LOCATION | Rear |
| IMPLICATION | May permit pest ingress. |

| RECOMMENDATION | Replace the soffit and repair any damage which may be revealed. |
| COST TO REMEDY | \$350 to \$450 |

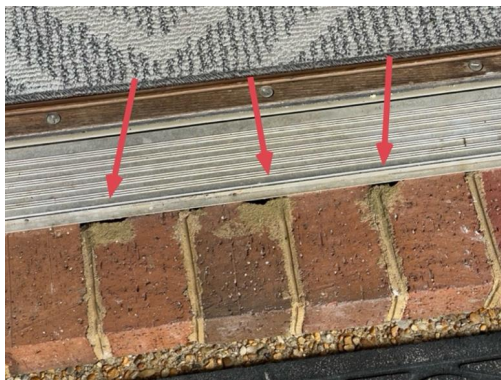
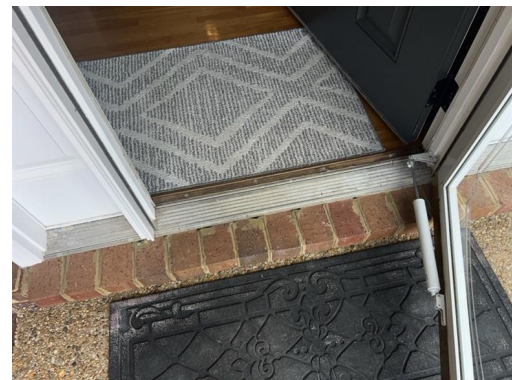
**Y** EXTERIOR/EXTERIOR DOORS

| 9. | <b>Exterior/Exterior Doors</b> The threshold below the door isn't sealed, gaps between the metal and veneer noted. Seal the threshold. LOCATION: Front. | 14 | |

| ISSUE | The threshold below the door isn't sealed, gaps between the metal and veneer noted. |
| LOCATION | Front |
| IMPLICATION | This affects energy efficiency and may permit moisture intrusion, pest ingress. |

| RECOMMENDATION | Seal the threshold. |

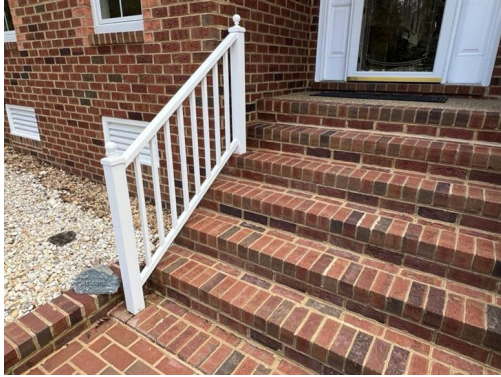
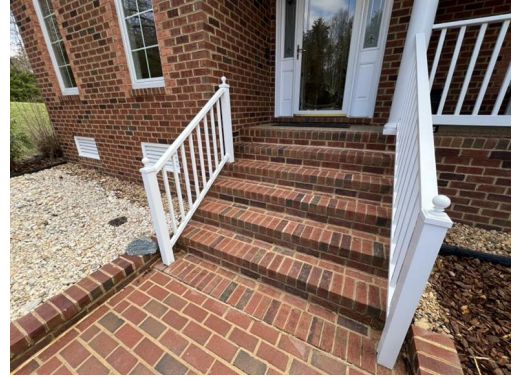
## EXTERIOR/EXTERIOR STAIRS/STEPS

| 3. | <b>Exterior/Exterior Stairs/Steps</b> The handrail is loose at the left side of the stairs. Secure or replace the handrail. Estimated cost to remedy: \$150 to \$250. | 15 | |

| ISSUE | The handrail is loose at the left side of the stairs. |
| IMPLICATION | This poses a safety issue. |

| RECOMMENDATION | Secure or replace the handrail. |
| COST TO REMEDY | \$150 to \$250 |

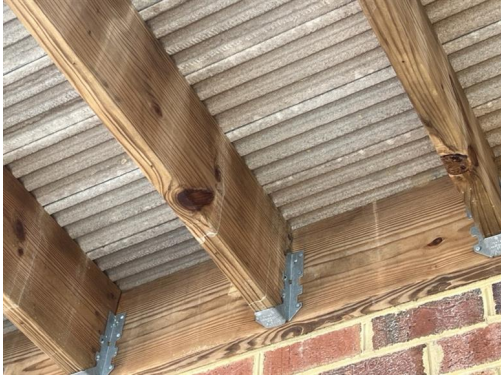
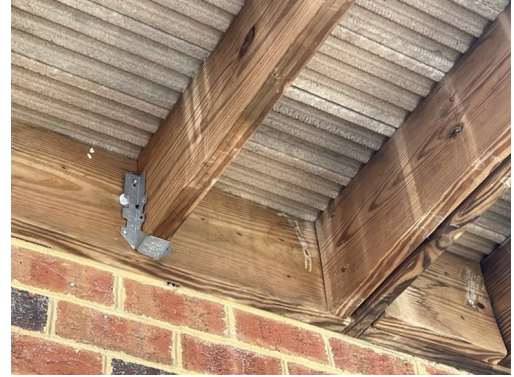
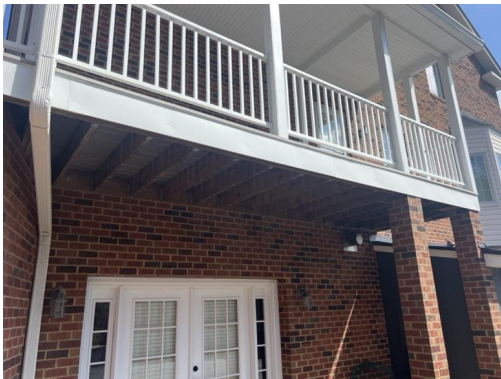
**R** EXTERIOR/PORCH

| 4. | <b>Exterior/Porch</b> The joist hangers are missing fasteners. Replace the fasteners. LOCATION: Right Side. Estimated cost to remedy: \$150 to \$250. | 16 | |

| ISSUE | The joist hangers are missing fasteners. |
| LOCATION | Right Side |
| IMPLICATION | This affects its load-bearing capacity. |

| RECOMMENDATION | Replace the fasteners. |
| COST TO REMEDY | \$150 to \$250 |

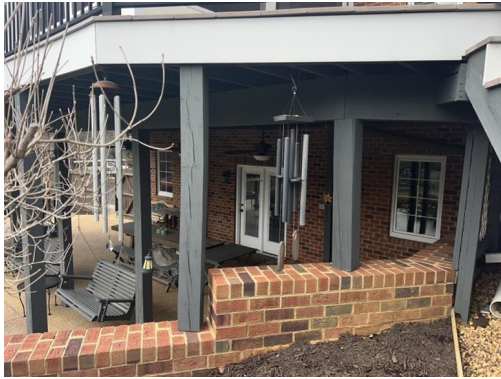
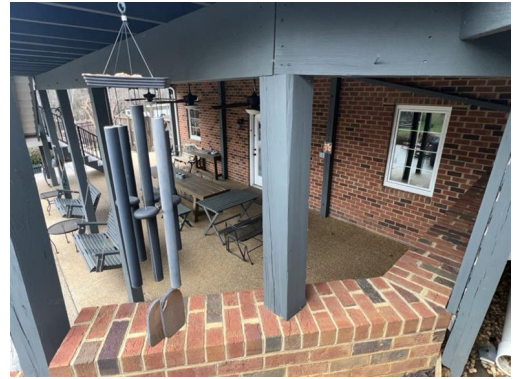
EXTERIOR/DECK/BALCONY

| 5. | <b>Exterior/Deck/Balcony</b> The left posts supported by the retaining wall is leaning. Adjust and secure the posts to prevent further movement. LOCATION: Rear. Estimated cost to remedy: \$100 to \$200. | 17 | |

| ISSUE | The left posts supported by the retaining wall is leaning. |
| LOCATION | Rear |
| IMPLICATION | Post or column has settled or moved. |

| RECOMMENDATION | Adjust and secure the posts to prevent further movement. |
| COST TO REMEDY | \$100 to \$200 |

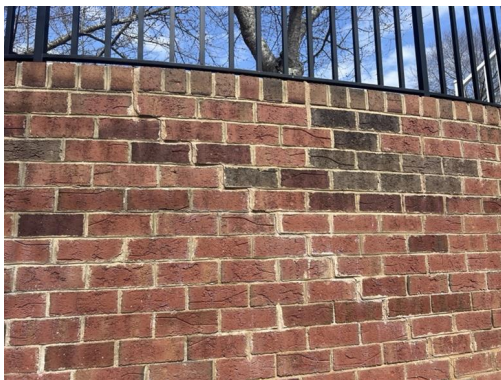
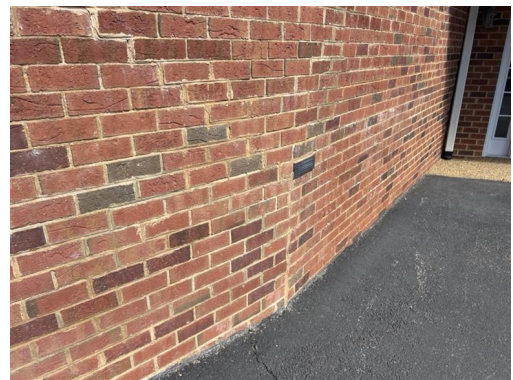
EXTERIOR/RETAINING WALL

| 10. | <b>Exterior/Retaining Wall</b> Airline stairstep cracks noted in the retaining wall next to the driveway. No significant movement or shifting observed. Monitor for any signs of movement or deterioration. Engage a masonry contractor to correct if concerns, exist or issues present. LOCATION: Right Side. | 17 | |

| ISSUE | Airline stairstep cracks noted in the retaining wall next to the driveway. No significant movement or shifting observed. |
| LOCATION | Right Side |
| IMPLICATION | This may indicate settlement or possible drainage issues. |

| RECOMMENDATION | Monitor for any signs of movement or deterioration. Engage a masonry contractor to correct if concerns, exist or issues present. |

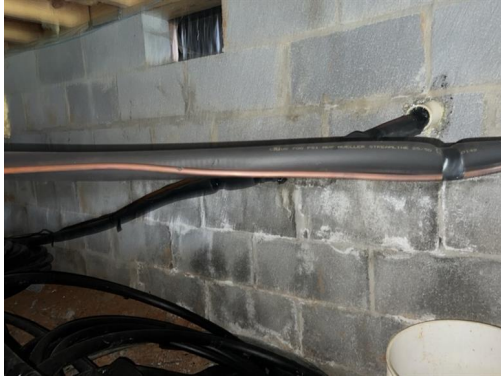
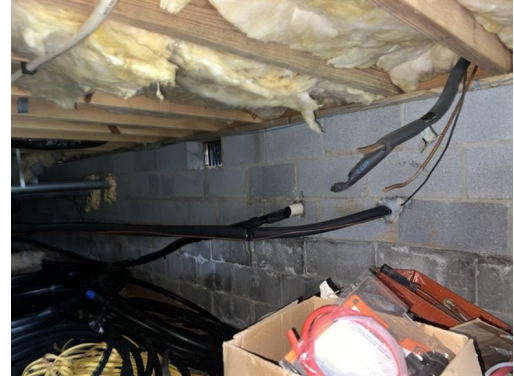
## ● STRUCTURE/FOUNDATION

| 12. | <b>Structure/Foundation</b> There is efflorescence (white crystalline deposits) along the foundation wall. Improve the grading, seal gaps, monitor, and engage for evaluation/repairs, as required. LOCATION: Left Side. | 24 | |

| ISSUE | There is efflorescence (white crystalline deposits) along the foundation wall. |
| LOCATION | Left Side |
| IMPLICATION | Indicates moisture absorption along the masonry. |

| RECOMMENDATION | Improve the grading, seal gaps, monitor, and engage for evaluation/repairs, as required. |

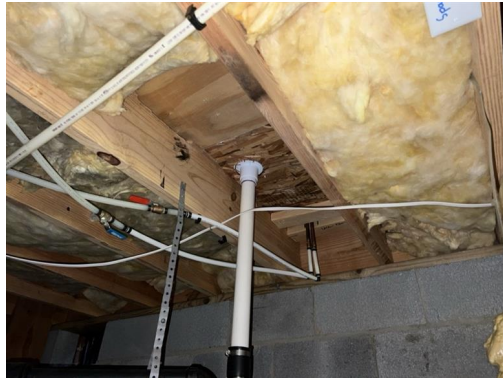
## INSULATION AND VENTILATION/CRAWL SPACE INSULATION

| 6. | <b>Insulation and Ventilation/Crawl Space Insulation</b> The insulation is missing. Install insulation in accordance with local guidelines. LOCATION: Left Side. Estimated cost to remedy: \$150 to \$250. | 26 | |

| ISSUE | The insulation is missing. |
| LOCATION | Left Side |
| IMPLICATION | This affects energy efficiency. |

| RECOMMENDATION | Install insulation in accordance with local guidelines. |
| COST TO REMEDY | \$150 to \$250 |

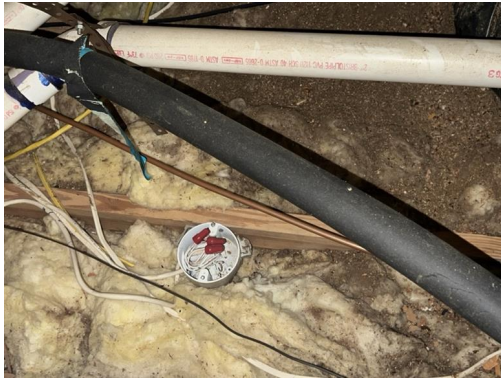
## R ELECTRICAL/BRANCH CIRCUITS

| 7. | <b>Electrical/Branch Circuits</b> There are exposed wire splices. Install a cover on the junction box. LOCATION: Attic. Estimated cost to remedy: \$50 to \$100. | 28 | |

| ISSUE | There are exposed wire splices. |
| LOCATION | Attic |
| IMPLICATION | Splices must be in an approved junction box with a proper cover and permanently accessible. |

| RECOMMENDATION | Install a cover on the junction box. |
| COST TO REMEDY | \$50 to \$100 |

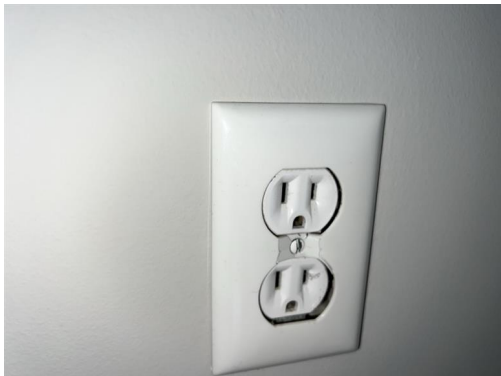
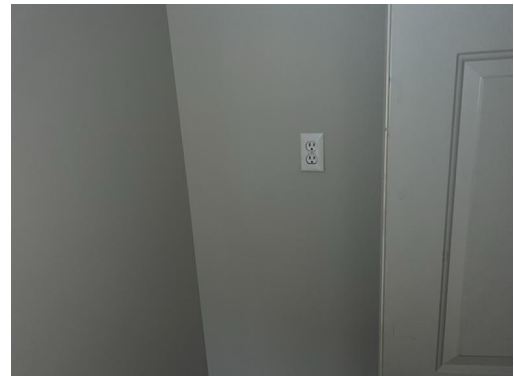
## Y ELECTRICAL/RECEPTACLES

| 11. | <b>Electrical/Receptacles</b> The receptacle is damaged or deteriorated. Replace the receptacle. LOCATION: Bedroom. | 28 | |

| ISSUE | The receptacle is damaged or deteriorated. |
| LOCATION | Bedroom |
| IMPLICATION | Damaged receptacles are shock hazards. |

| RECOMMENDATION | Replace the receptacle. |

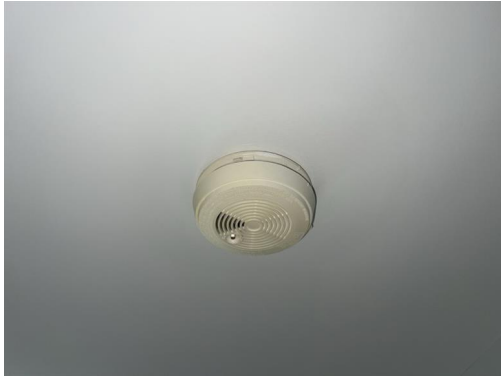
ELECTRICAL/SMOKE DETECTORS

| 13. | <b>Electrical/Smoke Detectors</b> The smoke detectors are in good working conition. It is recommended that a home have smoke alarms on each level of the dwelling and in every bedroom or sleeping area. Clients should replace any existing smoke alarms that are not in good working order with new ones and install smoke alarms where they may be missing or not properly located. Any test of a smoke alarm during a home inspection only reflects its condition at the time of inspection and is not a guarantee, warranty, or any form of insurance. A test performed during the home inspection does not supersede the smoke alarm manufacturer's testing recommendations. Clients should follow the manufacturer's instructions for proper placement, installation, and maintenance. LOCATION: Multiple Locations. | 29 | |

| ISSUE | The smoke detectors are in good working conition. |
| LOCATION | Multiple Locations |
| IMPLICATION | Components function as intended. |

| RECOMMENDATION | It is recommended that a home have smoke alarms on each level of the dwelling and in every bedroom or sleeping area. Clients should replace any existing smoke alarms that are not in good working order with new ones and install smoke alarms where they may be missing or not properly located. Any test of a smoke alarm during a home inspection only reflects its condition at the time of inspection and is not a guarantee, warranty, or any form of insurance. A test performed during the home inspection does not supersede the smoke alarm manufacturer's testing recommendations. Clients should follow the manufacturer's instructions for proper placement, installation, and maintenance. |

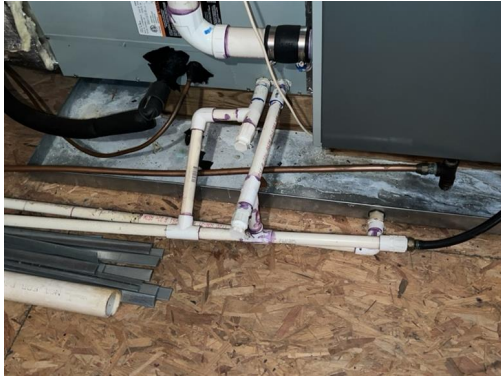
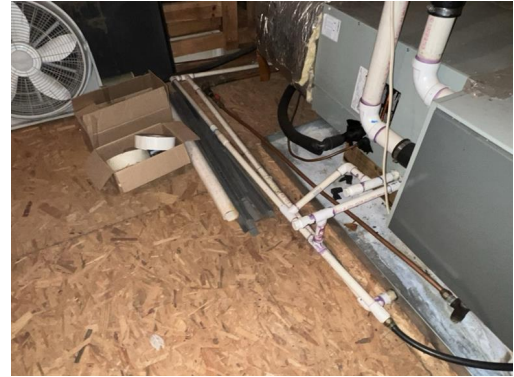
## HVAC/COOLING SYSTEM 2

| 8. | <b>HVAC/Cooling System 2</b> The Primary, secondary, overflow, and furnace drains are connected to the same discharge pipe. Gauge in HVAC technician to properly install condensate provisions/shut offs. LOCATION: Attic. Estimated cost to remedy: \$250 to \$350. | 32 | |

| ISSUE | The Primary, secondary, overflow, and furnace drains are connected to the same discharge pipe. |
| LOCATION | Attic |
| IMPLICATION | In the event of a blockage, water can overflow into the framing and finish areas below. |

| RECOMMENDATION | Gauge in HVAC technician to properly install condensate provisions/shut offs. |
| COST TO REMEDY | \$250 to \$350 |
