| DATE | 08/17/25 |
| ADDRESS | 4515 Winterbourne Dr,<br>Petersburg, VA |

# TABLE OF CONTENTS

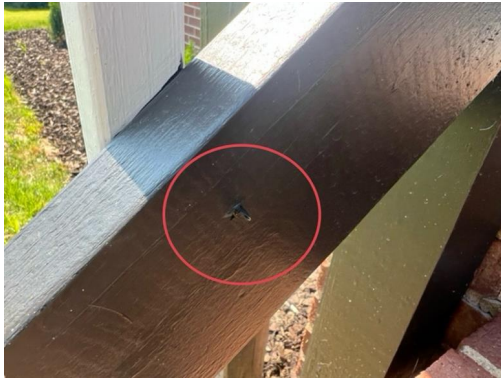
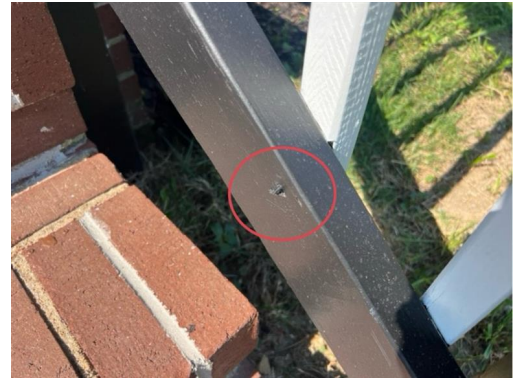
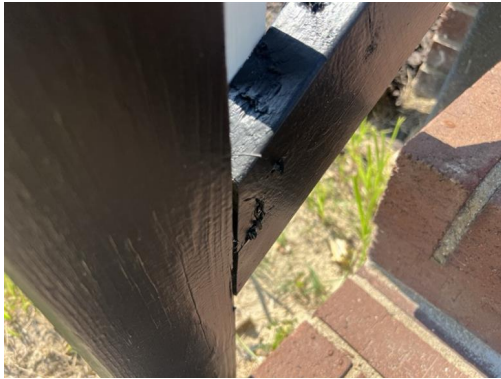
## R EXTERIOR/EXTERIOR STAIRS/STEPS

| 1. | <b>Exterior/Exterior Stairs/Steps</b> The noted item has not been completely corrected. Expose nails noted at the lower section of the railing. Have a licensed and insured contractor remove all exposed nails sticking through the railings and resecure as needed at the front of the property. LOCATION: Front. | 10 |

| ISSUE | The noted item has not been completely corrected. Expose nails noted at the lower section of the railing. Have a licensed and insured contractor remove all exposed nails sticking through the railings and resecure as needed at the front of the property. |

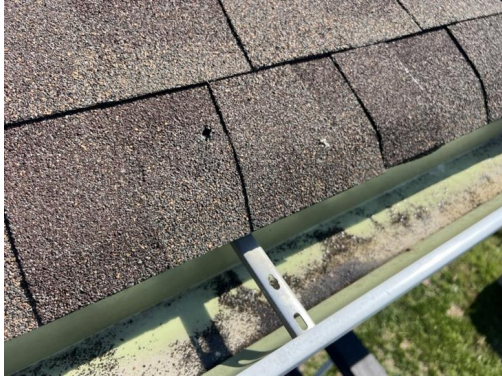
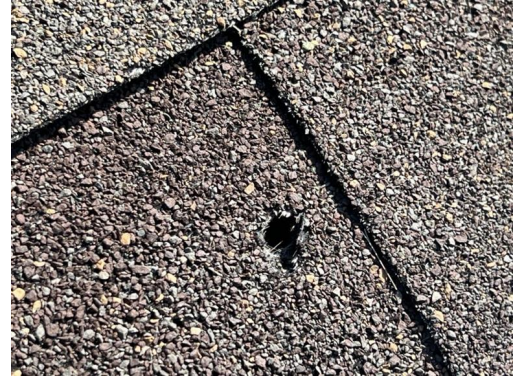
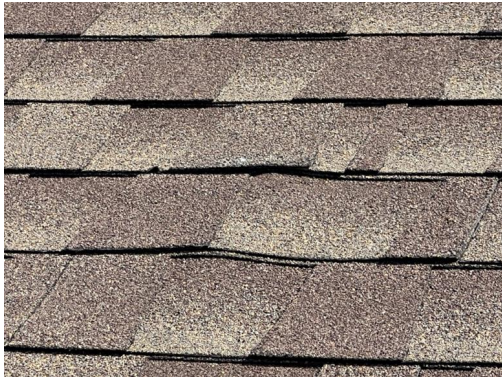
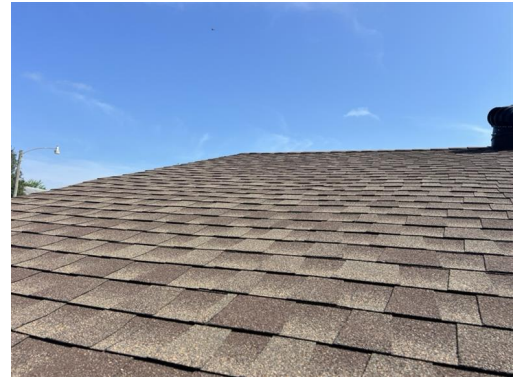
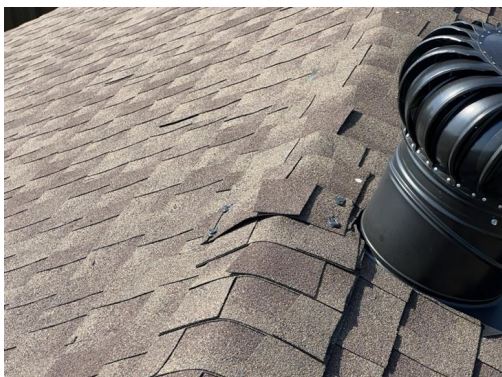
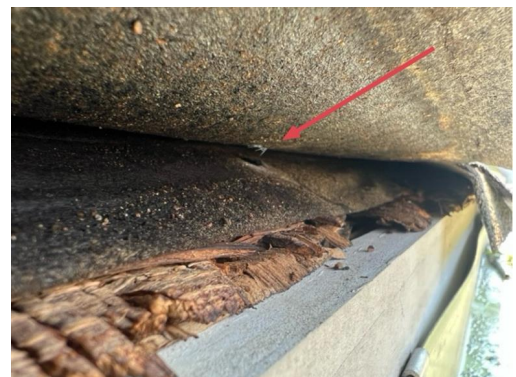
## ROOF/ROOFING

| 2. | <b>Roof/Roofing</b> The noted items have not been corrected. The nail protrusion is still present. There are holes in the shingles at the rear center and eaves of the lower roof. The ridge shingles have not been replaced (dimensional shingles used). LOCATION: Multiple Locations. | 12 |

The noted items have not been corrected. The nail protrusion is still present. There are holes in the shingles at the rear center and eaves of the lower roof. The ridge shingles have not been replaced (dimensional shingles used).

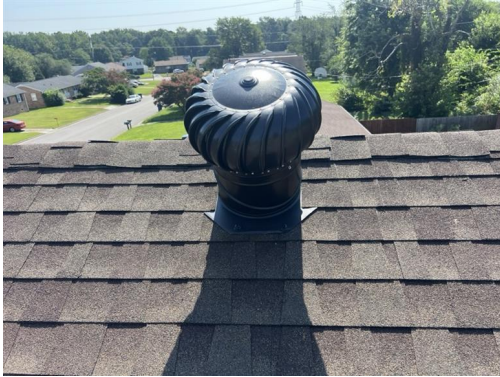
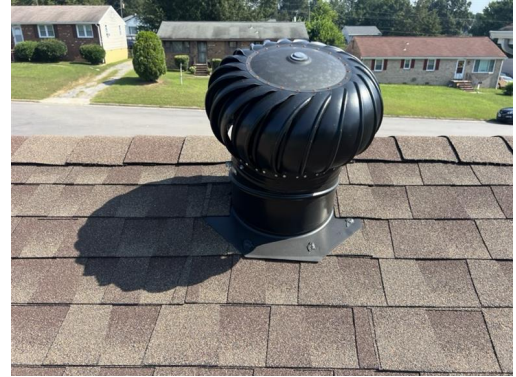
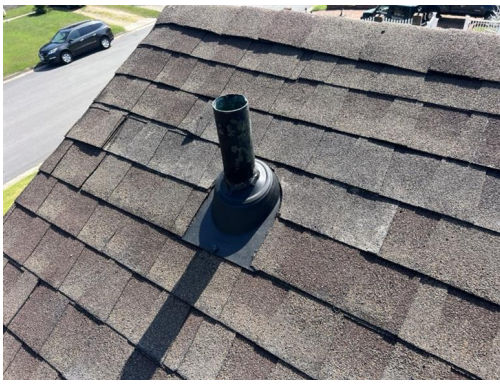
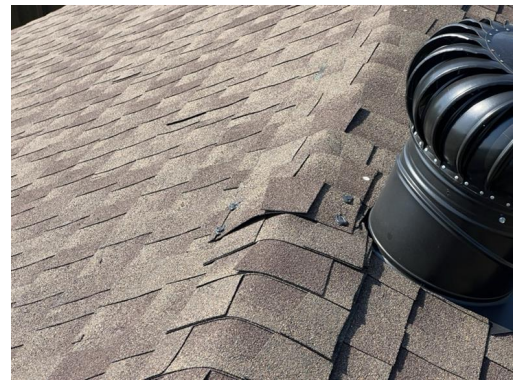
## ROOF/ROOFING

| 6. | <b>Roof/Roofing</b> The noted items have been corrected. Seal the exposed nail heads noted in inspection report with an approved roofing sealant. Install proper ridge shingles and replace all broken/torn shingles Property disassemble and reinstall upside-down pluming roor vent. LOCATION: Multiple Locations. | 13 |

| ISSUE | The noted items have been corrected. Seal the exposed nail heads noted in inspection report with an approved roofing sealant. Install proper ridge shingles and replace all broken/torn shingles Property disassemble and reinstall upside-down plumoing roor vent. |

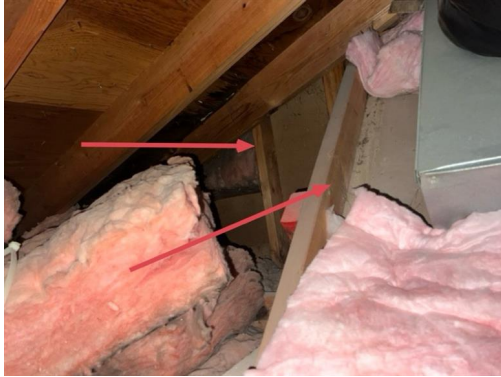
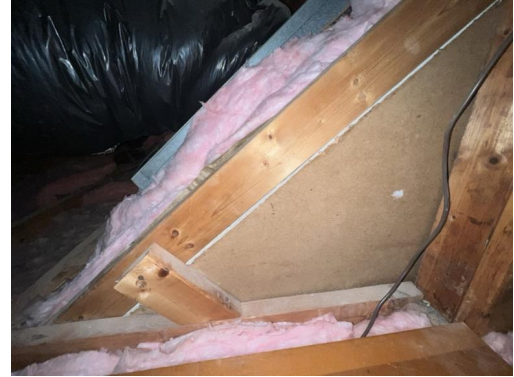
## INSULATION AND VENTILATION/ATTIC INSULATION

| 3. | <b>Insulation and Ventilation/Attic Insulation</b> The following item has not been completed. There is missing insulation around the return duct in the attic and along the rear bathroom wall and staircase. LOCATION: Attic. | 16 |

The following item has not been completed. There is missing insulation around the return duct in the attic and along the rear bathroom wall and staircase.

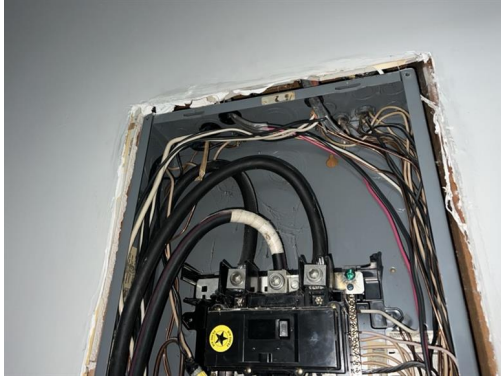
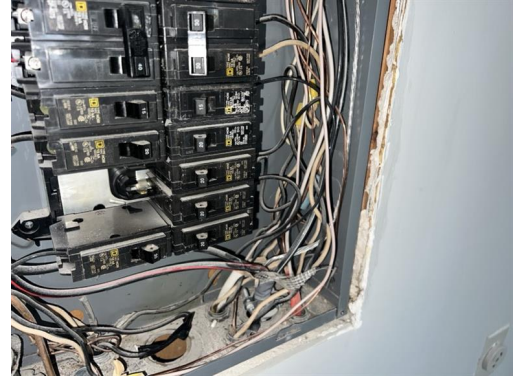
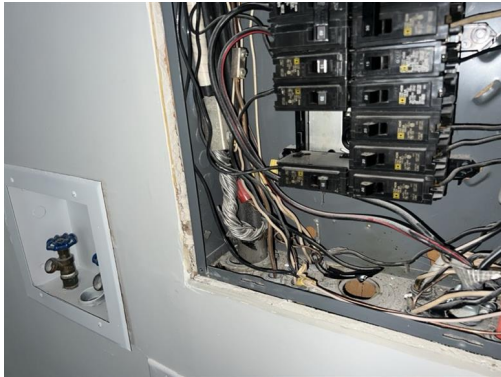
## ELECTRICAL/ELECTRICAL PANEL

| 7. | <b>Electrical/Electrical Panel</b> The following item has been corrected. Secure all improperly secured wires in the electrical panel. LOCATION: Laundry Room. | 18 |

| ISSUE | The following item has been corrected. Secure all improperly secured wires in the electrical panel. |

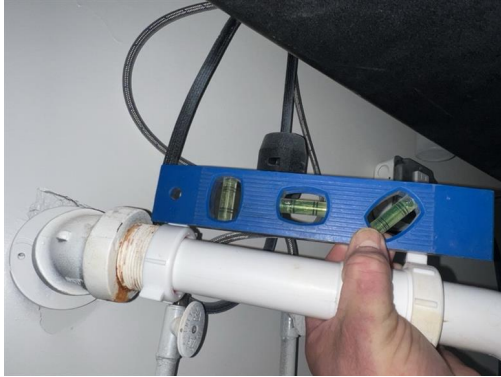
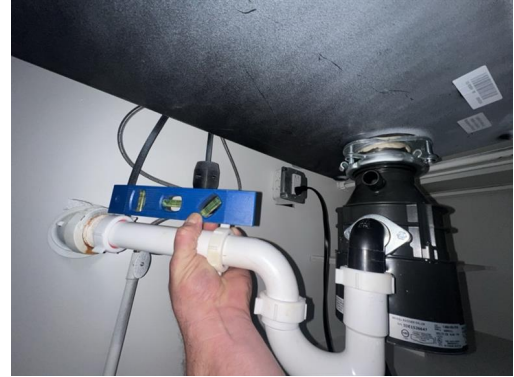
## R PLUMBING/DRAIN, WASTE, VENTS

| 4. | <b>Plumbing/Drain, Waste, Vents</b> The drain line connected to the disposal is improperly sloped, back pitched. This will affect drainage. Engage a plumbing contractor to adjust as required. LOCATION: Kitchen. | 20 |

| ISSUE | The drain line connected to the disposal is improperly sloped, back pitched. This will affect drainage. Engage a plumbing contractor to adjust as required. |

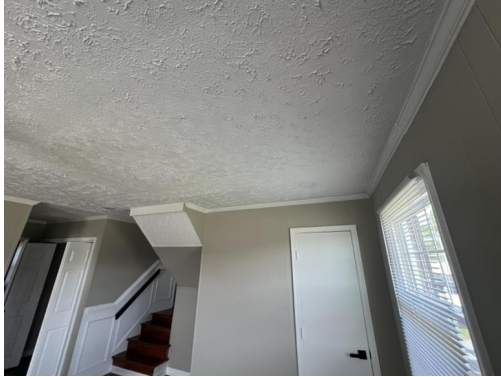
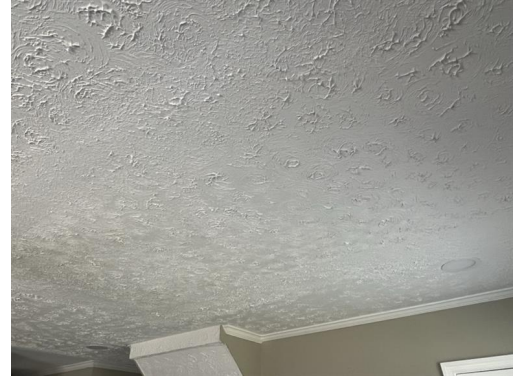
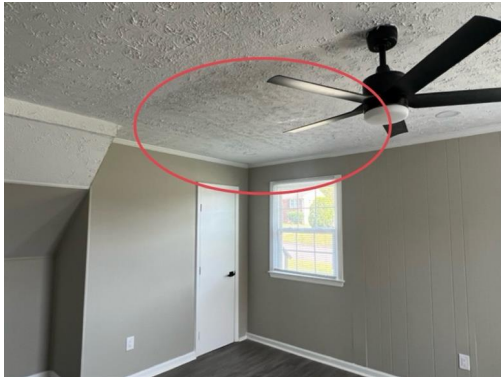
## R INTERIOR/INTERIOR CEILINGS

| 5. | <b>Interior/Interior Ceilings</b> The ceiling below the bathroom is sagging and flexes when touched. There are areas where the nails have pulled through. The ceiling will need to be secured to the framing above. LOCATION: Lower living room. Estimated cost to remedy: \$6 to \$60. | 22 |

| ISSUE | The ceiling below the bathroom is sagging and flexes when touched. There are areas where the nails have pulled through. The ceiling will need to be secured to the framing above. |

| COST TO REMEDY | \$6 to \$60 |

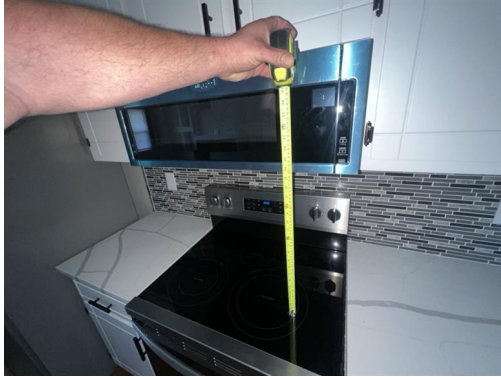
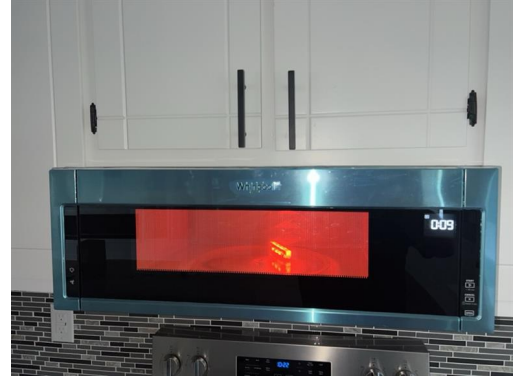
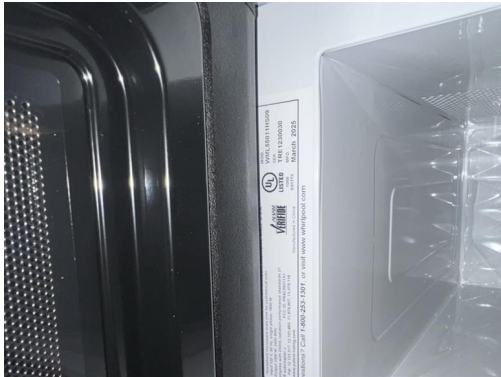
## APPLIANCES/MICROWAVE

| 8. | <b>Appliances/Microwave</b> The noted item has been corrected. Have a licensed and insured contractor install a proper sized microwave to allow for the minimum required clearance per the manufacturers installation guidelines. LOCATION: Kitchen. | 24 |

The noted item has been corrected. Have a licensed and insured contractor install a proper sized microwave to allow for the minimum required clearance per the manufacturers installation guidelines.

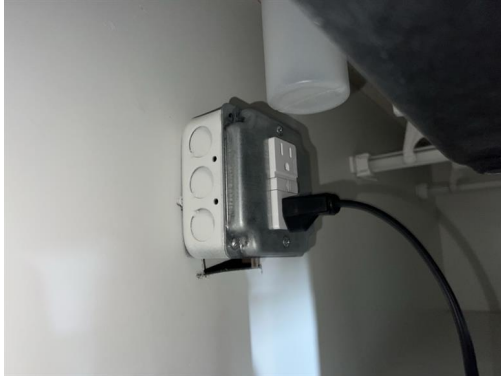
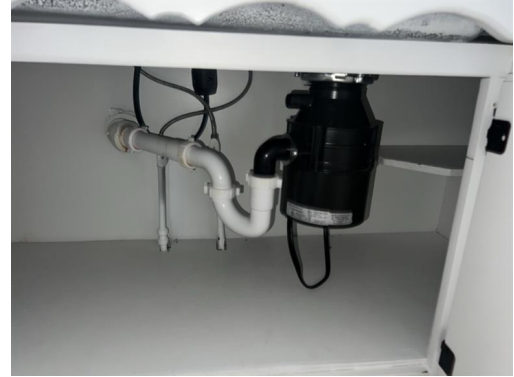
## APPLIANCES/GARBAGE DISPOSER

| 9. | <b>Appliances/Garbage Disposer</b> The noted item has been corrected. Have garbage disposal repaired to restore intended functionality and ensure that all electrical connections are correct and no longer trip the GFCI. LOCATION: Kitchen. | 25 |

| ISSUE | The noted item has been corrected. Have garbage disposal repaired to restore intended functionality and ensure that all electrical connections are correct and no longer trip the GFCI. |
