## INSPECTION INSIGHTS

| DATE | 02/23/24 |
| ADDRESS | 1903 Maddox Street,<br>Richmond, VA |

# TABLE OF CONTENTS

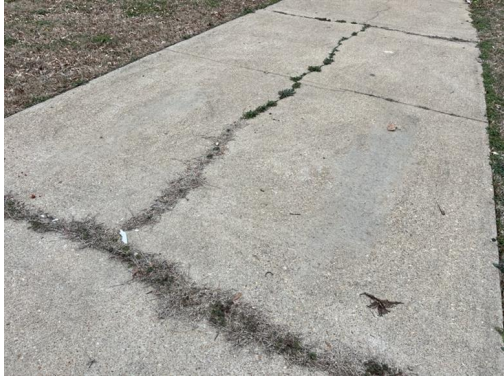
EXTERIOR/DRIVEWAY

| ISSUE | There are minor cracks in the driveway with vegetation growing in the seams. |
| LOCATION | Right Side |
| IMPLICATION | May permit water to penetrate the driveway, which may cause further damage. |

| RECOMMENDATION | Repair and seal cracks. |

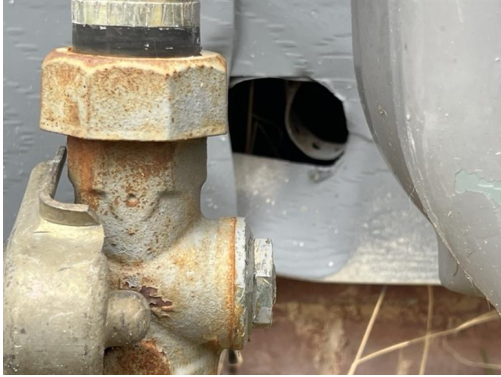
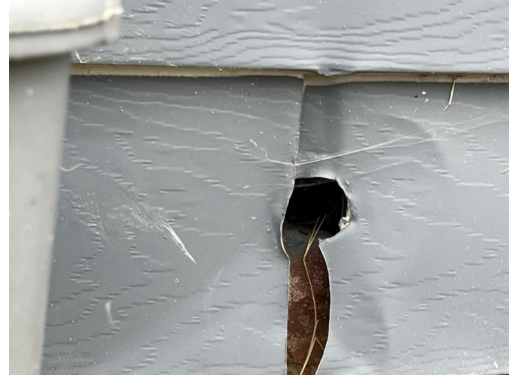
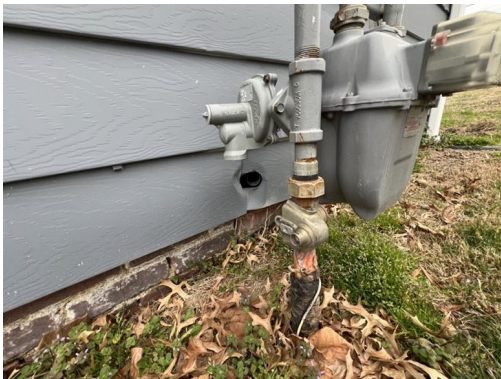
**R** EXTERIOR/EXTERIOR WALLS

| ISSUE | The bottom siding panels are damaged, holes from the previous gas line noted. |
| LOCATION | Right Side Rear |

| RECOMMENDATION | Replace the siding and repair any damage which may be revealed. |

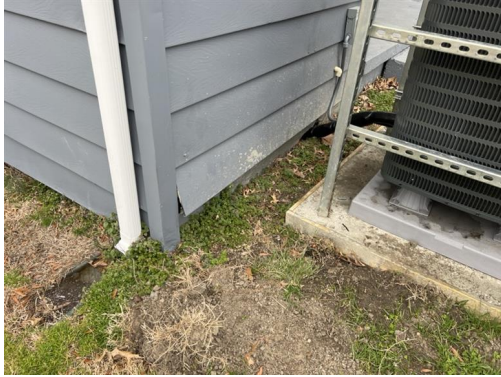
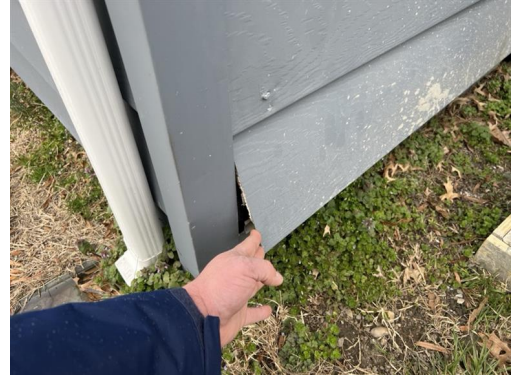
EXTERIOR/EXTERIOR WALLS

| ISSUE | The bottom siding panel is loose and lifting. |
| LOCATION | Rear |

| RECOMMENDATION | Replace the siding and repair any damage which may be revealed. |

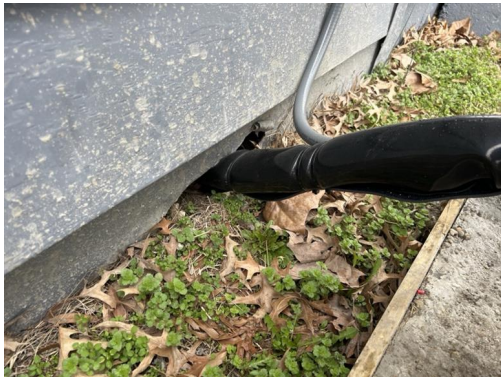
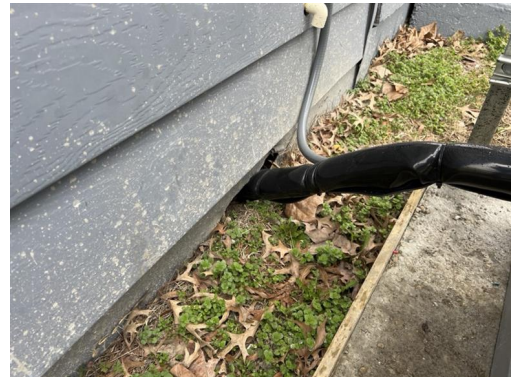
EXTERIOR/EXTERIOR WALLS

| ISSUE | There are gaps around the HVAC utility penetrations. |
| LOCATION | Rear |

| RECOMMENDATION | Seal around the penetrations. |

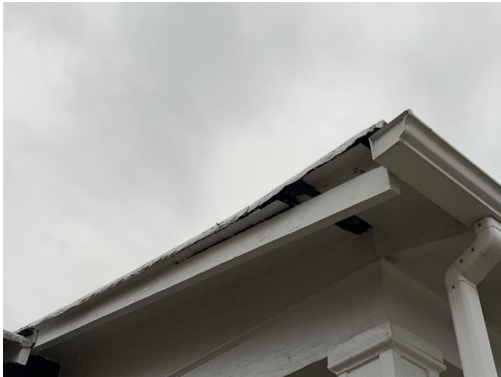
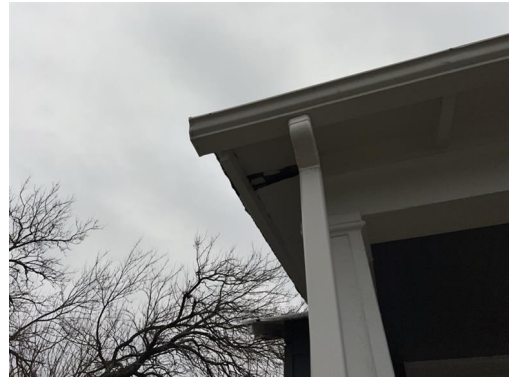
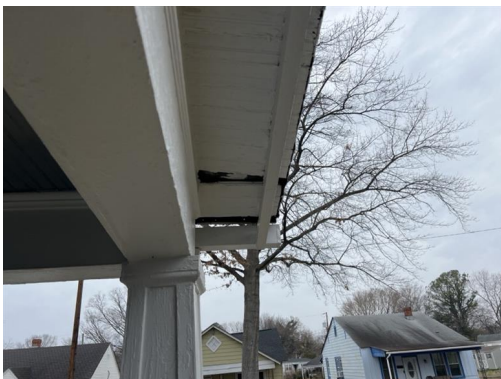
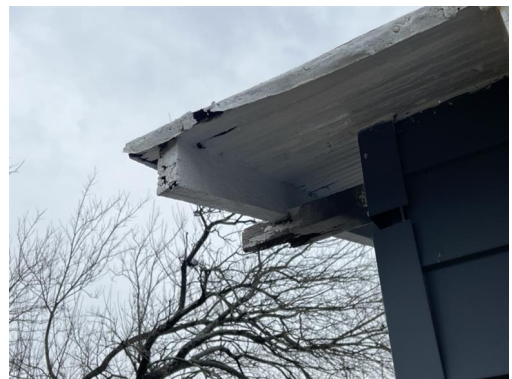
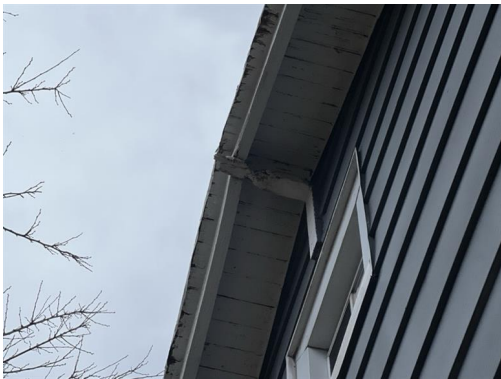
**R** EXTERIOR/EXTERIOR TRIM

| ISSUE | The rake supports are deteriorating/rotted at the left and right of the home. |
| LOCATION | Multiple Locations |

| RECOMMENDATION | Engage a contractor to replace all damaged supports. |

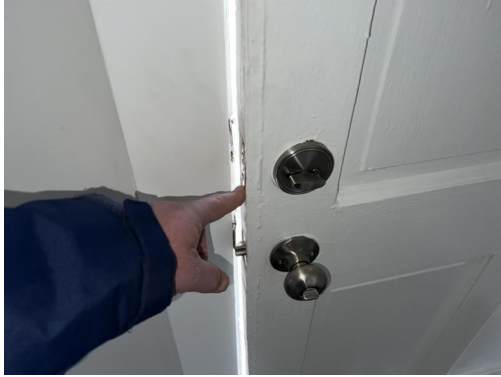
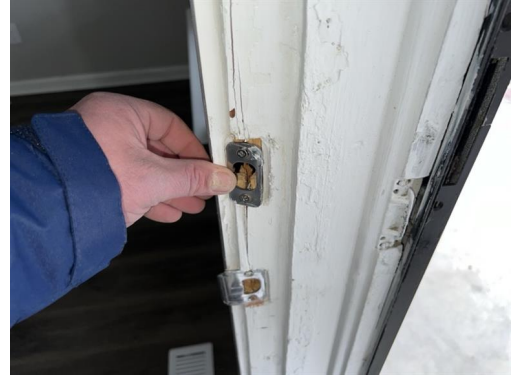
**R** EXTERIOR/EXTERIOR DOORS

| ISSUE | The deadbolt does not latch and the security plate is loose on the frame. |
| LOCATION | Front |

| RECOMMENDATION | Repair or replace the door hardware. |

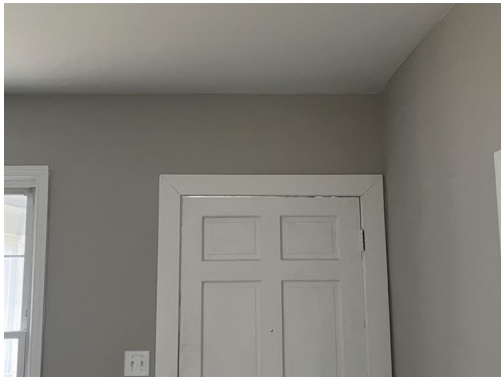
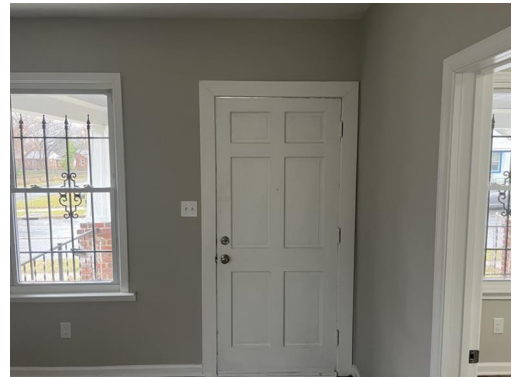
**R** EXTERIOR/EXTERIOR DOORS

| ISSUE | The weather-stripping is not completely installed. |
| LOCATION | Front |
| IMPLICATION | This affects energy efficiency and may permit moisture intrusion, pest ingress. |

| RECOMMENDATION | Replace the weather-stripping. |

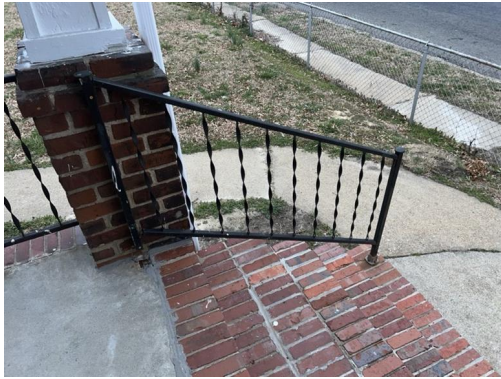
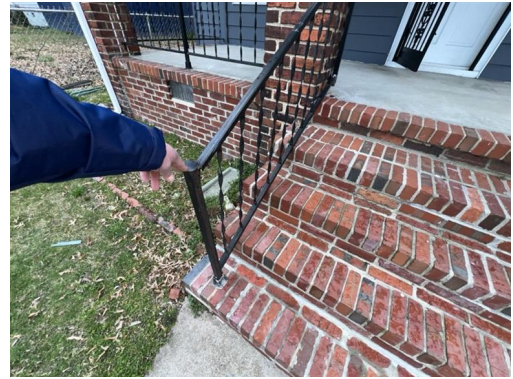
EXTERIOR/EXTERIOR STAIRS/STEPS

| ISSUE | The left handrailing is loose along the side of the front entry stairs. |
| LOCATION | Front |

| RECOMMENDATION | Secure or replace the handrailing as required for safety. |

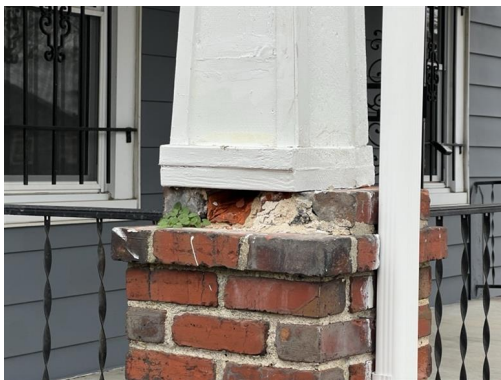
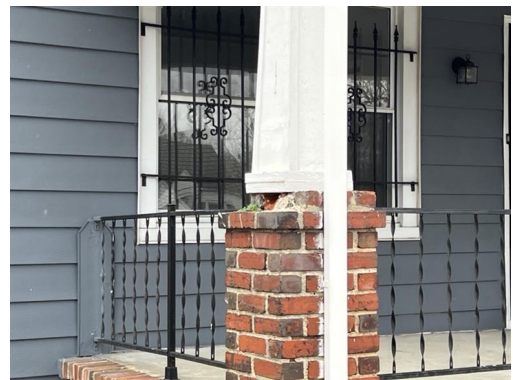
EXTERIOR/PORCH

| ISSUE | The post base is damaged/deteriorated. The top course of bricks is missing with deteriorated mortar. |
| LOCATION | Left Side |

| RECOMMENDATION | Repair the base. |

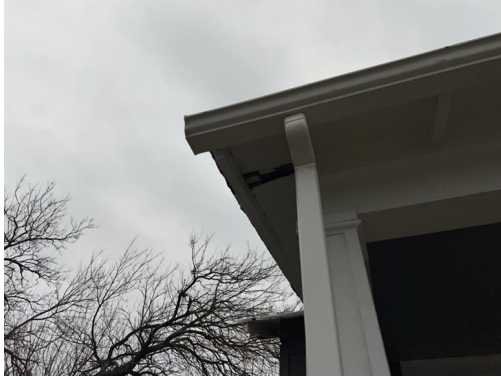
## ROOF/ROOFING

| ISSUE | The roof sheathing is decayed and rotted. |
| LOCATION | Left Side |

| RECOMMENDATION | Engage a roofing contractor to evaluate for all possible issues and correct as determined. |

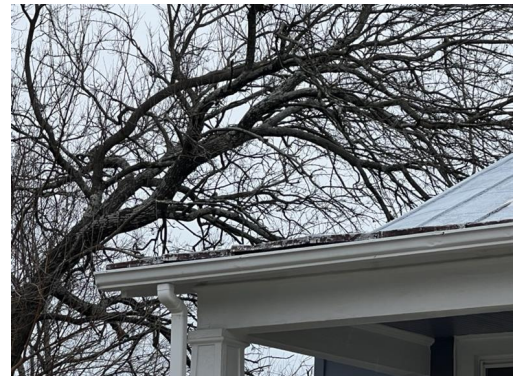
## ROOF/ROOFING

| ISSUE | The metal is lifting away from the rafters tails at the eaves. |
| LOCATION | Front |

| RECOMMENDATION | Engage a roofing contractor to make repairs or replace the roofing. |

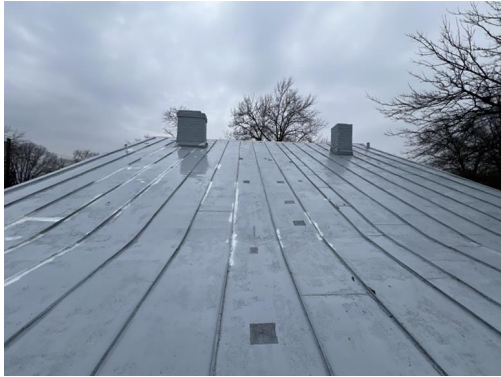
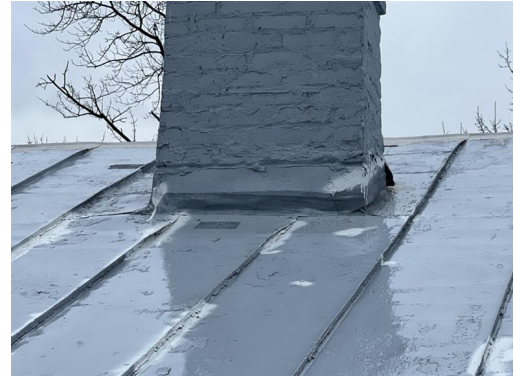
## ROOF/ROOFING

| ISSUE | The roof displays evidence of prior repairs. |
| LOCATION | Multiple Locations |
| IMPLICATION | The inspector can't determine the purpose of the repairs or if future repairs will be required. |

| RECOMMENDATION | Monitor the repairs to consider if additional action is required. |

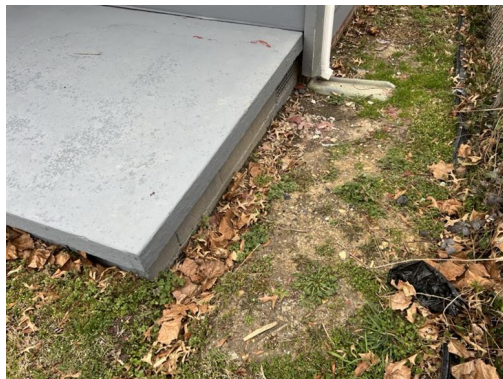
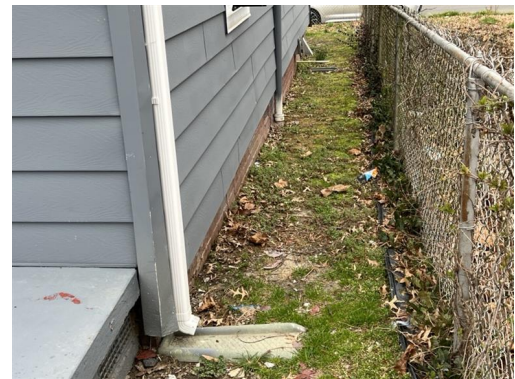
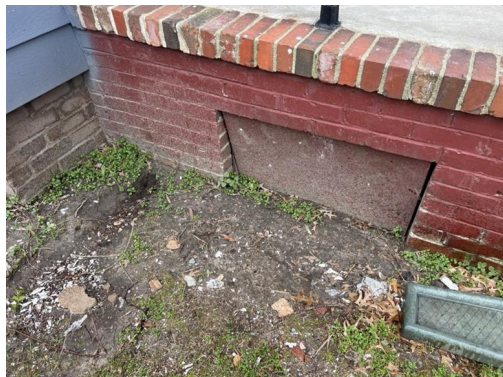
## WATER CONTROL/GRADING

| ISSUE | The grading is sloping towards the foundation. |
| LOCATION | Rear left corner of the house. |

| RECOMMENDATION | Regrade to divert surface water away from foundation; grading should be sloped at 1"/foot up to 6' from the house. |

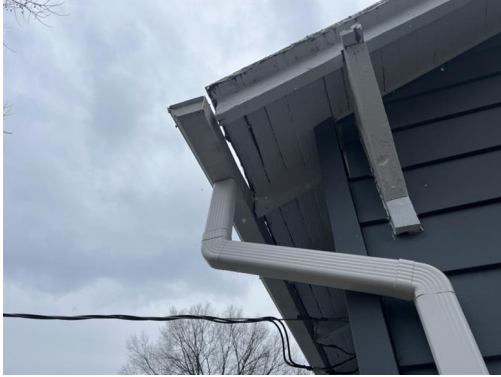
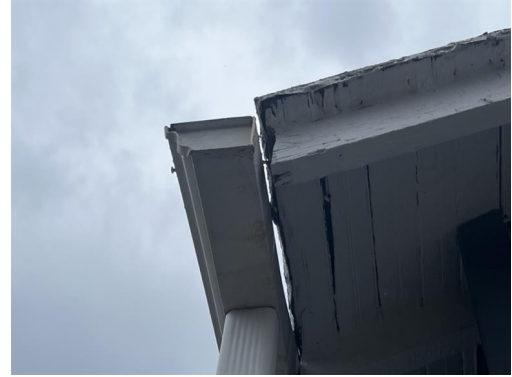
## WATER CONTROL/GUTTERS/DOWNSPOUTS

| ISSUE | The gutters are loose and pulling away from the structure. |
| LOCATION | Rear |

| RECOMMENDATION | Secure the gutters. |

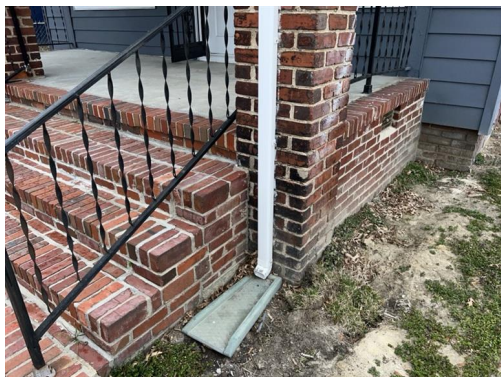
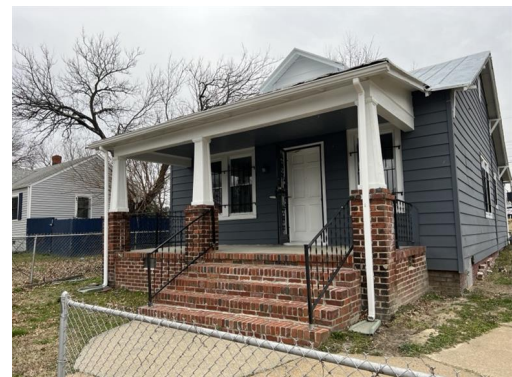
## WATER CONTROL/GUTTERS/DOWNSPOUTS

| ISSUE | The downspout extension is missing. |
| LOCATION | Multiple Locations |

| RECOMMENDATION | Install downspout extensions. |

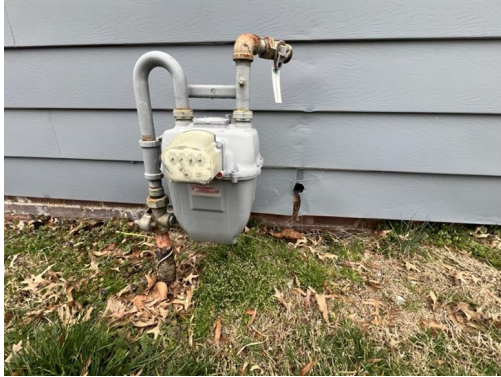
## FUEL SERVICES/FUEL METER

The fuel meter is locked out, no service to the property.

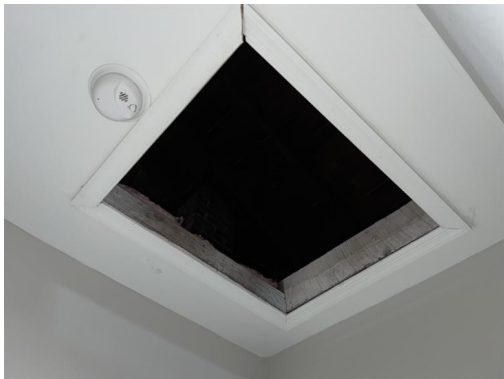
STRUCTURE/ATTIC

| ISSUE | The access cover is missing. |
| LOCATION | Hallway |
| IMPLICATION | This affects energy efficiency and may permit water to enter and damage the structure. |

| RECOMMENDATION | Replace the cover. |

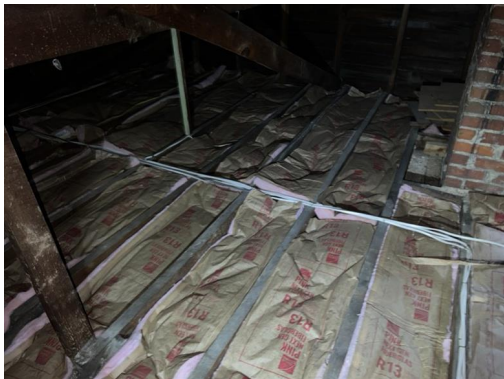
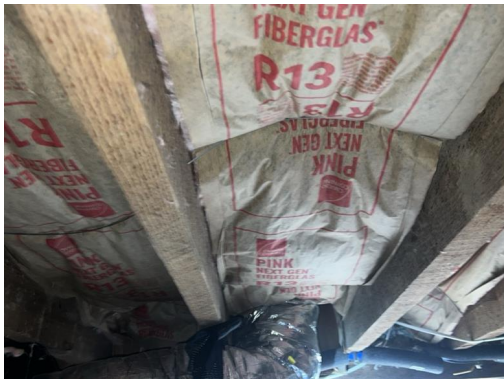
**R** INSULATION AND VENTILATION/ATTIC INSULATION

| ISSUE | The insulation is upside down. |
| LOCATION | Attic |
| IMPLICATION | May cause the nail to contromize |

| RECOMMENDATION | Have all of the insurance flipped and installed correctly. |

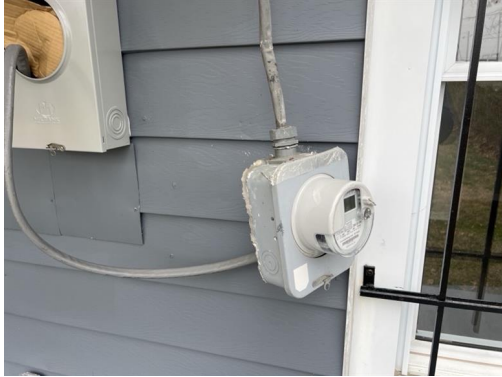
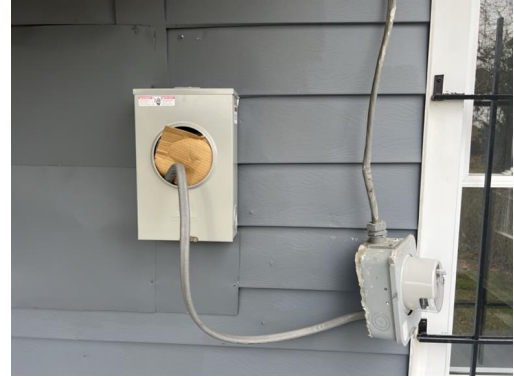
## R ELECTRICAL/ELECTRICAL SERVICE

| ISSUE | The entrance cable and meter are improperly secured. |
| LOCATION | Rear |
| IMPLICATION | Possible loose connections and presents a safety issues. |

| RECOMMENDATION | Engage an electrical contractor to properly install the cable and meter. |

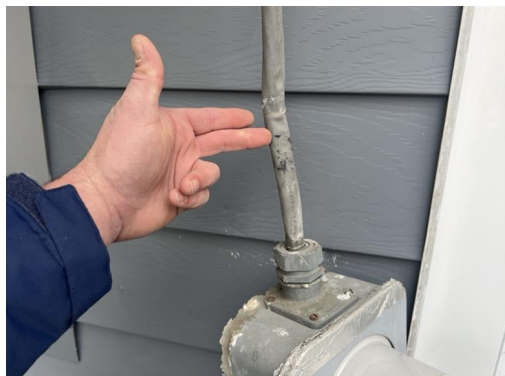
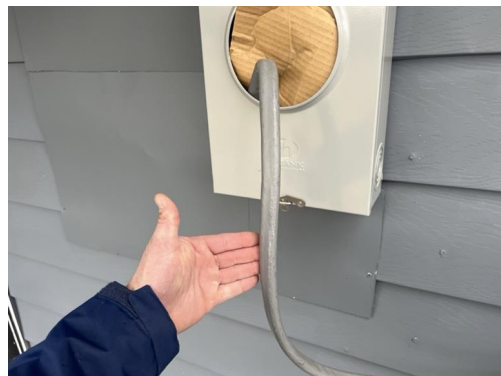
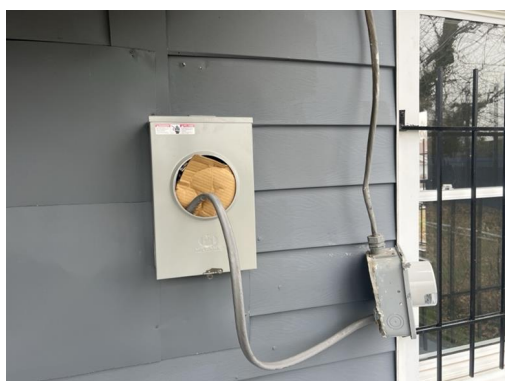
**R** ELECTRICAL/ELECTRICAL SERVICE

| ISSUE | The electrical service is inadequate to meet the needs of the property. The panel is requiring 200amps with 100amps supplied, also the feeder wire from the meter to the panel is undersized. |
| LOCATION | Multiple Locations |

| RECOMMENDATION | Engage an electrical contractor to evaluate and to make repairs, as required. |

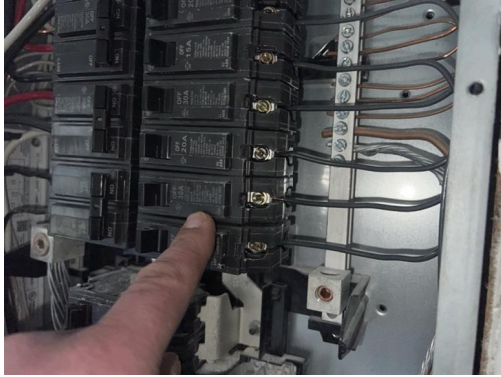
**R** ELECTRICAL/ELECTRICAL PANEL

| ISSUE | The wiring is undersized for the 30amp breaker on the right side of the panel. |
| LOCATION | Bedroom |
| IMPLICATION | This may present a safety hazard. |

| RECOMMENDATION | Engage an electrical contractor to correct as required. |

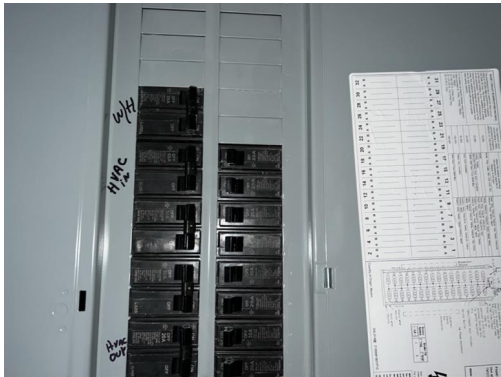
**R** ELECTRICAL/ELECTRICAL PANEL

| ISSUE | The electrical panel isn't labeled. |
| LOCATION | Bedroom |

| RECOMMENDATION | Label the panel. |

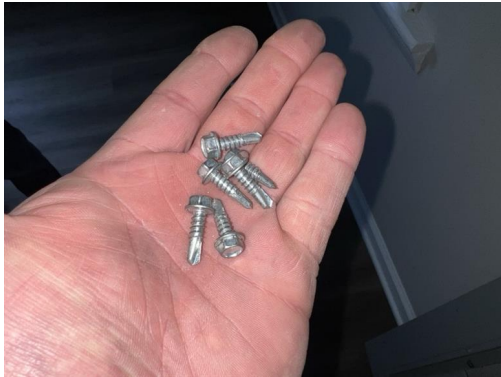
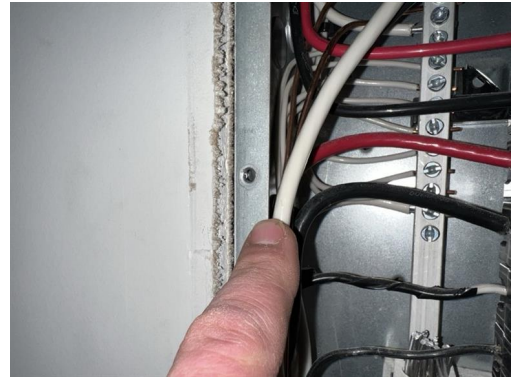
## R ELECTRICAL/ELECTRICAL PANEL

| ISSUE | There are pointed screws securing the cover. One of the neutral wire show the beginning signs of penetration. |
| LOCATION | Bedroom |

| RECOMMENDATION | Engage an electrical contractor to replace the screws. |

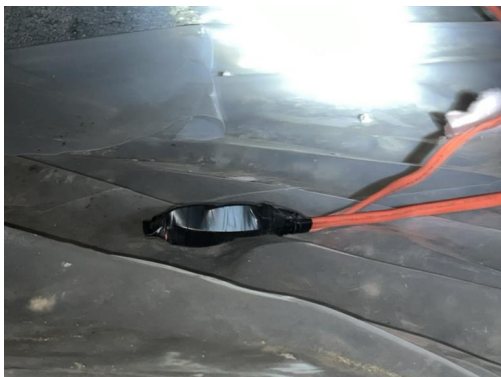
## R ELECTRICAL/BRANCH CIRCUITS

| ISSUE | There are exposed wire splices and an improper connection found on the wiring. |
| LOCATION | Rear Center of the Crawl Space |

| RECOMMENDATION | Engage an electrical contractor to make repairs, as required. |

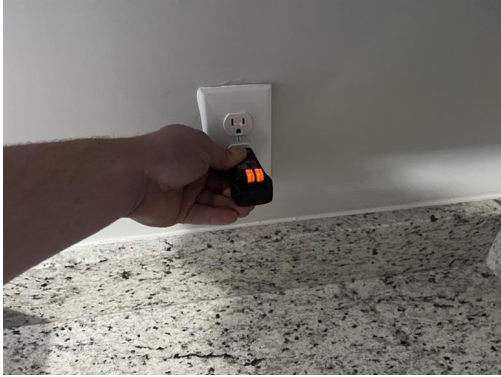
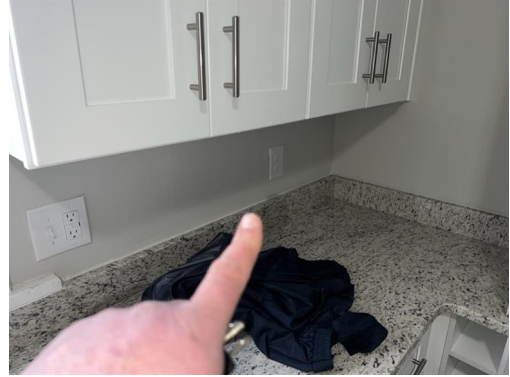
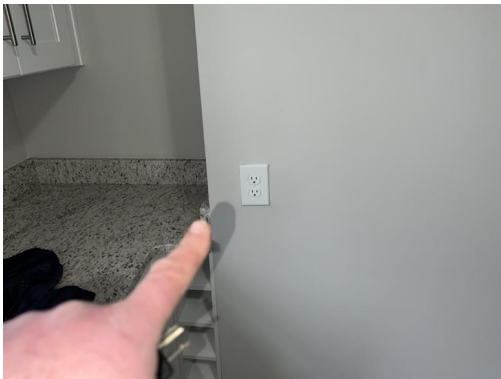
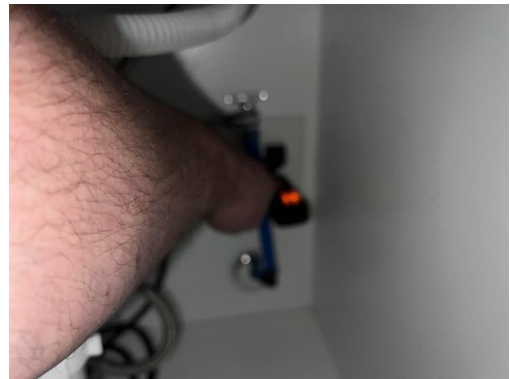
**R** ELECTRICAL/RECEPTACLES

| ISSUE | There is a standard receptacle installed in a location that currently requires a GFCI device. The front and under the sink outlets are not protected. |
| LOCATION | Kitchen |
| IMPLICATION | Receptacle is a shock hazard. |

| RECOMMENDATION | Engage an electrical contractor to replace the receptacle. |

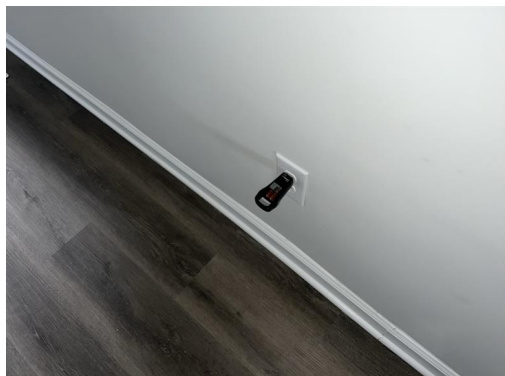
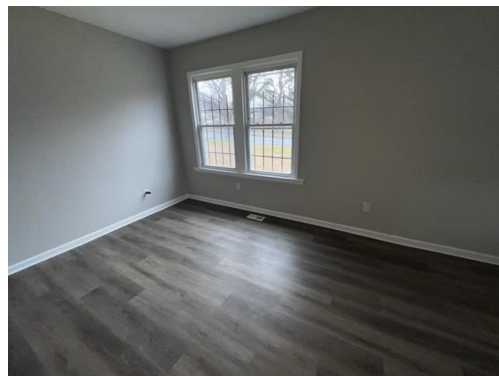
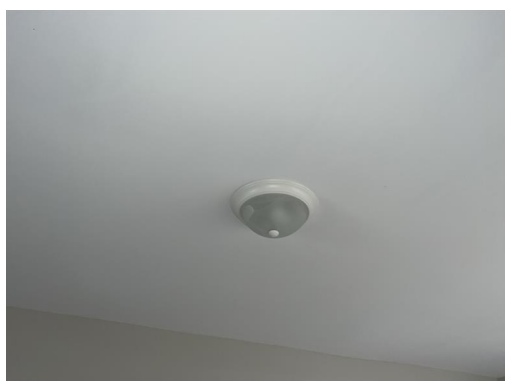
**R** ELECTRICAL/RECEPTACLES

| ISSUE | The receptacles and ceiling do not have power. No determination is made of the cause. |
| LOCATION | Living Room |

| RECOMMENDATION | Engage an electrical contractor to evaluate for all remedial needs and correct as required. |

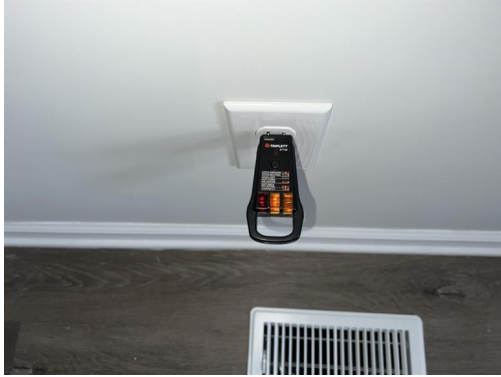
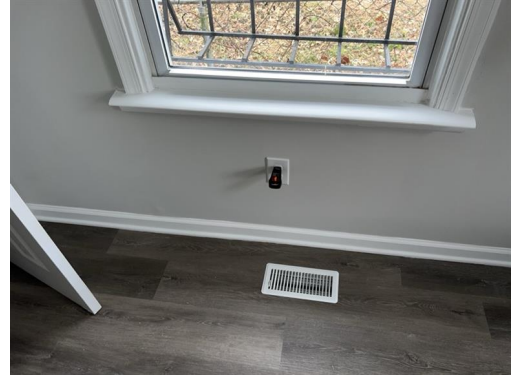
**R** ELECTRICAL/RECEPTACLES

| ISSUE | The left side receptacle has reversed polarity. |
| LOCATION | Rear left bedroom. |
| IMPLICATION | Devices may be damaged when plugged in. |

| RECOMMENDATION | Engage an electrical contractor to make repairs, as required. |

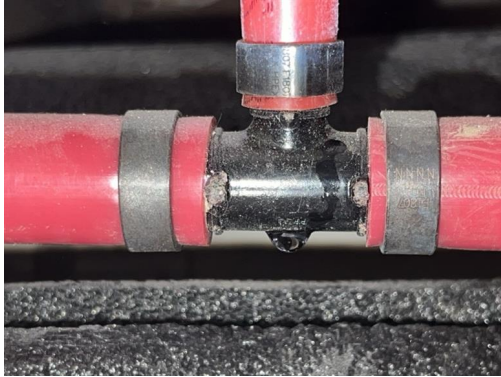
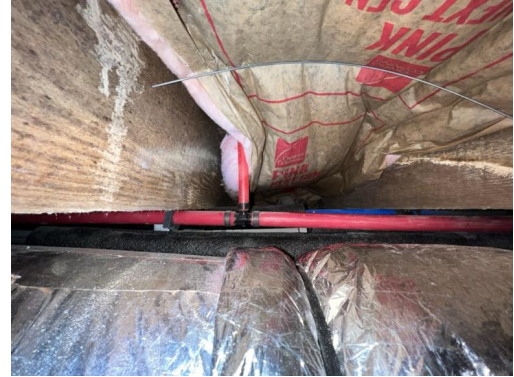
## R PLUMBING/SUPPLY PIPES

| ISSUE | The water supply pipe leaks at the T connector. The leaking connection is at the 4th joist bay behind the chimney. |
| LOCATION | Right Rear of the Crawl Space |
| IMPLICATION | Water may penetrate and damage the structure. |

| RECOMMENDATION | Engage a plumbing contractor to repair or replace the pipe. |

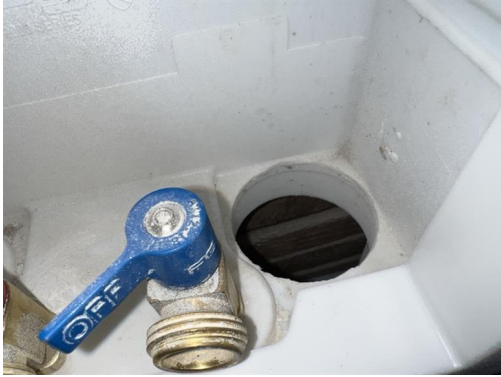
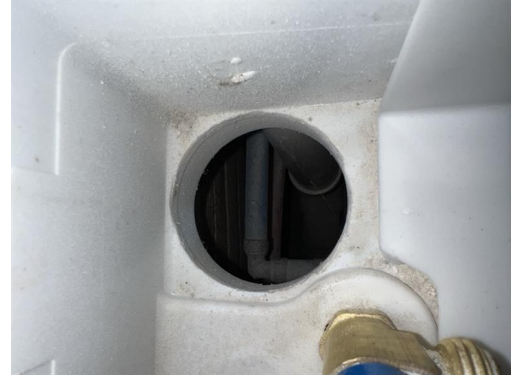
## PLUMBING/DRAIN, WASTE, VENTS

| ISSUE | The laundry drain is missing from the washing supply box. |
| LOCATION | Laundry Room |

| RECOMMENDATION | Engage a plumber to seal the opening and remove the drain plug from the other side. Verify operation prior to landing. |

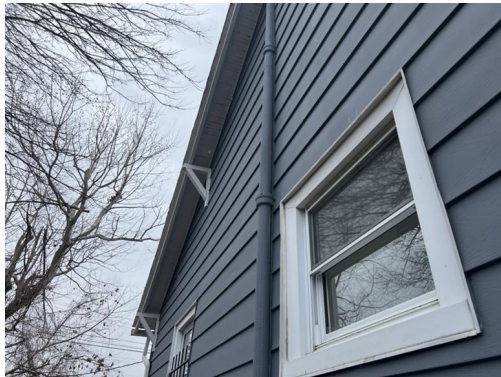
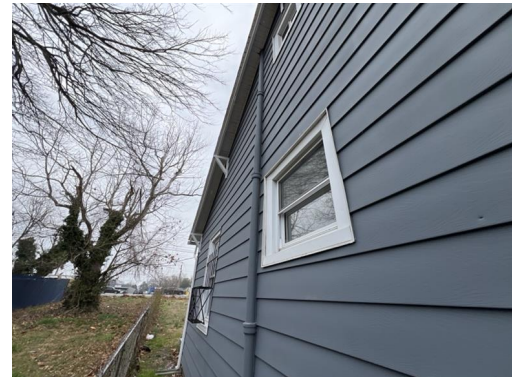
## PLUMBING/DRAIN, WASTE, VENTS

| ISSUE | The cast iron vent stack is inadequately secured to the structure. |
| LOCATION | Left Side |
| IMPLICATION | The vent pipe may loose and become damaged. |

| RECOMMENDATION | Engage a plumbing contractor to secure the vent stack. |

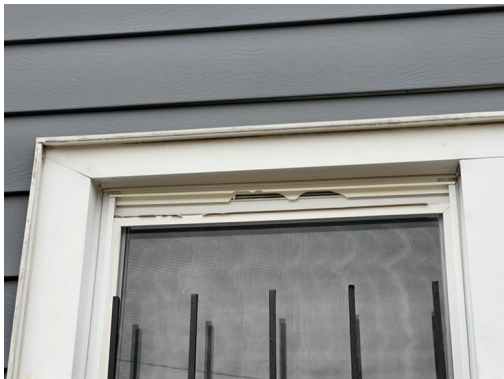
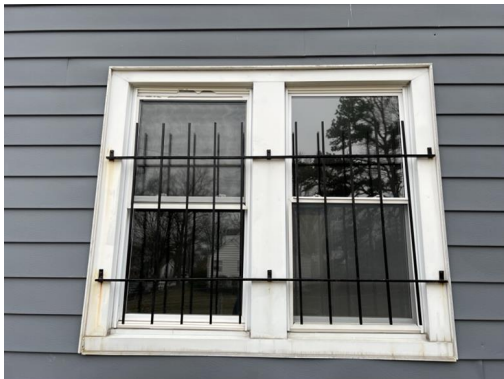
**R** INTERIOR/WINDOWS

| ISSUE | The window vinyl frame is damaged or deteriorated. |
| LOCATION | Right side front window |
| IMPLICATION | This affects energy efficiency and may permit water to enter and damage the structure. |

| RECOMMENDATION | Repair or replace the window. |

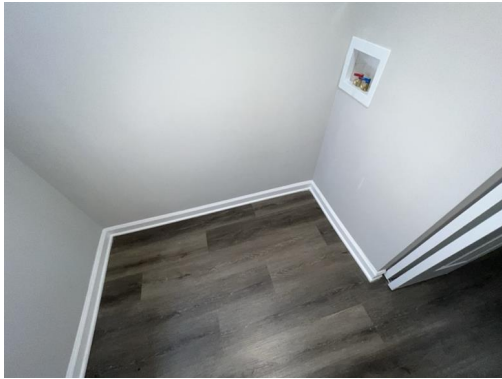
APPLIANCES/DRYER 1 VENTILATION

| ISSUE | Missing dryer exterior exhaust vent. |
| LOCATION | Laundry Room |
| IMPLICATION | Prevents humid air from discharging into the house. |

| RECOMMENDATION | Engage a qualified professional to install a vent to the exterior |
