## INSPECTION INSIGHTS

| DATE | 01/29/24 |
| ADDRESS | 110 North Harrison Street,<br>Richmond, VA |

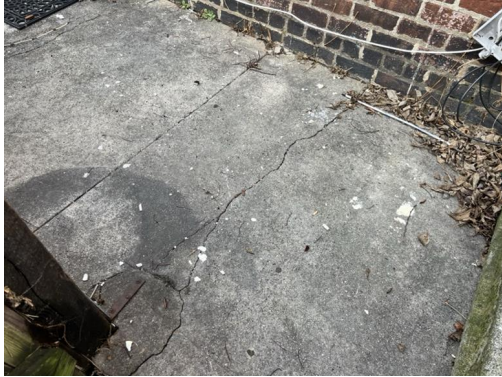
## ● EXTERIOR/WALKS

| ISSUE | There are minor cracks in the walk. |
| LOCATION | Left Side |
| IMPLICATION | May permit water to penetrate the walk, which may cause further damage. |

| RECOMMENDATION | Monitor and repair/seal cracks, as required. |

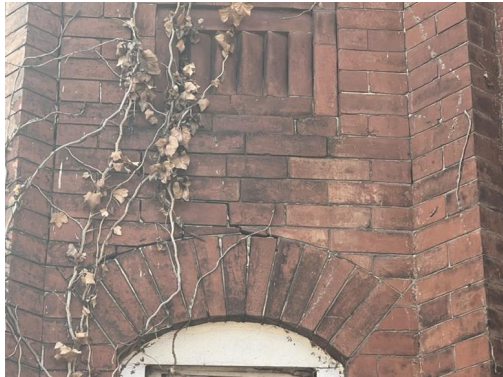
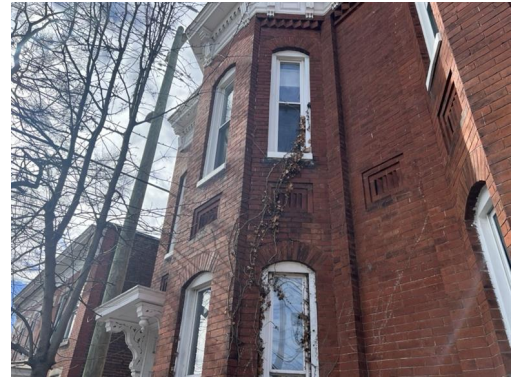
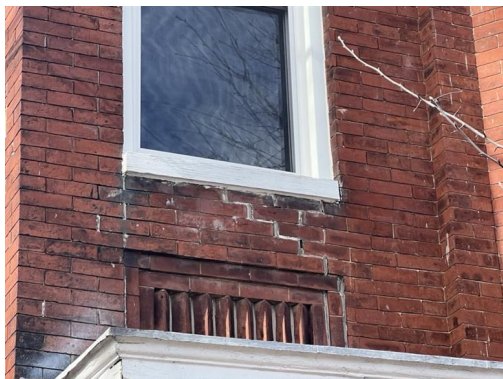
**R** EXTERIOR/EXTERIOR WALLS

| ISSUE | There are deteriorated mortar joints, gaps noted between the brick. |
| LOCATION | The front below the second floor windows. |

| RECOMMENDATION | Engage an experienced mason familiar with building older materials to repair/repoint the mortar joints. |

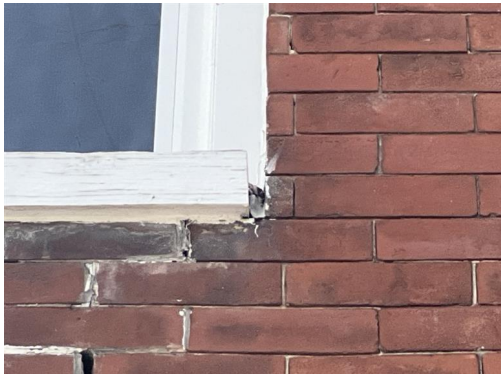
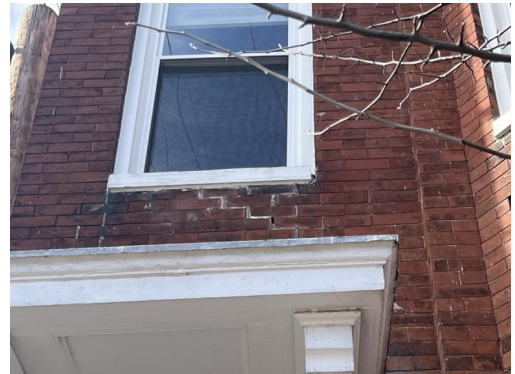
## EXTERIOR/EXTERIOR TRIM

| ISSUE | A gaps at the side of the window sill noted. |
| LOCATION | Second floor front left window. |

| RECOMMENDATION | Seal as required to prevent water, infiltration and subsequent damage. |

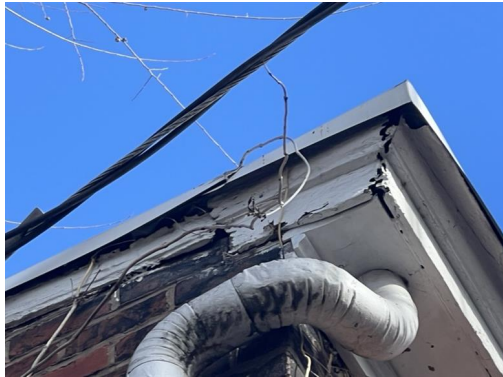
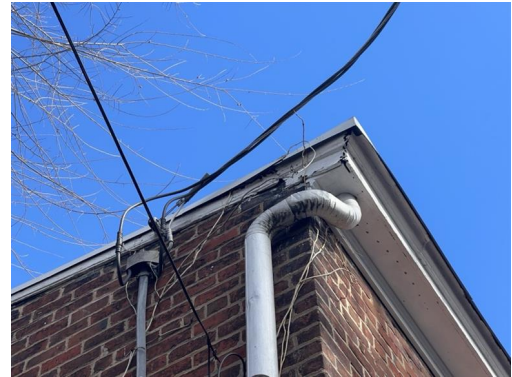
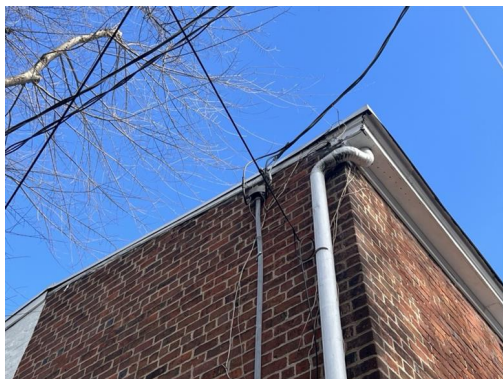
**R** EXTERIOR/EXTERIOR TRIM

| ISSUE | The fascia/soffit is rotted/deteriorated. |
| LOCATION | Rear left corner of the house. |

| RECOMMENDATION | Replace the fascia and repair any damage which may be revealed. |

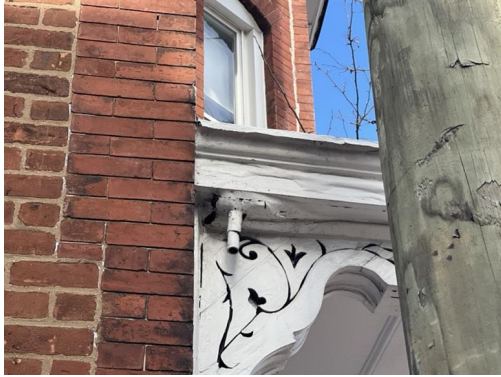
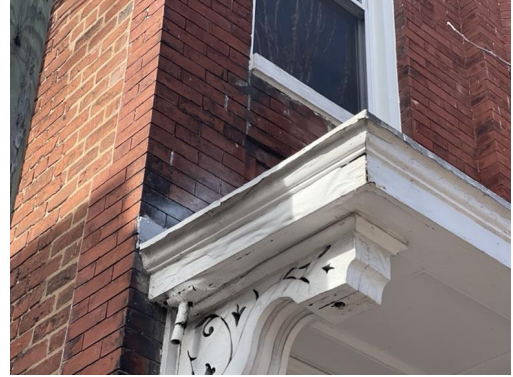
## EXTERIOR/EXTERIOR TRIM

| ISSUE | The porch roof soffit is deteriorated. |
| LOCATION | Front |

| RECOMMENDATION | Replace the soffit and repair any damage which may be revealed. |

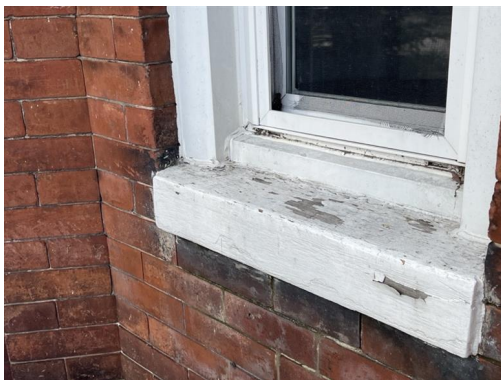
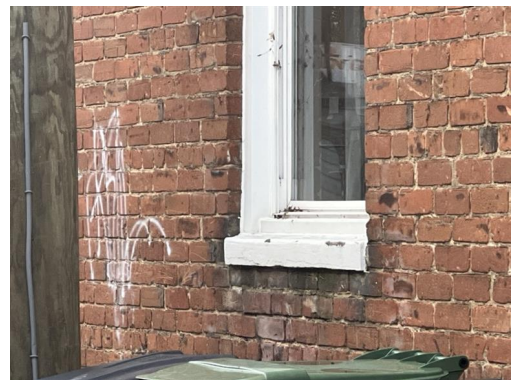
## EXTERIOR/EXTERIOR TRIM

| ISSUE | The paint is peeling, blistering, or deteriorating. |
| LOCATION | Multiple Locations |

| RECOMMENDATION | Replace the trim and repair any damage which may be revealed. |

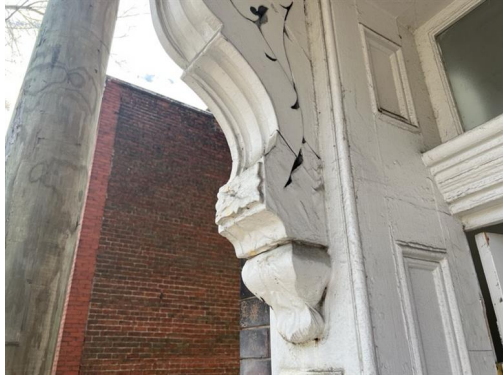
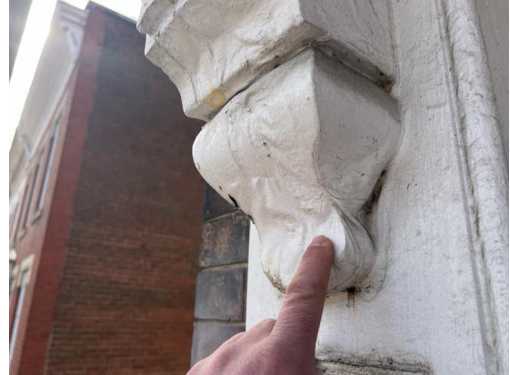
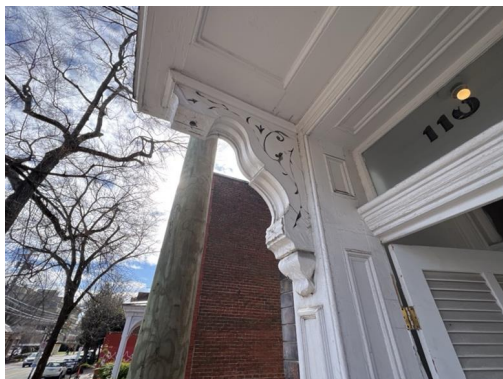
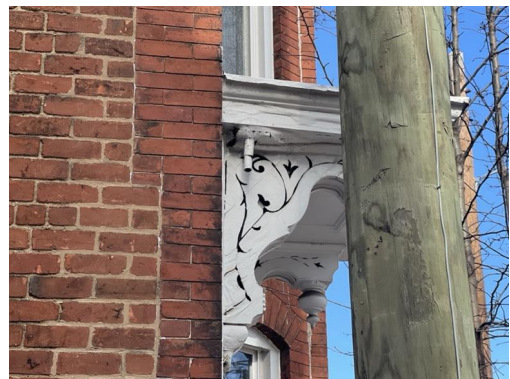
## EXTERIOR/EXTERIOR TRIM

| ISSUE | There is rotted/damaged trim. |
| LOCATION | Front porch trim. |

| RECOMMENDATION | Replace the trim and repair any damage which may be revealed. |

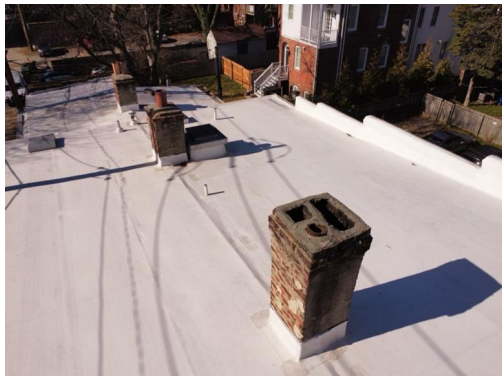
## R EXTERIOR/CHIMNEY

| ISSUE | The chimney is missing a rain cap/spark arrestor. |
| LOCATION | Right side of the roof. |

| RECOMMENDATION | Install a rain cap/spark arrestor. |

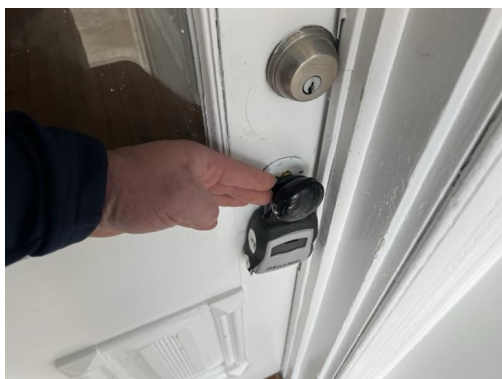
## R EXTERIOR/EXTERIOR DOORS

| ISSUE | The handle hardware is inoperative, the deadbolt is the only way to secure the door. |
| LOCATION | Front |

| RECOMMENDATION | Repair or replace the door hardware. |

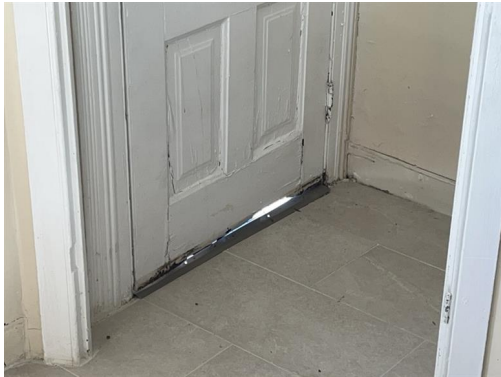
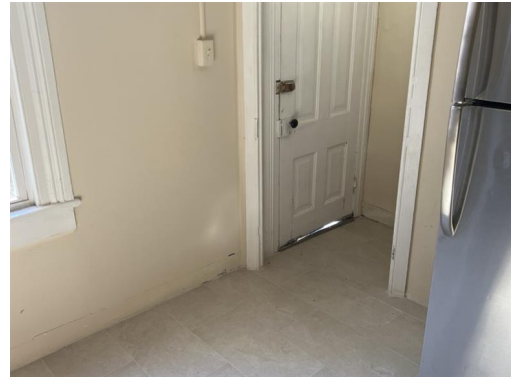
## EXTERIOR/EXTERIOR DOORS

| ISSUE | The bottom of the rear door is rotted/deteriorated. |
| LOCATION | Rear |

| RECOMMENDATION | Repair or replace the door. |

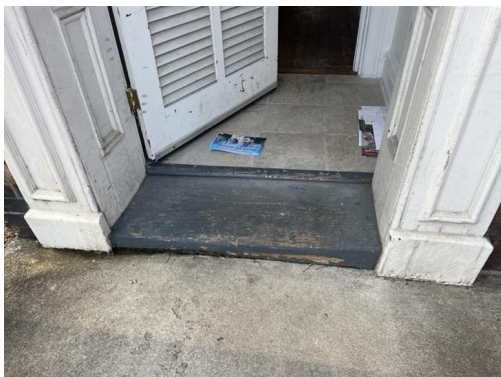
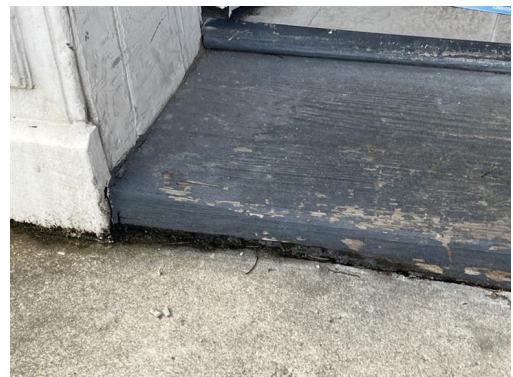
## EXTERIOR/EXTERIOR DOORS

| ISSUE | The threshold below the front door is deteriorated/decayed. |
| LOCATION | Front |
| IMPLICATION | This affects energy efficiency and may permit water to enter and damage the structure. |

| RECOMMENDATION | Repair or replace the threshold, as required. |

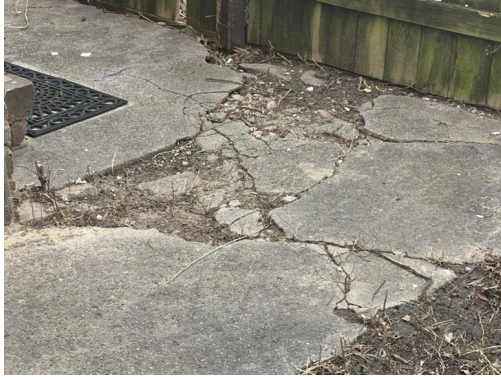
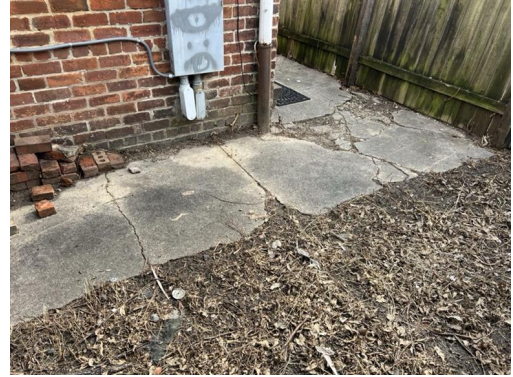
EXTERIOR/PATIO

| ISSUE | The patio is significantly deteriorated with cracking and missing sections. |
| LOCATION | Rear |
| IMPLICATION | Deterioration may have an impact on function; water may also penetrate the patio and cause further deterioration. |

| RECOMMENDATION | Repair and seal the patio. |

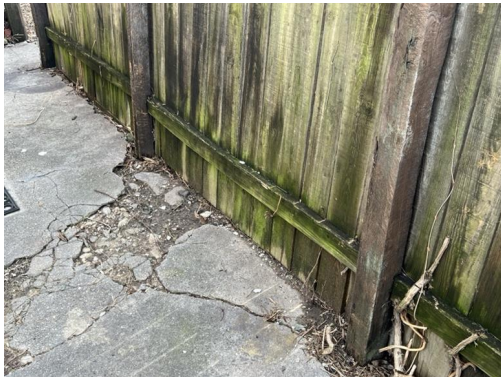
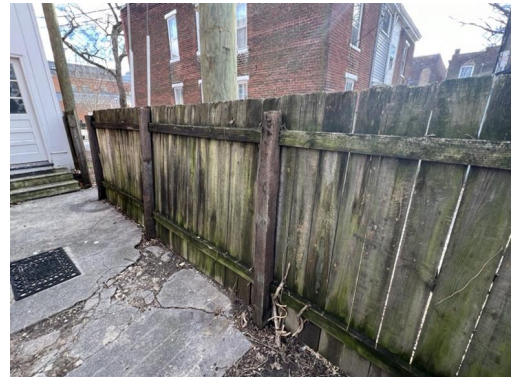
EXTERIOR/FENCE

| ISSUE | The posts or columns are leaning and decayed.. |
| LOCATION | Left Side |

| RECOMMENDATION | Repair or replace the posts and any other found rotted materials. |

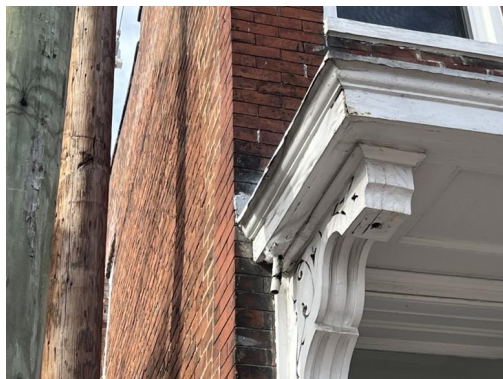
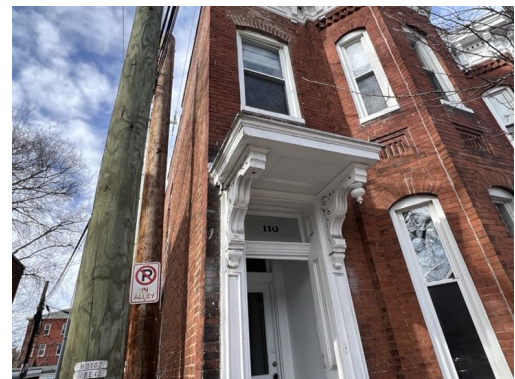
## WATER CONTROL/GUTTERS/DOWNSPOUTS

| ISSUE | The downspout is missing from the front porch roof. |
| LOCATION | Front |

| RECOMMENDATION | Install downspouts as required. |

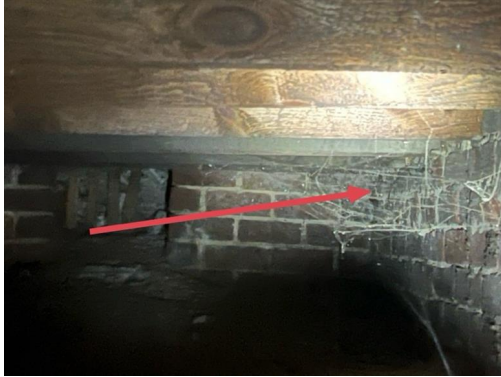
## R STRUCTURE/FLOOR STRUCTURE

| ISSUE | The floor joist is damaged or deteriorated. |
| LOCATION | The front left corner of the crawlspace. |

| RECOMMENDATION | Engage a structural contractor to evaluate and to make repairs, as required. |

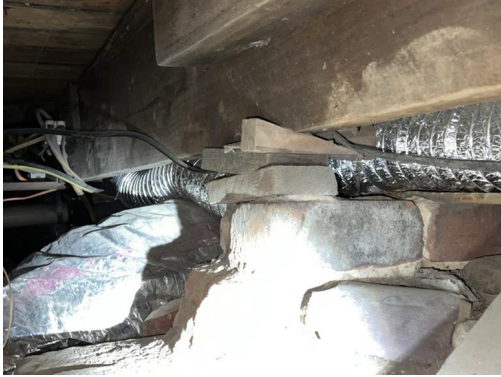
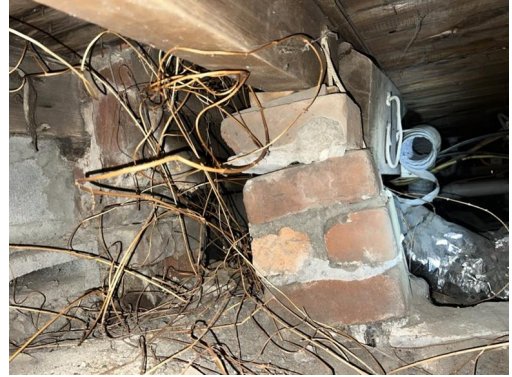
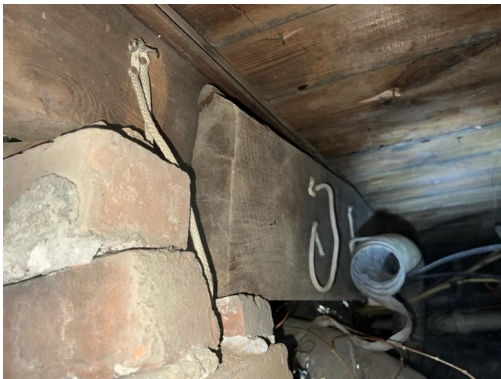
## STRUCTURE/FLOOR STRUCTURE

| ISSUE | The joist has inadequate bearing, wooden wedges and stacked bricks noted at the entry of the rear crawlspace. |
| LOCATION | Rear most crawlspace. |

| RECOMMENDATION | Engage a structural contractor to evaluate and to make repairs, as required. Additional support may be needed. |

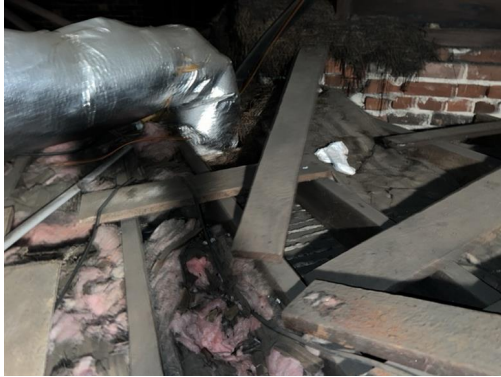
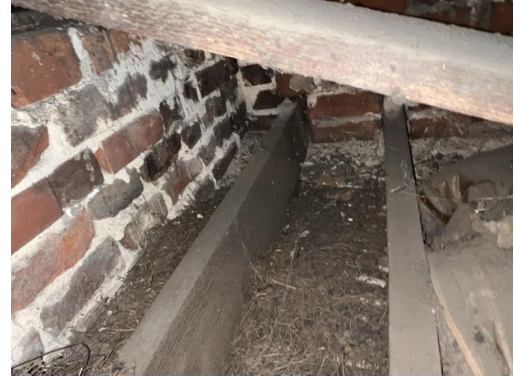
## INSULATION AND VENTILATION/ATTIC INSULATION

| ISSUE | The insulation is missing and low in several joist bay. |
| LOCATION | Multiple Locations |

| RECOMMENDATION | Install insulation in accordance with local guidelines. |

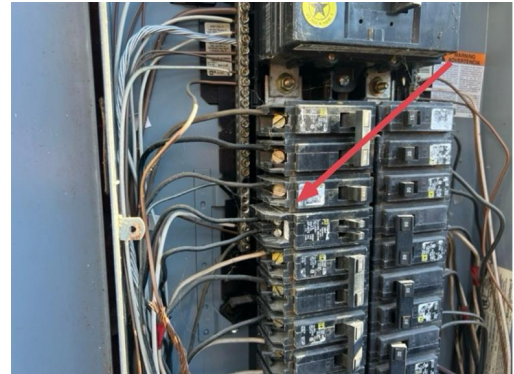
## ELECTRICAL/ELECTRICAL PANEL

| ISSUE | There are double-tapped breakers. |
| LOCATION | Rear exterior. |

| RECOMMENDATION | Engage an electrical contractor to evaluate and to make repairs, as required. |

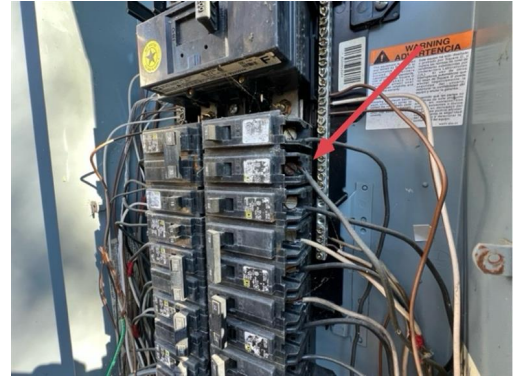
## ELECTRICAL/ELECTRICAL PANEL

| ISSUE | The wires are overheated at the right side of the panel. |
| LOCATION | Rear exterior |
| IMPLICATION | Overheating may cause a fire. |

| RECOMMENDATION | Engage an electrical contractor to evaluate and to make repairs, as required. |

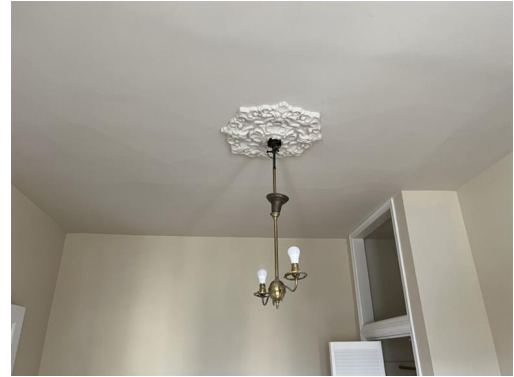
ELECTRICAL/BRANCH CIRCUITS

| ISSUE | There is exposed and unprotected wiring above the ceiling light. |
| LOCATION | The living room. |
| IMPLICATION | Exposed wires are a shock hazard. |

| RECOMMENDATION | Engage an electrical contractor to make repairs, as required. |

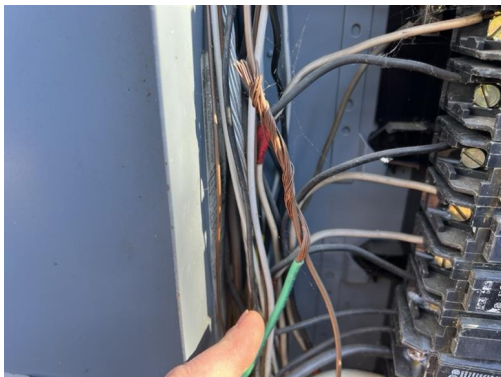
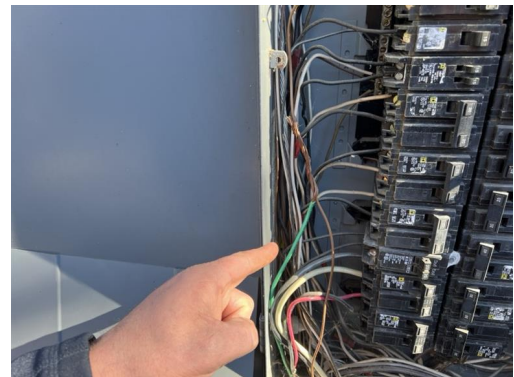
ELECTRICAL/GROUNDING/BONDING

| ISSUE | The ground wire is improperly grounded. |
| LOCATION | Electrical panel |

| RECOMMENDATION | Engage an electrical contractor to make repairs, as required. |

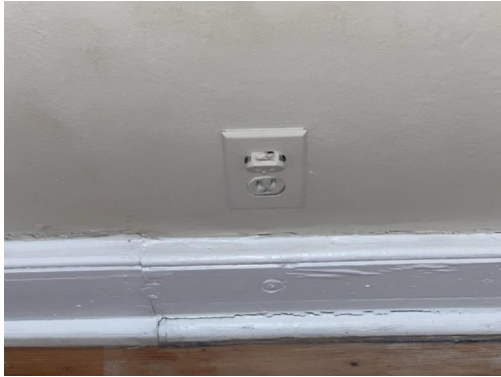
**R** ELECTRICAL/RECEPTACLES

| ISSUE | The receptacle is damaged or deteriorated. |
| LOCATION | Left rear of the rear bedroom. |
| IMPLICATION | Damaged receptacles are shock hazards. |

| RECOMMENDATION | Replace the receptacle. |

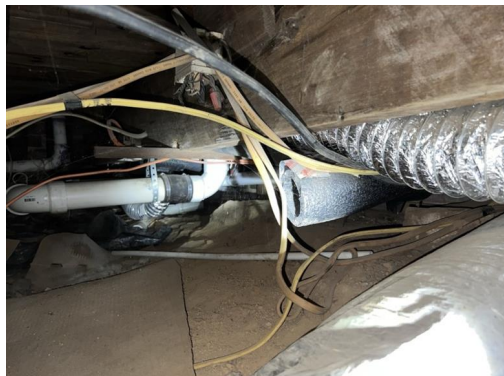
**R** ELECTRICAL/RECEPTACLES

| ISSUE | The cover plate is missing. |
| LOCATION | Crawl Space |

| RECOMMENDATION | Replace the cover plate. |

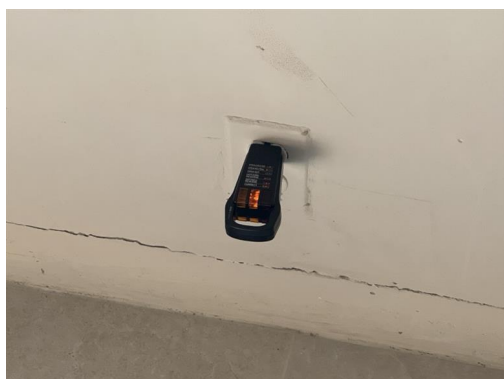
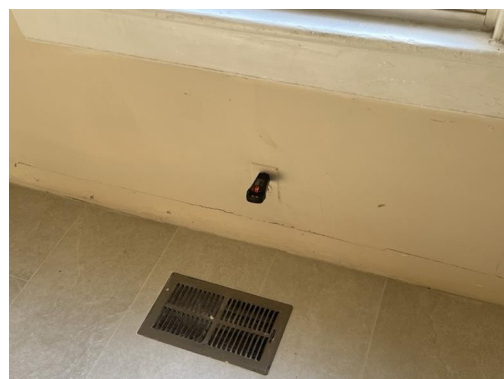
**R** ELECTRICAL/RECEPTACLES

| ISSUE | The receptacle has an open ground connection. |
| LOCATION | Left side of the kitchen. |

| 25. | <b>Electrical/Receptacles</b> The receptacle has an open ground connection. Engage an electrical contractor to make repairs, as required. LOCATION: Left side of the kitchen. Estimated cost to remedy: \$150 to \$250. | 38 |

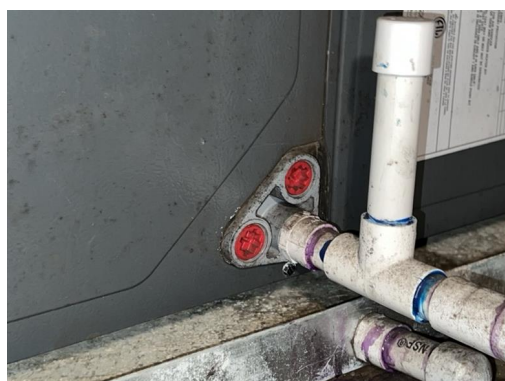
## R HVAC/COOLING SYSTEM

| ISSUE | The condensate auxiliary overflow drain isn't installed. |
| LOCATION | Attic |

| 26. | <b>HVAC/Cooling System</b> The condensate auxiliary overflow drain isn't installed. Engage an HVAC contractor to make repairs, as required. LOCATION: Attic. Estimated cost to remedy: \$150 to \$200. | 40 |

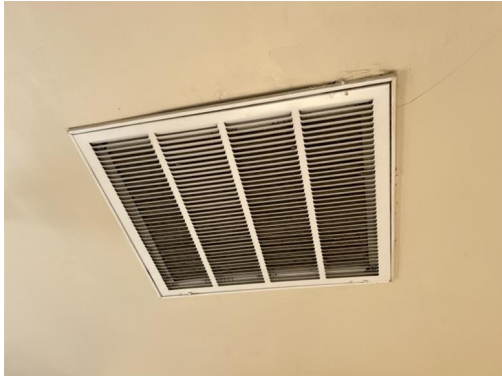
HVAC/DISTRIBUTION

| ISSUE | The air filter is dirty. |
| LOCATION | Hall |

| 42. | <b>HVAC/Distribution</b> The air filter is dirty. Replace the filter. LOCATION: Hall. | 41 |

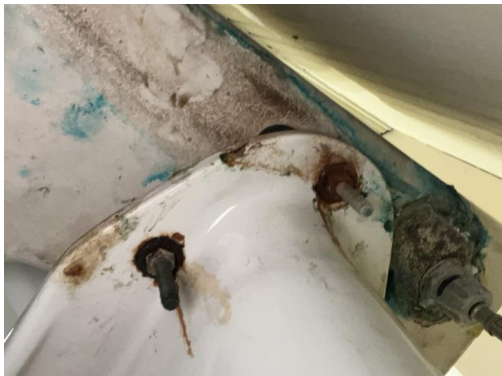
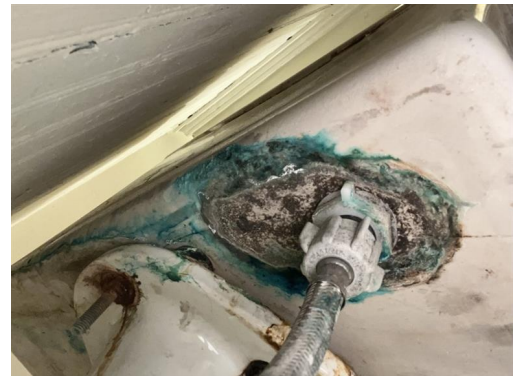
## Ⓡ PLUMBING/TOILETS

| ISSUE | Evidence of leakage from the tank bolts noted. |
| LOCATION | Second floor hall bathroom. |

| 27. | <b>Plumbing/Toilets</b> Evidence of leakage from the tank bolts noted. Repair or replace the toilet. LOCATION: Second floor hall bathroom. Estimated cost to remedy: \$350 to \$400. | 43 |

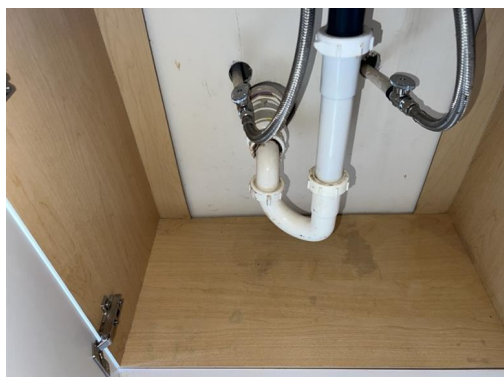
**R** PLUMBING/SINKS

| ISSUE | The drain leaks. |
| LOCATION | Second floor hall bathroom. |

| 29. | <b>Plumbing/Sinks</b> The drain leaks. Repair or replace the drain. LOCATION: Second floor hall bathroom. Estimated cost to remedy: \$200 to \$250. | 44 |

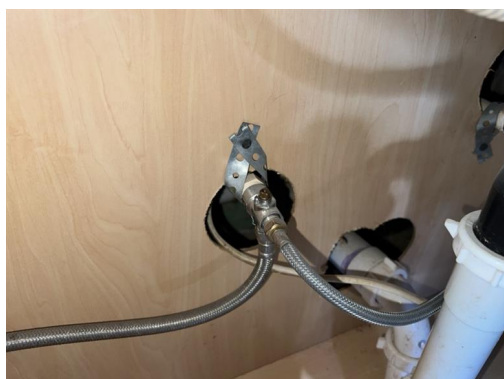
**R** PLUMBING/SINKS

| ISSUE | The shut-off valve is missing. |
| LOCATION | Kitchen |

| 28. | <b>Plumbing/Sinks</b> The shut-off valve is missing. Install a shut-off valve. LOCATION: Kitchen. Estimated cost to remedy: \$100 to \$150. | 44 |

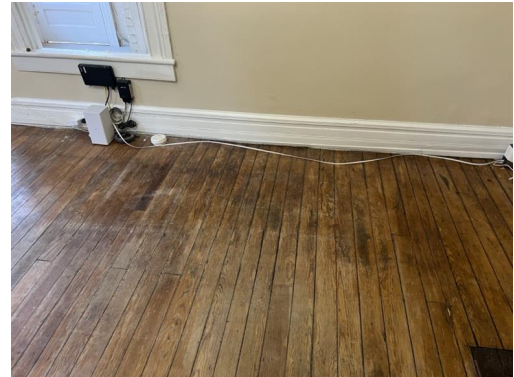
## R INTERIOR/INTERIOR FLOORS

| ISSUE | The floorboards sag at the rear of the dining room. |
| LOCATION | Rear wall of the family room. |

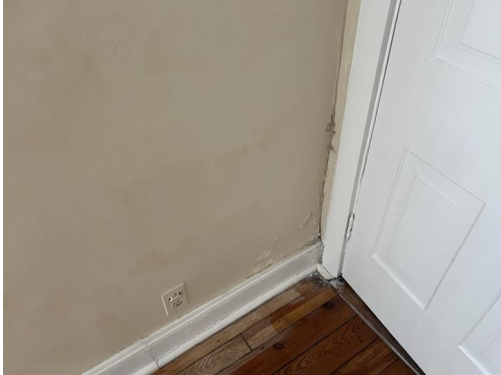
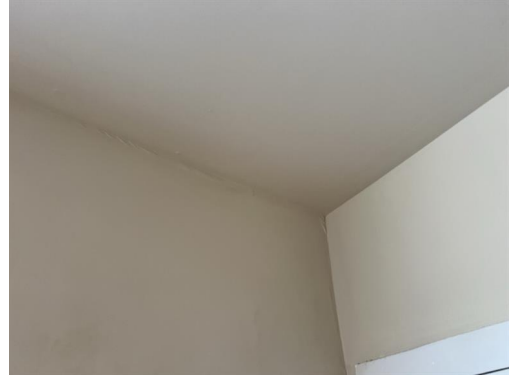
● INTERIOR/INTERIOR WALLS

| ISSUE | The wall is water-stained or damaged; testing with a moisture meter confirms no/low moisture content. |
| LOCATION | Left wall of the rear bedroom. |

| 45. | <b>Interior/Interior Walls</b> The wall is water-stained or damaged; testing with a moisture meter confirms no/low moisture content. Engage a contractor to evaluate and to make repairs, as required. LOCATION: Left wall of the rear bedroom. | 47 |

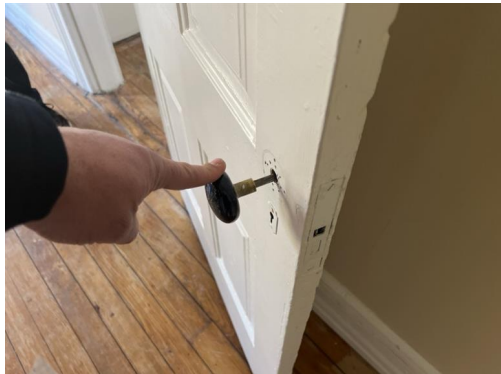
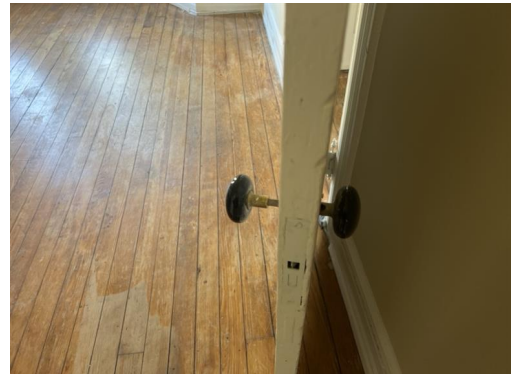
● INTERIOR/INTERIOR DOORS

| ISSUE | The door handle is loose and not functional. |
| LOCATION | Multiple Locations |

| 43. | <b>Interior/Interior Doors</b> The door handle is loose and not functional. Secure the door hardware. LOCATION: Multiple Locations. Estimated cost to remedy: \$250 to \$300. | 47 |

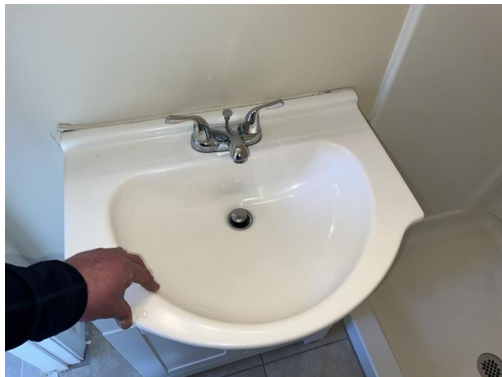
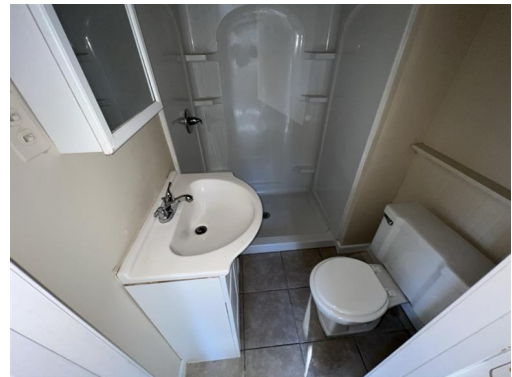
**R** INTERIOR/CABINETS/DRAWERS

| ISSUE | The cabinet is inadequately secured to the wall. |
| LOCATION | Second floor hall bathroom. |

| 32. | <b>Interior/Cabinets/Drawers</b> The cabinet is inadequately secured to the wall. Secure the cabinet to the wall. LOCATION: Second floor hall bathroom. Estimated cost to remedy: \$150 to \$200. | 48 |

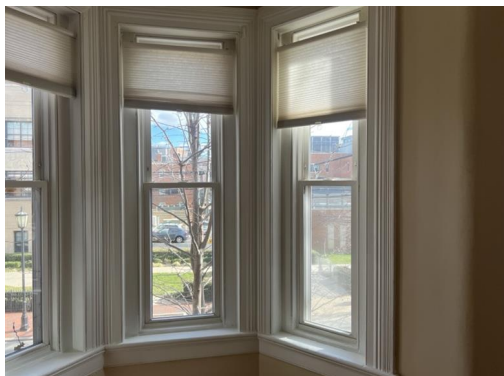
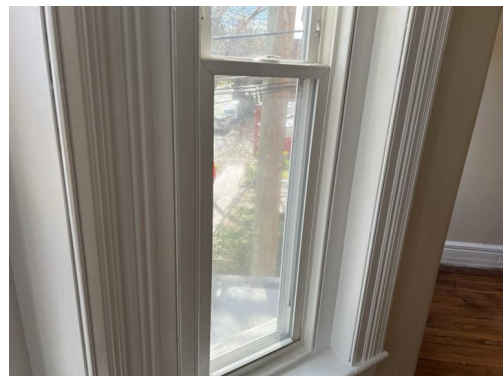
**R** INTERIOR/WINDOWS

| ISSUE | The window has a failed insulated glass seal. |
| LOCATION | The bottom sash in the left side front bedroom window. |

| 33. | <b>Interior/Windows</b> The window has a failed insulated glass seal. Replace the insulated glass unit or the window. LOCATION: The bottom sash in the left side front bedroom window. Estimated cost to remedy: \$250 to \$300. | 49 |

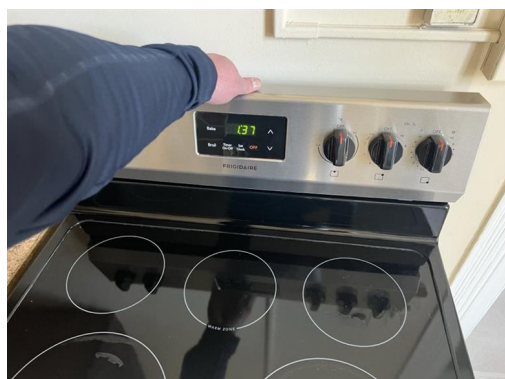
## R APPLIANCES/RANGE/OVEN

| ISSUE | The anti-tip device is missing. |
| LOCATION | Kitchen |

| 34. | <b>Appliances/Range/Oven</b> The anti-tip device is missing. Install an anti-tip device. LOCATION: Kitchen. Estimated cost to remedy: \$100 to \$150. | 51 |

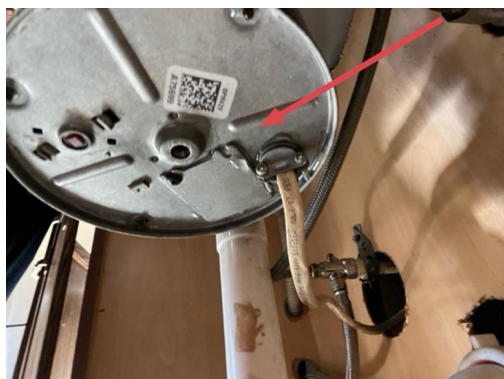
**R** APPLIANCES/GARBAGE DISPOSER

| ISSUE | The garbage disposer leaks from inside the unit. |
| LOCATION | Kitchen |

| 35. | <b>Appliances/Garbage Disposer</b> The garbage disposer leaks from inside the unit. Replace the disposer. LOCATION: Kitchen. Estimated cost to remedy: \$400 to \$500. | 52 |

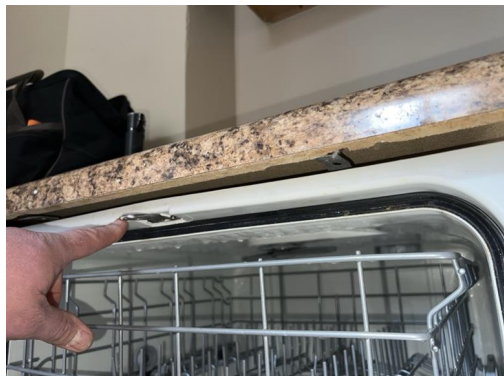
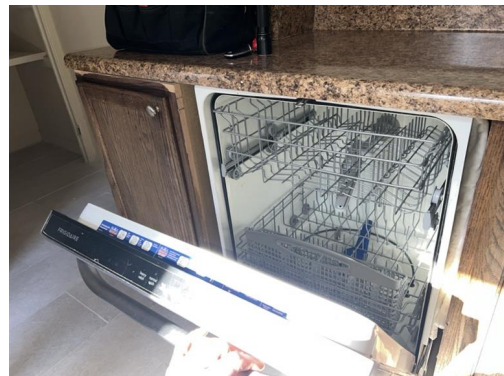
## R APPLIANCES/DISHWASHER

| ISSUE | The dishwasher is inadequately secured to the cabinet or the countertop. |
| LOCATION | Kitchen |

| 36. | <b>Appliances/Dishwasher</b> The dishwasher is inadequately secured to the cabinet or the countertop. Secure the dishwasher. LOCATION: Kitchen. Estimated cost to remedy: \$100 to \$150. | 53 |

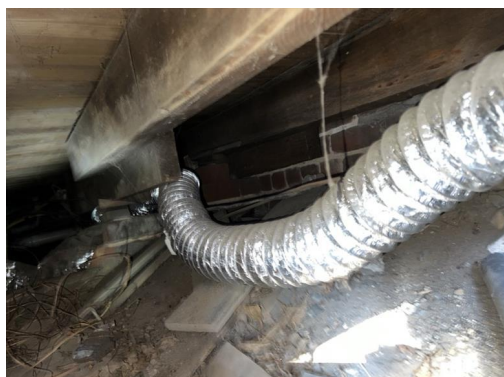
## APPLIANCES/DRYER 1 VENTILATION

| ISSUE | The vent pipe is an improper material. |
| LOCATION | Rear crawlspace. |

| 37. | <b>Appliances/Dryer 1 Ventilation</b> The vent pipe is an improper material. Replace the duct with a smooth walled vent pipe. LOCATION: Rear crawlspace. Estimated cost to remedy: \$250 to \$350. | 54 |
