## INSPECTION INSIGHTS

| DATE | 05/09/23 |
| ADDRESS | 3121 Stony Point Rd unit<br>d, Richmond, VA |

# OBJECTIVES AND SCOPE

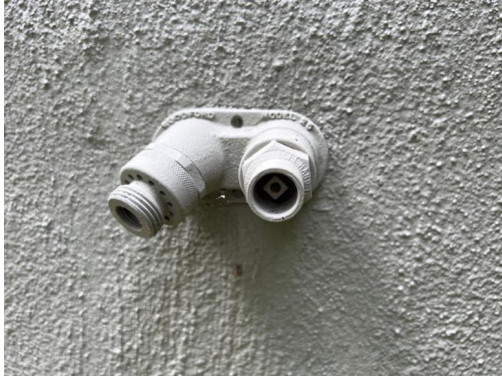
## EXTERIOR/HOSE FAUCETS

The service handle key is not present.

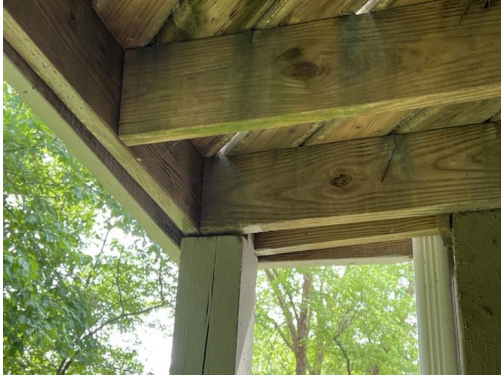
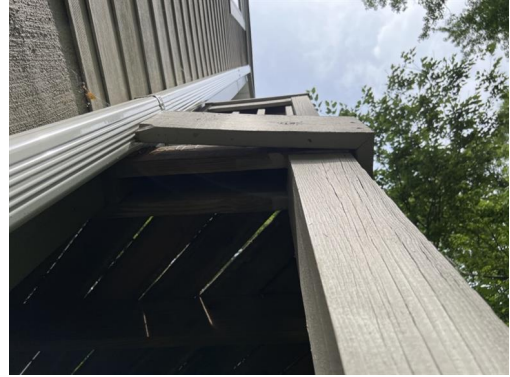
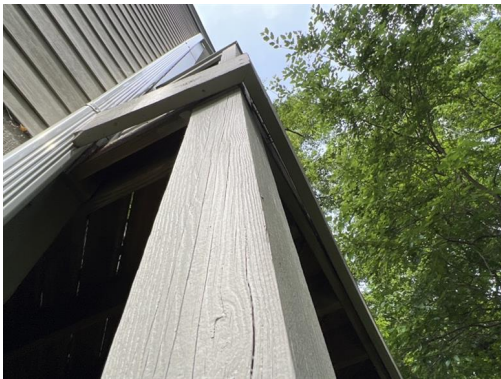
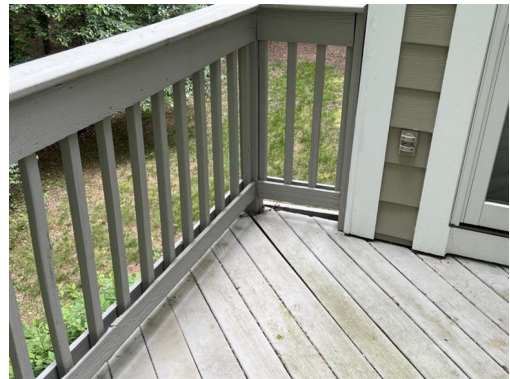
**R** EXTERIOR/DECK/BALCONY

| | 1. Exterior/Deck/Balcony | The outside boards are separating from the deck rim joist, also, the band board and inside room Joyce are not in contact with the top of the post. LOCATION: The rear right corner of the deck. 13 |

| ISSUE | The outside boards are separating from the deck rim joist, also, the band board and inside room Joyce are not in contact with the top of the post. |
| LOCATION | The rear right corner of the deck. |
| IMPLICATION | This is causing the deck corner above to slant/drop. |

| RECOMMENDATION | Have all boards secured, and properly supported/fastened as required to prevent further movement. |

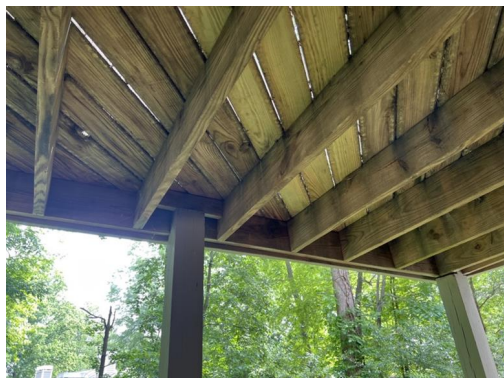
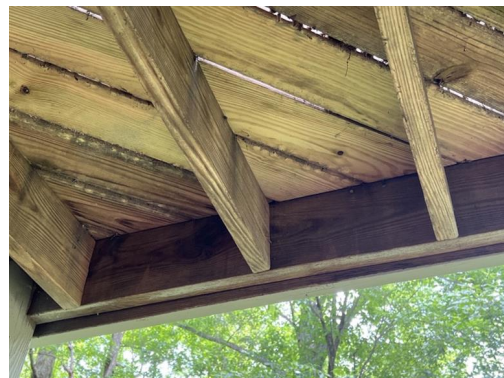
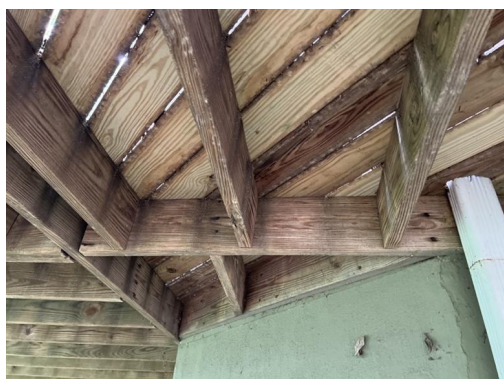
**R** EXTERIOR/DECK/BALCONY

| | 2. Exterior/Deck/Balcony | The joists are installed without proper hanger hardware. LOCATION: Outside joist ends. 14 |

| ISSUE | The joists are installed without proper hanger hardware. |
| LOCATION | Outside joist ends. |
| IMPLICATION | This affects its load-bearing capacity. |

| RECOMMENDATION | Secure with appropriate hardware. |

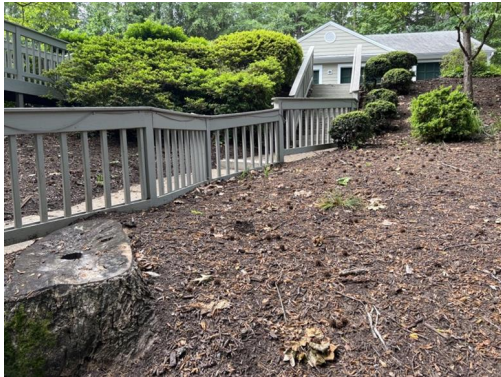
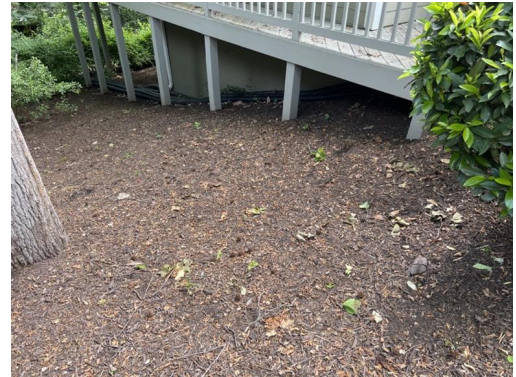
## WATER CONTROL/GRADING

| | 6. Water Control/Grading | The grading is sloping towards the foundation. LOCATION: Front. 17 |

| ISSUE | The grading is sloping towards the foundation. |
| LOCATION | Front |
| IMPLICATION | May permit water to accumulate at the structure; water may penetrate the structure. |

| RECOMMENDATION | Maintain grading to divert water away from the structure. |

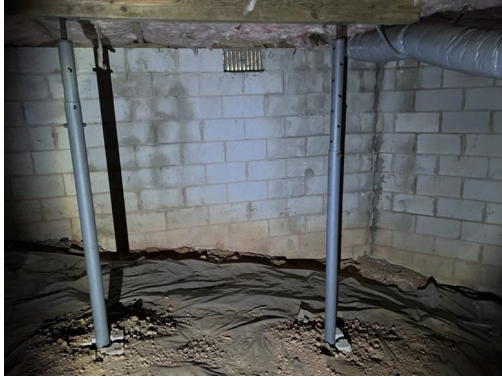
STRUCTURE/PIERS/POSTS

| | 7. Structure/Piers/Posts | Metal screw jacks supporting beams have been installed throughout the crawl space. These are most likely to prevent bounce in the flooring above. LOCATION: The crawl space. 20 |

| ISSUE | Metal screw jacks supporting beams have been installed throughout the crawl space. These are most likely to prevent bounce in the flooring above. |
| LOCATION | The crawl space. |
| IMPLICATION | This indicates a previous issue. |

| RECOMMENDATION | Monitor and maintain as required. Consider obtaining a second opinion if movement is observed in the flooring above. |

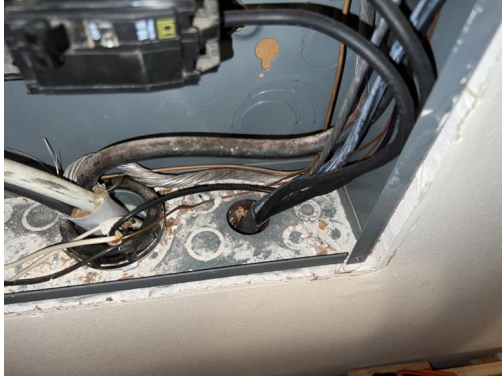
## R ELECTRICAL/ELECTRICAL PANEL

| | 3. Electrical/Electrical Panel | There are improperly secured wires at the electrical panel. LOCATION: Laundry Room. 23 |

| ISSUE | There are improperly secured wires at the electrical panel. |
| LOCATION | Laundry Room |
| IMPLICATION | Standards require a retainer/clamp at the points at which wires enter a panel. |

| RECOMMENDATION | Engage an electrical contractor to make repairs, as required. |

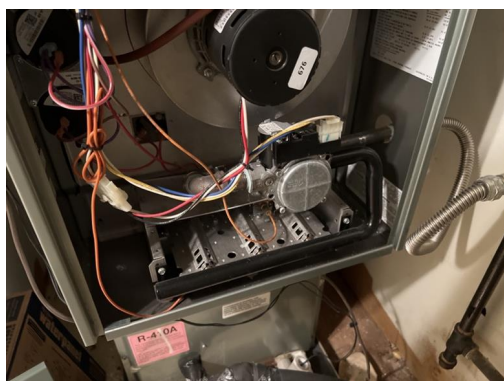
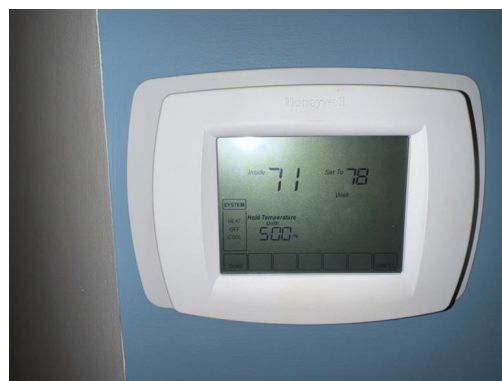
### R HVAC/HEATING SYSTEM

| | 4. HVAC/Heating System | The furnace does not function, the thermostat indicates the unit is in heating mode however the inducer fan or burners do not work. LOCATION: Utility Room. 25 |

| ISSUE | The furnace does not function, the thermostat indicates the unit is in heating mode however the inducer fan or burners do not work. |
| LOCATION | Utility Room |
| IMPLICATION | The house does heat. |

| RECOMMENDATION | Have the system evaluated and repaired as required to restore proper function. |

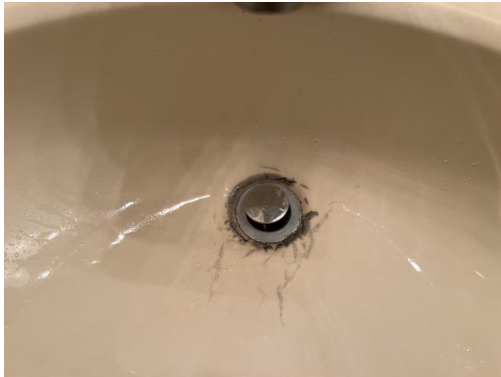
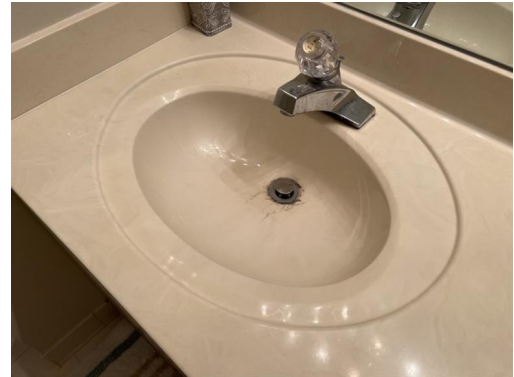
## PLUMBING/SINKS

| | 8. Plumbing/Sinks | The left sink basin has hairline cracking around the drain, no leakage observed in the cabinet below. LOCATION: Primary Bathroom. 28 |

ISSUE The left sink basin has hairline cracking around the drain, no leakage observed in the cabinet below.  
 LOCATION Primary Bathroom  
 IMPLICATION The cracks can worsen over time and allow water to infiltrate into the area below.  
 RECOMMENDATION Monitor for further degeneration and replace as required.  
 RESOURCE Experienced professional

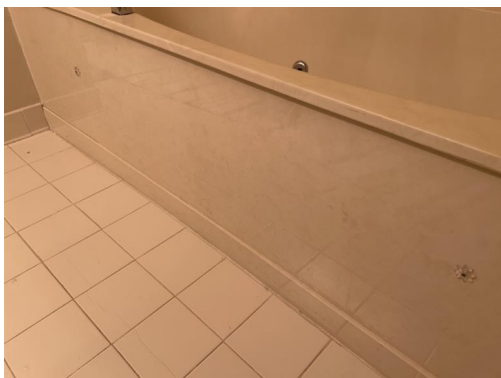
## PLUMBING/WHIRLPOOL

| | 5. Plumbing/Whirlpool | The whirlpool access panel is sealed shut. LOCATION: Primary Bathroom. 28 |

ISSUE The whirlpool access panel is sealed shut.  
 LOCATION Primary Bathroom  
 IMPLICATION The pump reset button can't be operated.  
 RECOMMENDATION Have the panel adjusted to allow easy access.  
 RESOURCE Experienced professional
