## INSPECTION INSIGHTS

| DATE | 06/29/23 |
| ADDRESS | 1910 Windsordale Drive,<br>Richmond, VA |

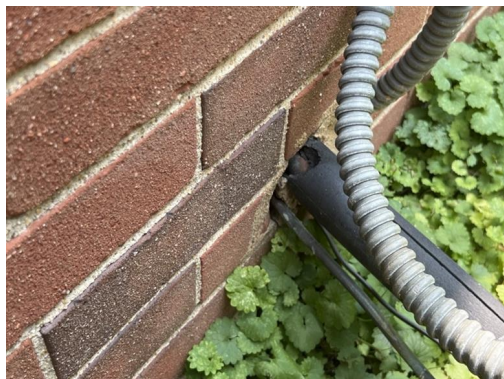
| 1. | <b>Exterior/Exterior Walls</b> There are gaps around the HVAC line set penetrations into the house. Seal around the penetrations. LOCATION: Rear. Estimated cost to remedy: \$50 to \$100. | 12 |

| ISSUE | There are gaps around the HVAC line set penetrations into the house. Seal around the penetrations. |

| RECOMMENDATION | Seal around the penetrations. |

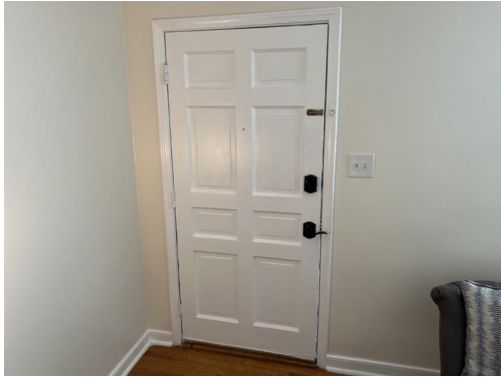
| 2. | <b>Exterior/Exterior Doors</b> The door rubs against the frame at the entrance to the converted garage. Have the door just is required to restore, proper function. LOCATION: Front. | 13 |

| ISSUE | The door rubs against the frame at the entrance to the converted garage. Have the door just is required to restore, proper function. |

| RECOMMENDATION | Have the door just is required to restore, proper function. |

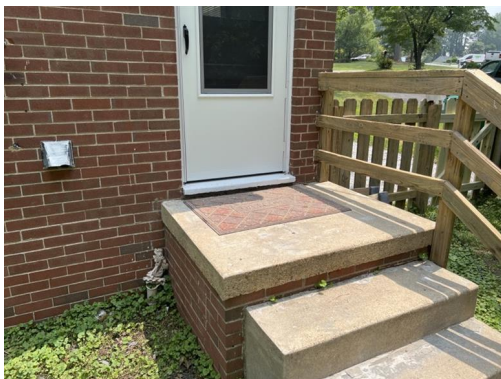
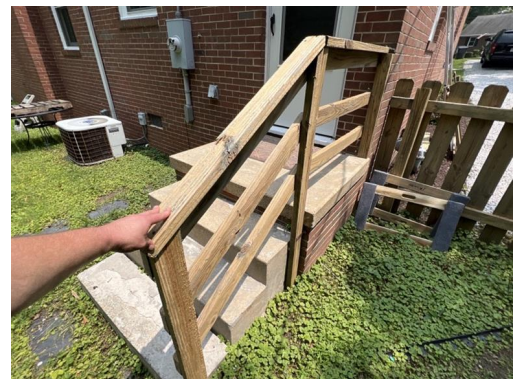
| 3. | <b>Exterior/Exterior Stairs/Steps</b> The left railing is loose and the right side railing is missing. Have the a railing installed at the open side of the landing and the current railing secured as required for safety. LOCATION: Rear. Estimated cost to remedy: \$750 to \$800. | 13 |

| ISSUE | The left railing is loose and the right side railing is missing. Have the a railing installed at the open side of the landing and the current railing secured as required for safety. |
| IMPLICATION | This is a falling hazard and safety issue. |

| RECOMMENDATION | Have the a railing installed at the open side of the landing and the current railing secured as required for safety. |

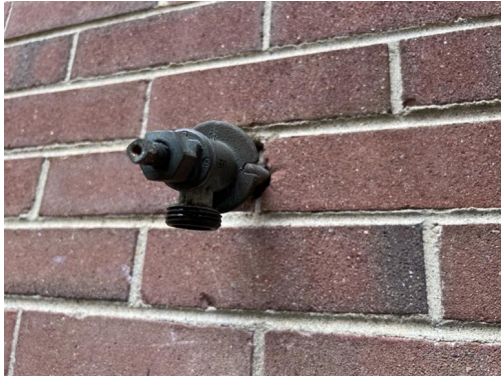
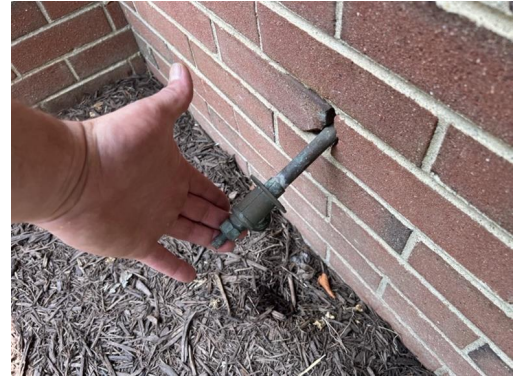
| 4. | <b>Exterior/Hose Faucets</b> The front hose bib is leaking, missing the handle, and stick out excessively from the house. Have the hose bib replaced and secured as required. LOCATION: Front. Estimated cost to remedy: \$350 to \$400. | 14 |

| ISSUE | The front hose bib is leaking, missing the handle, and stick out excessively from the house. Have the hose bib replaced and secured as required. |
| IMPLICATION | The unit is damaged and leaking water, also the piping may be inadvertently damaged. |

| RECOMMENDATION | Have the hose bib replaced and secured as required. |

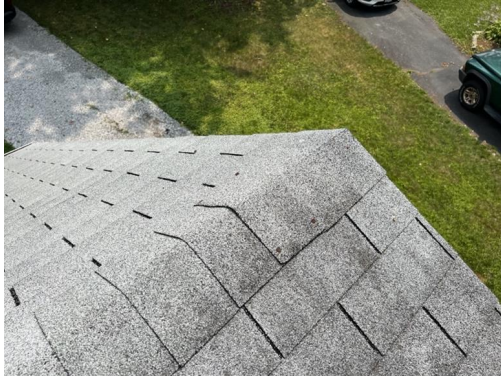
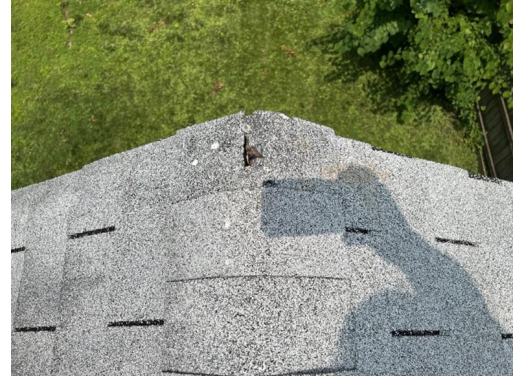
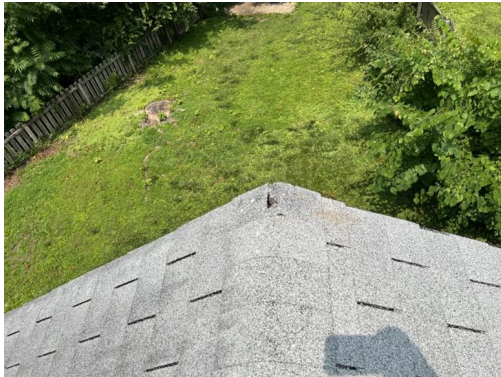
| 5. | <b>Roof/Roofing</b> The shingles are damaged with a hole from the top edge of the rake boards. Engage a roofing contractor to make repairs or replace the roofing. LOCATION: The right side ridge end. Estimated cost to remedy: \$250 to \$300. | 16 |

| ISSUE | The shingles are damaged with a hole from the top edge of the rake boards. Engage a roofing contractor to make repairs or replace the roofing. |

| RECOMMENDATION | Engage a roofing contractor to make repairs or replace the roofing. |

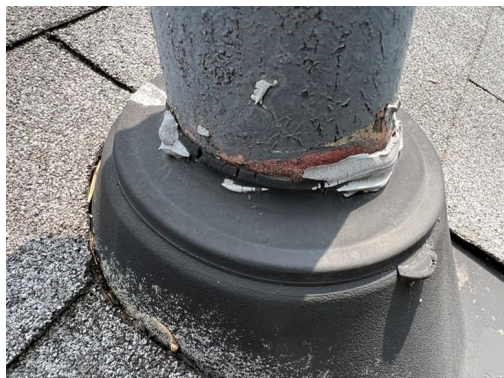
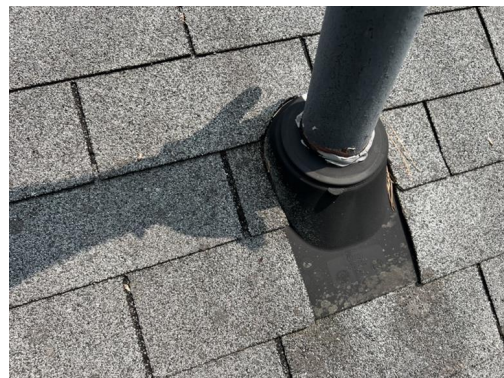
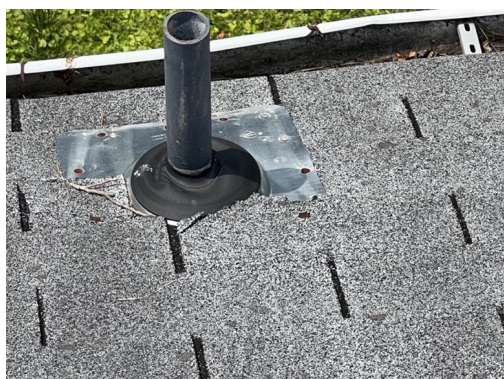
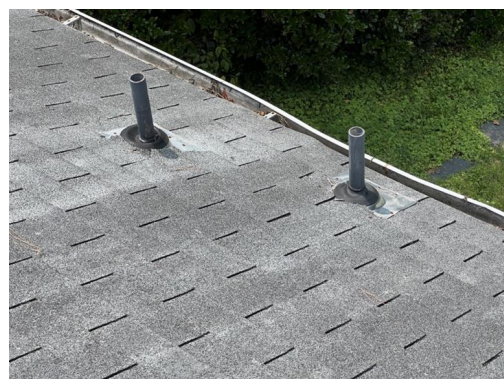
| 6. | <b>Roof/Flashing</b> The vent boot is damaged at the base of a plumbing vent. Gaps in cracking observed around the rubber collar of the boot. Replace the vent boot and repair any damage which may be revealed. LOCATION: The front and rear of the roof. Estimated cost to remedy: \$500 to \$600. | 17 |

| ISSUE | The vent boot is damaged at the base of a plumbing vent. Gaps in cracking observed around the rubber collar of the boot. Replace the vent boot and repair any damage which may be revealed. |

| RECOMMENDATION | Replace the vent boot and repair any damage which may be revealed. |

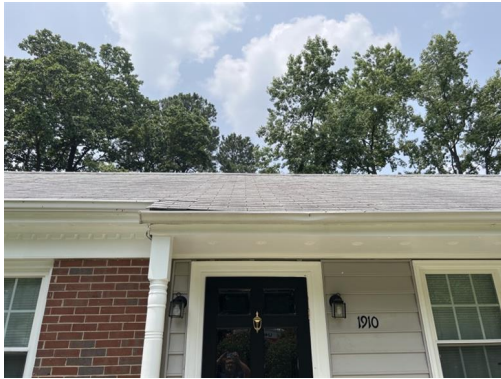
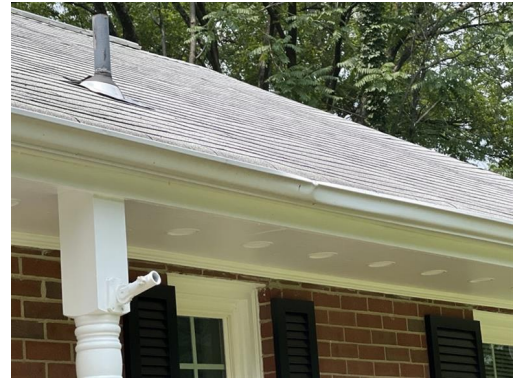
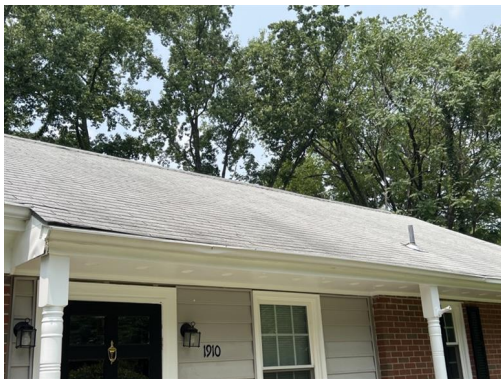
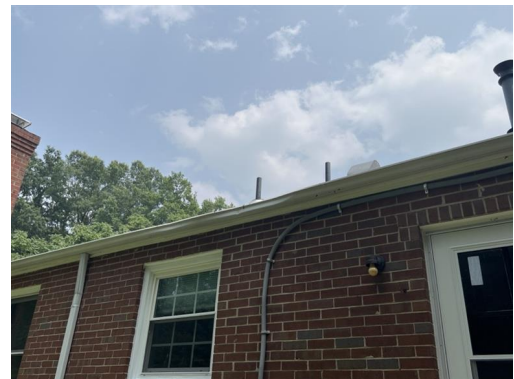
| 7. | <b>Water Control/Gutters/Downspouts</b> The gutters are dented, also the trough is not properly pitched due to damage. Repair or replace the gutters to carry water away from the structure. LOCATION: Front. Estimated cost to remedy: \$400 to \$500. | 20 |

| ISSUE | The gutters are dented, also the trough is not properly pitched due to damage. Repair or replace the gutters to carry water away from the structure. |

| RECOMMENDATION | Repair or replace the gutters to carry water away from the structure. |

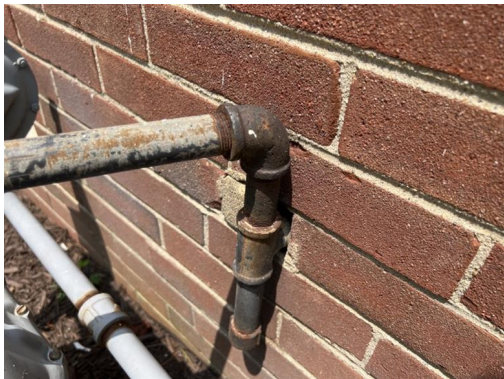
| 17. | <b>Fuel Services/Fuel Meter</b> The gas lines are inadequately protected against damage at the entry into the house. No protective PVC sleeve found around the gas pipe. Structure made predate requirement. | 22 |

| ISSUE | The gas lines are inadequately protected against damage at the entry into the house. No protective PVC sleeve found around the gas pipe. Structure made predate requirement. |
| IMPLICATION | The steel piping in contact with masonry block may accelerate corrosion. |

| RECOMMENDATION | Have a protective sleeve added as required for safety. |

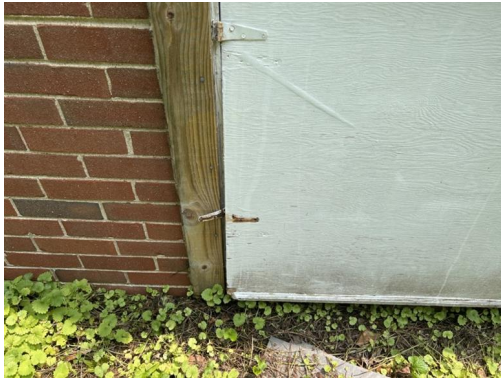
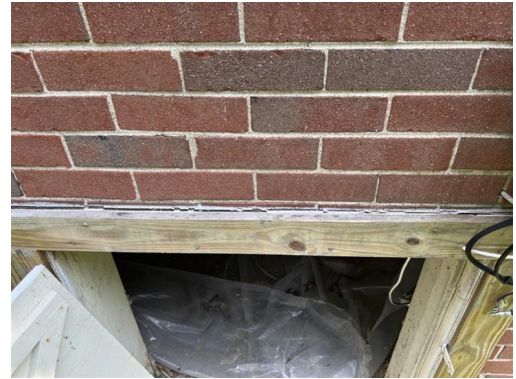
| 8. | <b>Structure/Crawl Space</b> The crawlspace door has a broken hinge and does not properly secure. Have the access door repaired/replaced as required. LOCATION: Rear. | 24 |

| ISSUE | The crawlspace door has a broken hinge and does not properly secure. Have the access door repaired/replaced as required. |
| IMPLICATION | May permit energy loss, moisture, and animals to enter the crawl space. |

| RECOMMENDATION | Have the access door repaired/replaced as required. |

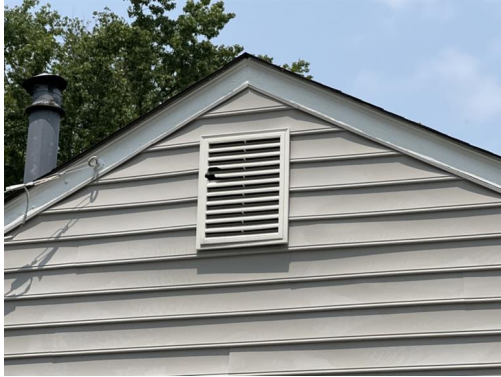
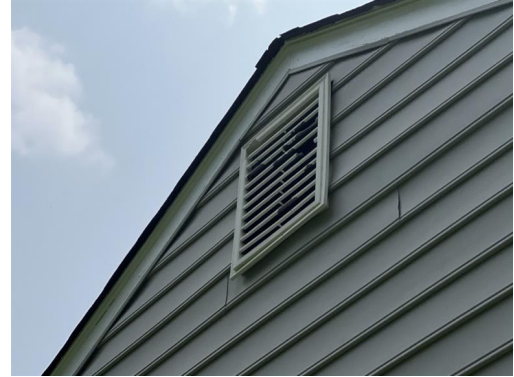
| 18. | <b>Insulation and Ventilation/Attic Ventilation</b> The exterior cover for the outside gable vents are damaged. Repair or replace the vents. LOCATION: Both gable vents. | 26 |

| ISSUE | The exterior cover for the outside gable vents are damaged. Repair or replace the vents. |
| IMPLICATION | Further damage to the vents me allow for pest intrusion. |

| RECOMMENDATION | Repair or replace the vents. |

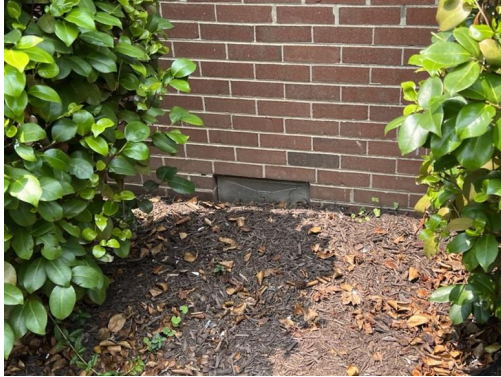
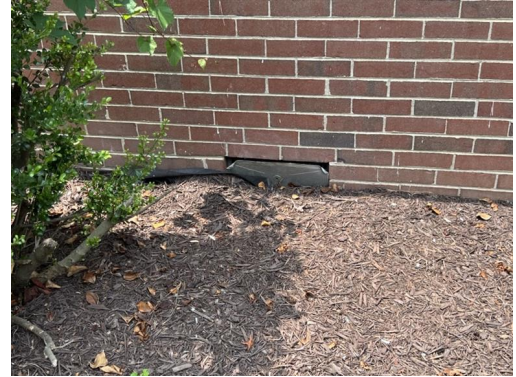
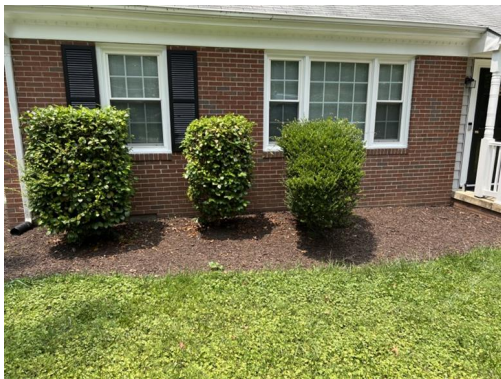
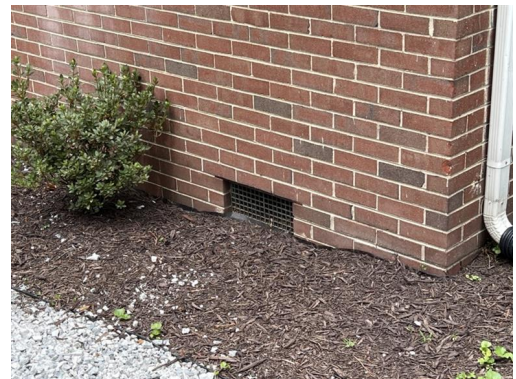
| 19. | <b>Insulation and Ventilation/Crawl Space Ventilation</b> Exterior crawlspace, fence, or below/even with the exterior grade. No water intrusion noted at the inside of the crawlspace. Adjust the grade in front of the vents to divert water away from the structure. Consider adding small wells in front of the vents to drain water prior to entering. LOCATION: The front left, and left front corner of the house. | 27 |

| ISSUE | Exterior crawlspace, fence, or below/even with the exterior grade. No water intrusion noted at the inside of the crawlspace. Adjust the grade in front of the vents to divert water away from the structure. Consider adding small wells in front of the vents to drain water prior to entering. |

| RECOMMENDATION | Adjust the grade in front of the vents to divert water away from the structure. Consider adding small wells in front of the vents to drain water prior to entering. |

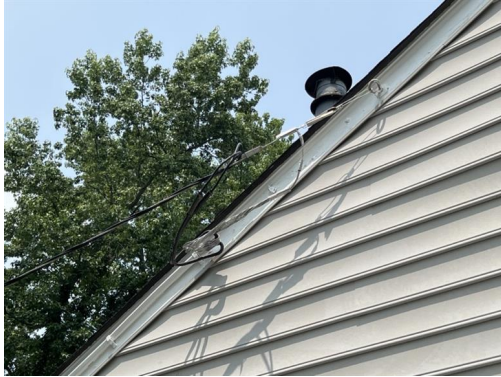
| 9. | <b>Electrical/Electrical Service</b> The weatherhead cover is missing at the bottom of the service drop. Engage an electrical contractor to replace the weather-head. LOCATION: Left Side. Estimated cost to remedy: \$150 to \$200. | 29 |

| ISSUE | The weatherhead cover is missing at the bottom of the service drop. Engage an electrical contractor to replace the weather-head. |
| IMPLICATION | Exposed wiring has the potential for water damage. |

| RECOMMENDATION | Engage an electrical contractor to replace the weather-head. |

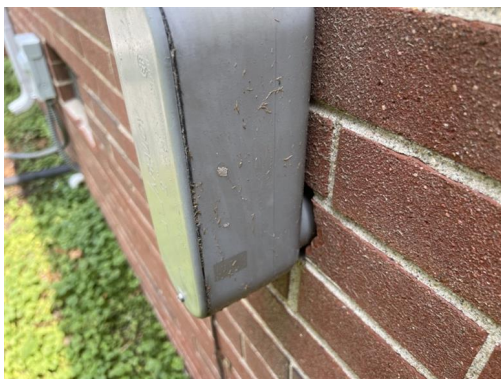
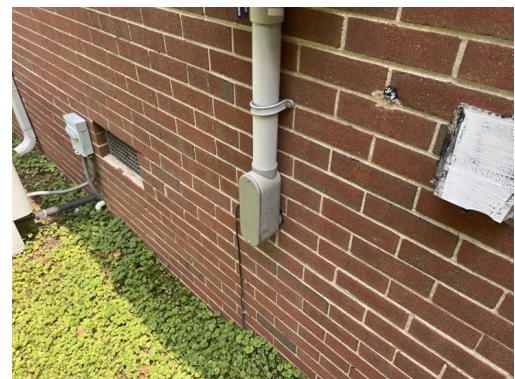
| 20. | <b>Electrical/Electrical Service</b> The entrance conduit is inadequately sealed where it enters the house. Seal the gaps. LOCATION: Rear. | 29 |

| ISSUE | The entrance conduit is inadequately sealed where it enters the house. Seal the gaps. |
| IMPLICATION | Moisture may enter the electrical system. |

| RECOMMENDATION | Seal the gaps. |

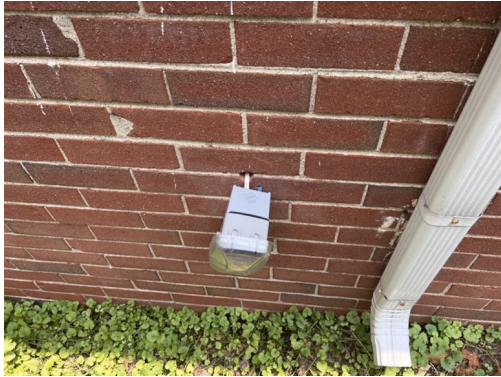
| 10. | <b>Electrical/Branch Circuits</b> The rear exterior junction box is loose and hanging by the wiring. At the junction box secured, and sealed is required to prevent further damage. LOCATION: Rear. Estimated cost to remedy: \$100 to \$150. | 30 |

| ISSUE | The rear exterior junction box is loose and hanging by the wiring. At the junction box secured, and sealed is required to prevent further damage. |
| IMPLICATION | Wire connections may be damaged. |

| RECOMMENDATION | At the junction box secured, and sealed is required to prevent further damage. |

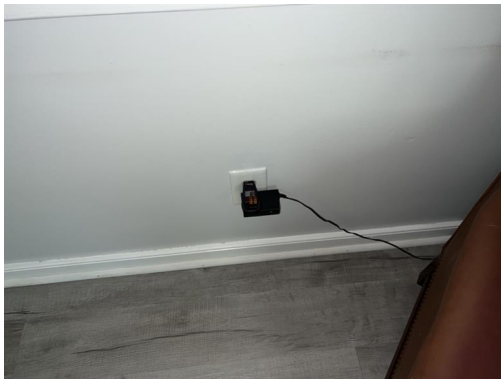
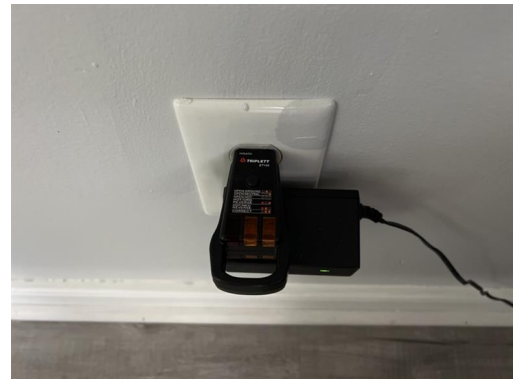
| 11. | <b>Electrical/Receptacles</b> The receptacle outlet is inoperative. Replace the receptacle. LOCATION: The front left living room outlet. Estimated cost to remedy: \$150 to \$200. | 30 |

| ISSUE | The receptacle outlet is inoperative. Replace the receptacle. |

| RECOMMENDATION | Replace the receptacle. |

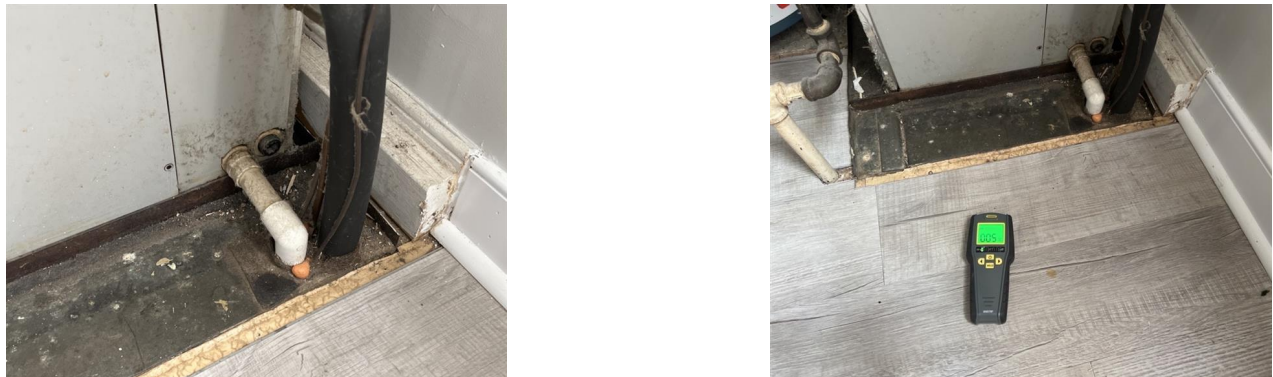
| 12. | <b>HVAC/Cooling System</b> The condensate auxiliary overflow drain isn't installed. Engage an HVAC contractor to install a secondary provision/shut off as required. LOCATION: Laundry Room. Estimated cost to remedy: \$150 to \$200. | 32 |

| ISSUE | The condensate auxiliary overflow drain isn't installed. Engage an HVAC contractor to install a secondary provision/shut off as required. |
| IMPLICATION | If the main condensate line is clogged, the overflow may flow into the appliance, causing water damage to the system and the property. |

| RECOMMENDATION | Engage an HVAC contractor to install a secondary provision/shut off as required. |

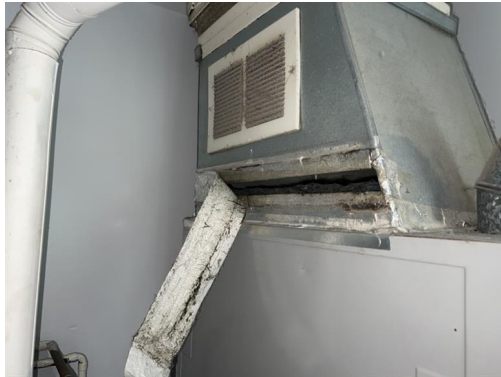
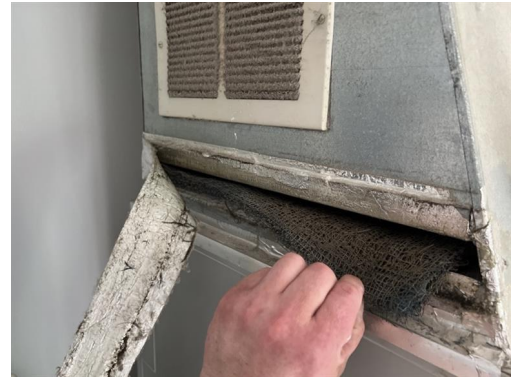
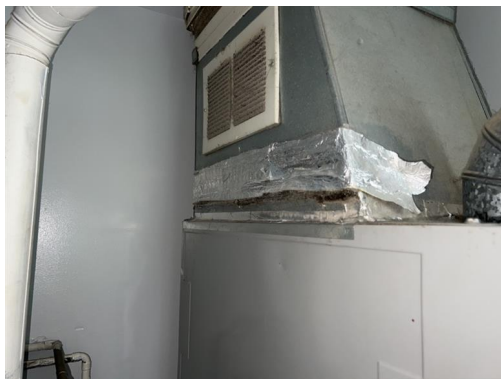
| 13. | <b>HVAC/Distribution</b> The air filter enclosure isn't properly secured or sealed on the return above the air handler. Repair and seal the enclosure. LOCATION: Laundry Room. Estimated cost to remedy: \$300 to \$350. | 33 |

| ISSUE | The air filter enclosure isn't properly secured or sealed on the return above the air handler. Repair and seal the enclosure. |

| RECOMMENDATION | Repair and seal the enclosure. |

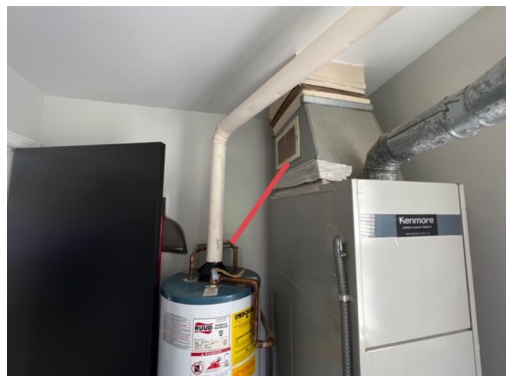
| 14. | <b>HVAC/Distribution</b> The return opening is improperly located above the air handle next to the water heater. Engage an HVAC contractor to relocate the return opening. LOCATION: Laundry Room. Estimated cost to remedy: \$400 to \$500. | 34 |

| ISSUE | The return opening is improperly located above the air handle next to the water heater. Engage an HVAC contractor to relocate the return opening. |

| RECOMMENDATION | Engage an HVAC contractor to relocate the return opening. |

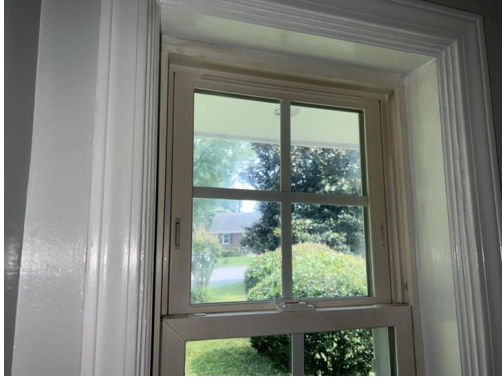
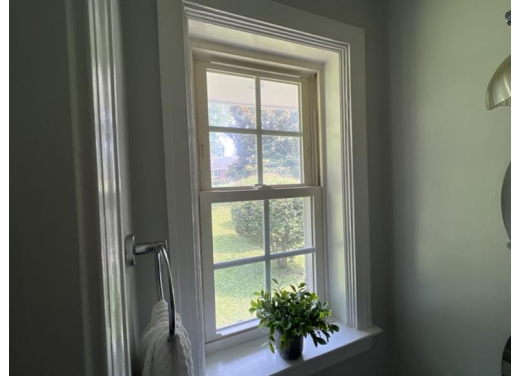
| 15. | <b>Interior/Windows</b> The window has a failed insulated glass seal. Replace the insulated glass unit or the window. LOCATION: The upper sash in the primary bathroom. Estimated cost to remedy: \$200 to \$250. | 37 |

| ISSUE | The window has a failed insulated glass seal. Replace the insulated glass unit or the window. |

| RECOMMENDATION | Replace the insulated glass unit or the window. |

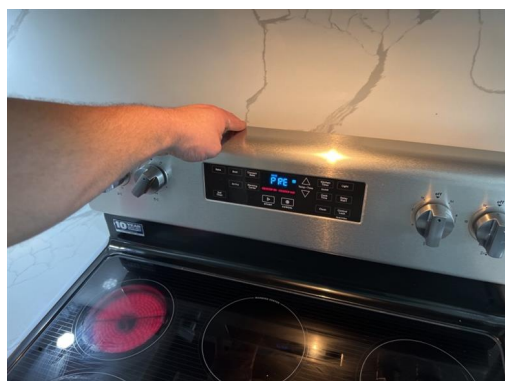
| 16. | <b>Appliances/Range/Oven</b> The anti-tip device is missing. Install an anti-tip device. LOCATION: Kitchen. Estimated cost to remedy: \$100 to \$150. | 39 |

| ISSUE | The anti-tip device is missing. Install an anti-tip device. |

| RECOMMENDATION | Install an anti-tip device. |
