## INSPECTION INSIGHTS

| DATE | 06/30/23 |
| ADDRESS | 8368 Abbey Road,<br>Richmond, VA |

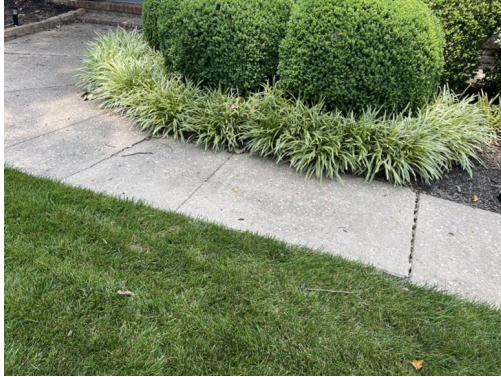
| ISSUE | The walk is cracked and settled slightly. Monitor settlement and make repairs, as required. |
| IMPLICATION | Minimal impact on function; additional settling permits water to penetrate the walk, which may cause further settling. |

| RECOMMENDATION | Monitor settlement and make repairs, as required. |

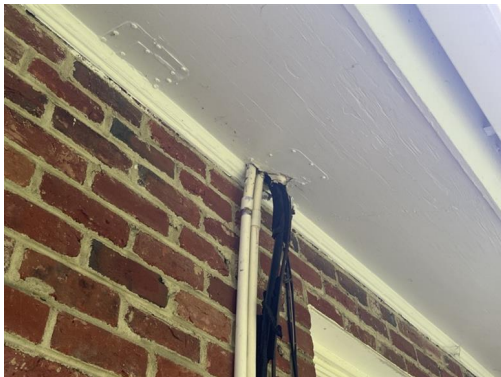
| ISSUE | There are gaps around utility penetrations. Seal around the penetrations. |
| IMPLICATION | May permit water and pest to penetrate the structure. |

| RECOMMENDATION | Seal around the penetrations. |

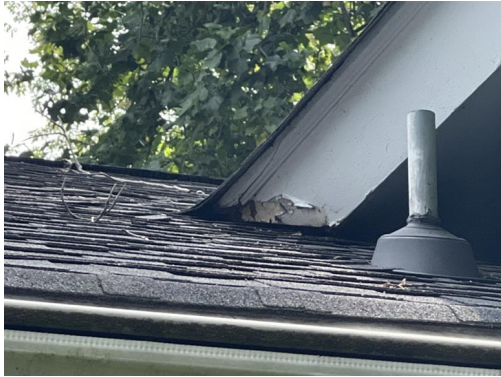
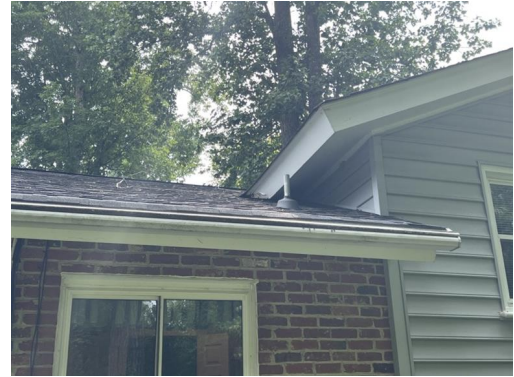
| ISSUE | The fascia is damaged/peeling . |
| IMPLICATION | May permit water to penetrate the structure. |

| RECOMMENDATION | Repair/replace the fascia as required. |

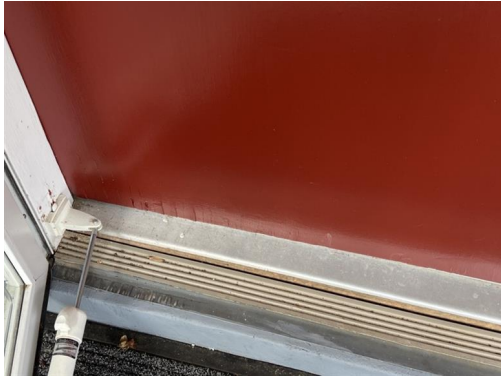
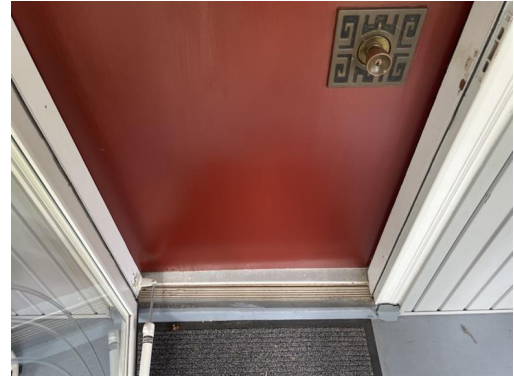
| ISSUE | The first the bottom of the door is beginning to delaminate |
| IMPLICATION | The wood will continue to deteriorate if not corrected. |

| RECOMMENDATION | Have the bottom the door, seal them painted as required. |

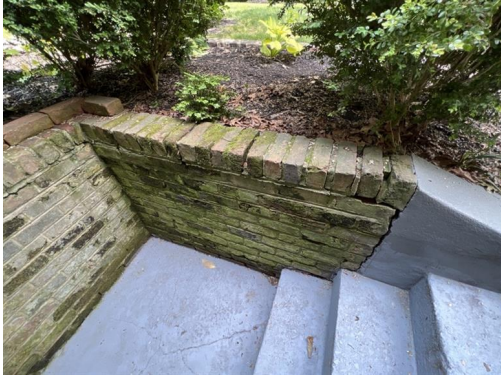
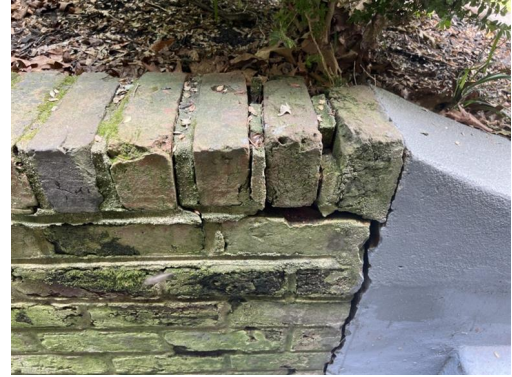
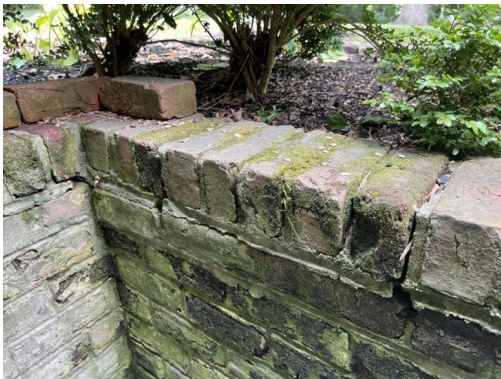
| ISSUE | Gaps in the mortar and loose bricks observed at the top course of the exterior basement entry wall. Have all damage mortar removed and repointed as required. |
| IMPLICATION | For the decay of the mortar may allow Rich to fall in wall structure to be compromised. |

| RECOMMENDATION | Have all damage mortar removed and repointed as required. |

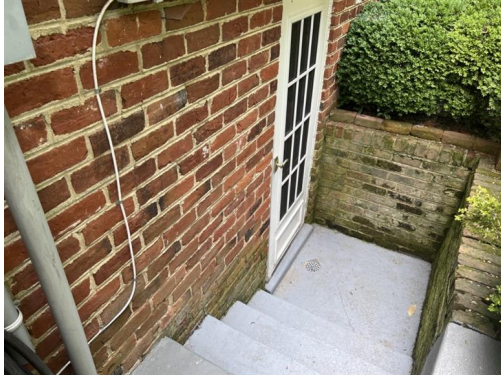
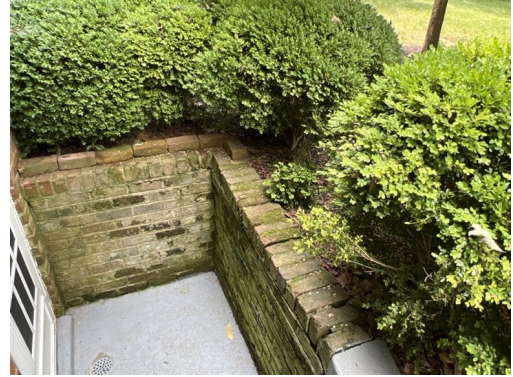
| ISSUE | The graspable handrailing, and guard railing are missing. Have both railings installed as required for safety. |
| IMPLICATION | This is a safety issue and falling hazard. |

| RECOMMENDATION | Have both railings installed as required for safety. |

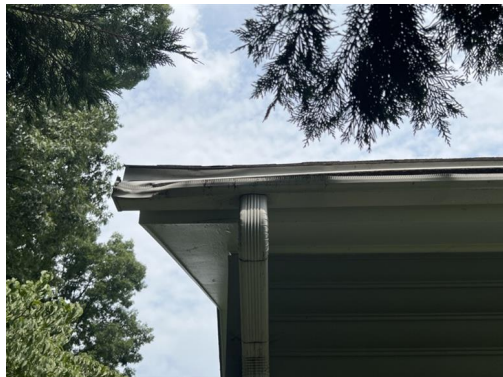
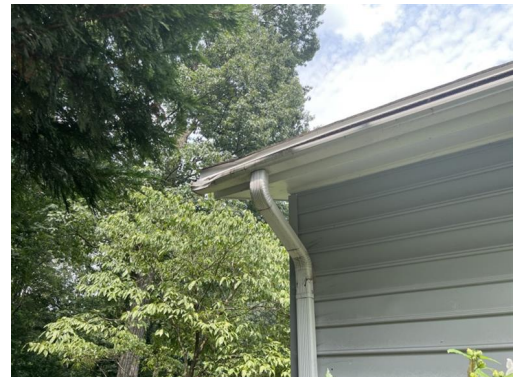
| ISSUE | The gutters end is damaged. |
| IMPLICATION | The damage section and a leak at the seams and overflow water. |

| RECOMMENDATION | Repair/replace the damage section as required to allow proper drainage. |

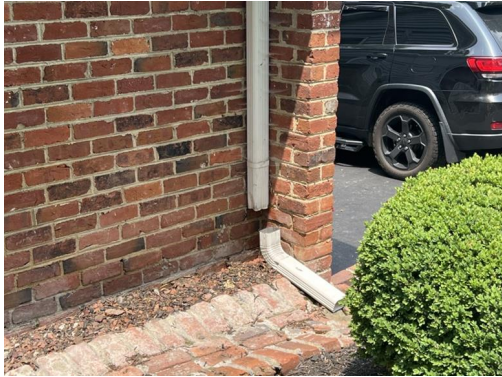
| ISSUE | The bottom downspout elbow is missing. Replace the downspout elbow. |

| RECOMMENDATION | Replace the downspout elbow. |

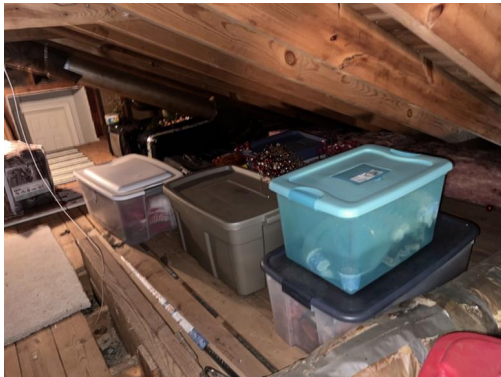
| ISSUE | The ducting is concealed under insulation and belongings. |

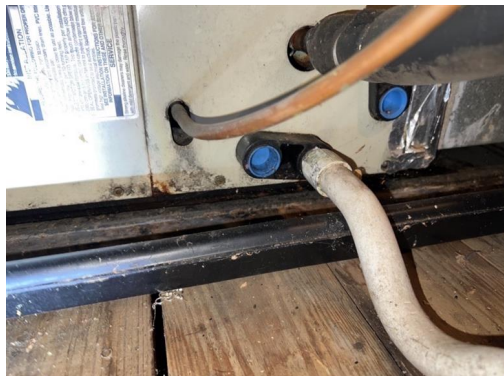
| ISSUE | The condensate auxiliary overflow drain isn't installed. |
| IMPLICATION | If the main condensate line is clogged, the overflow may flow into the appliance, causing water damage to the system and the property. |

| RECOMMENDATION | Engage an HVAC contractor to make repairs, as required. |

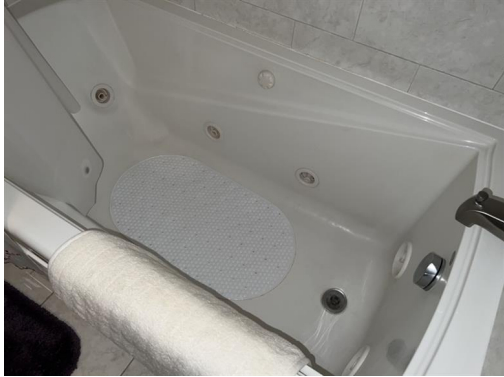
| ISSUE | The whirlpool is inoperative. Engage a plumbing contractor to evaluate and to make repairs, as required. |

| RECOMMENDATION | Engage a plumbing contractor to evaluate and to make repairs, as required. |

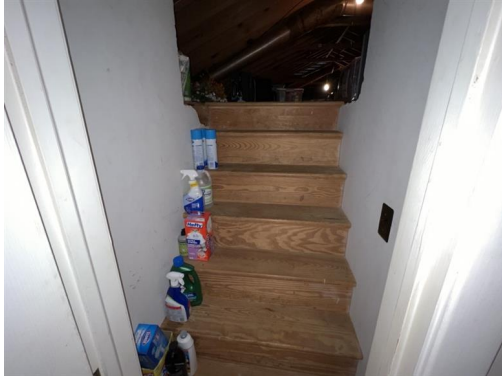
| ISSUE | The graspable hand railing is missing. Install a railing as required for safety. |

| RECOMMENDATION | Install a railing as required for safety. |

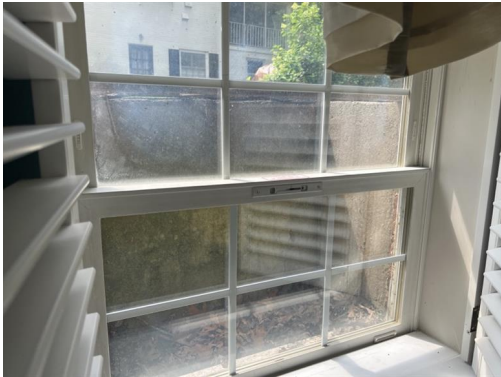
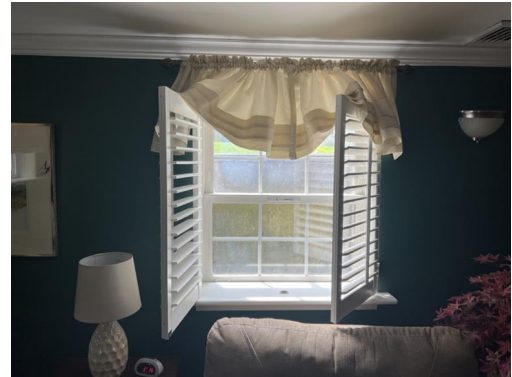
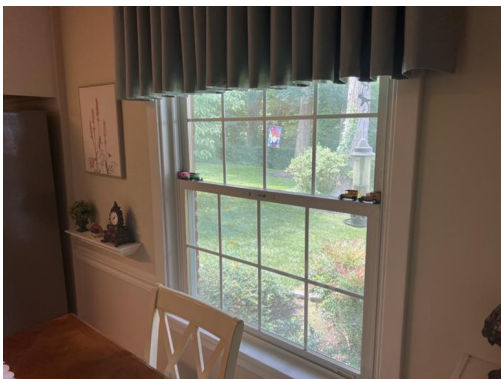
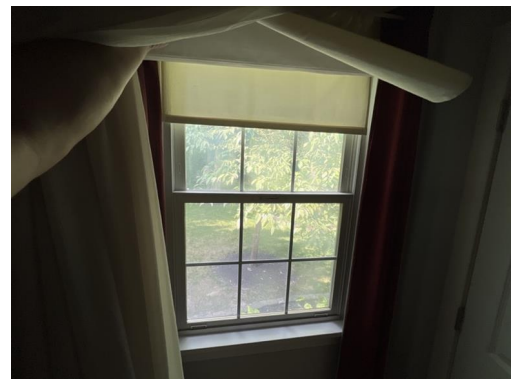
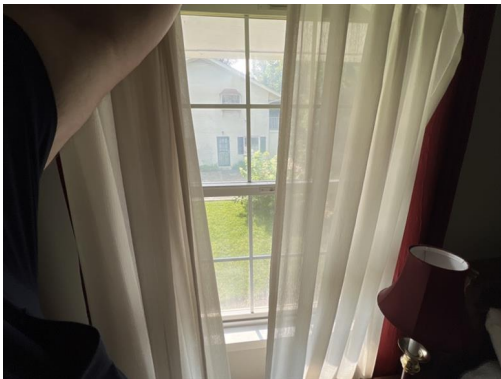
| ISSUE | The window has a failed insulated glass seal. |

| RECOMMENDATION | Replace the insulated glass unit or the window. |

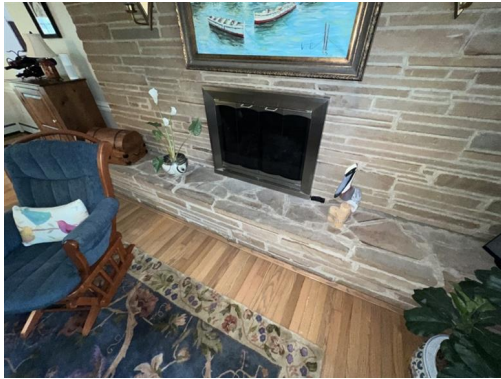
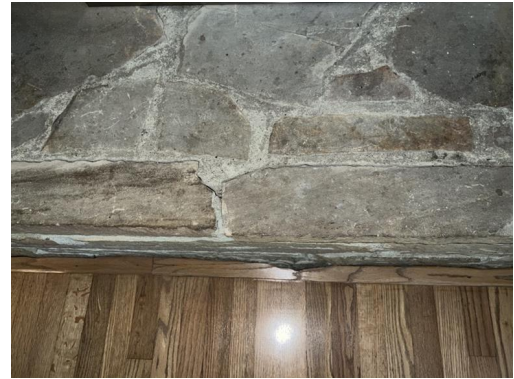
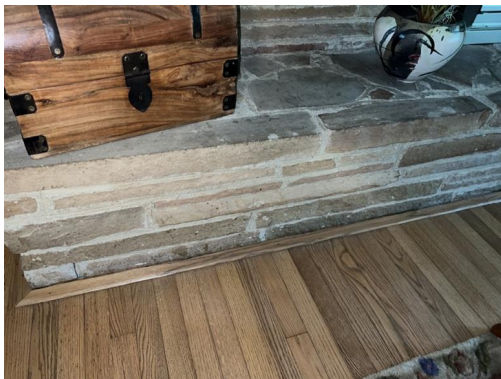
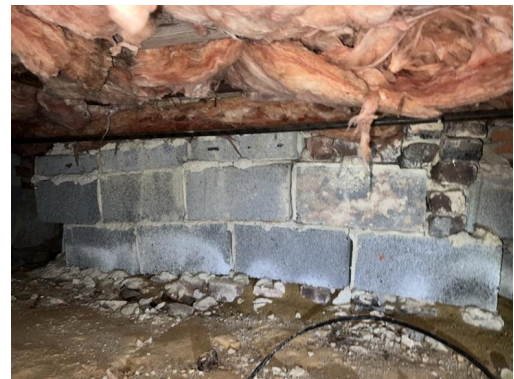
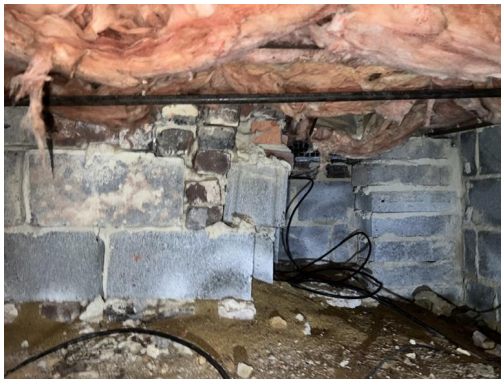
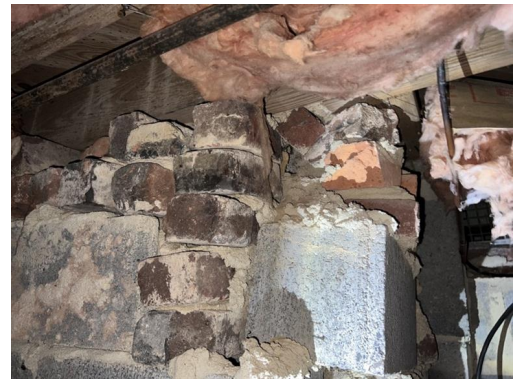
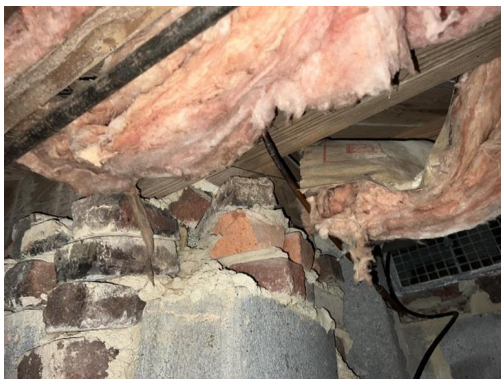
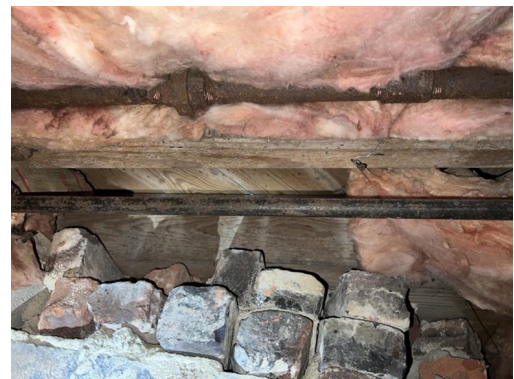
| ISSUE | The hearth or hearth extension bricks are cracked/loose it appears the foundation support is inadequate and failing in the crawlspace below. Have a structural contractor evaluate for all support and remedial needs and correct as required. Additionally piers and bracing may be necessary. |

| RECOMMENDATION | Have a structural contractor evaluate for all support and remedial needs and correct as required. Additionally piers and bracing may be necessary. |

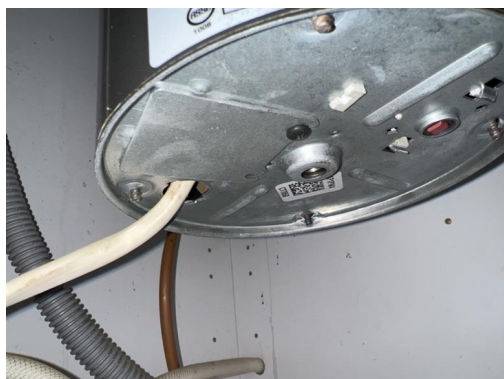
| ISSUE | Protective clamp is missing at the wire entry into the unit. Secure the wiring is required for safety. |
| IMPLICATION | The wiring may be damage to vibration, presenting a possible shock risk. |

| RECOMMENDATION | Secure the wiring is required for safety. |

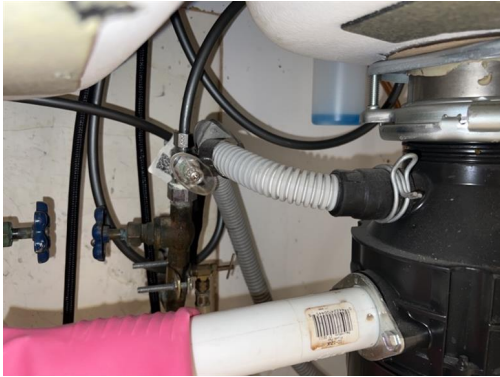
| ISSUE | The dishwasher is missing an anti-siphon/high loop device on the drain line. |

| RECOMMENDATION | Install a "high loop" or an anti-siphon device. |

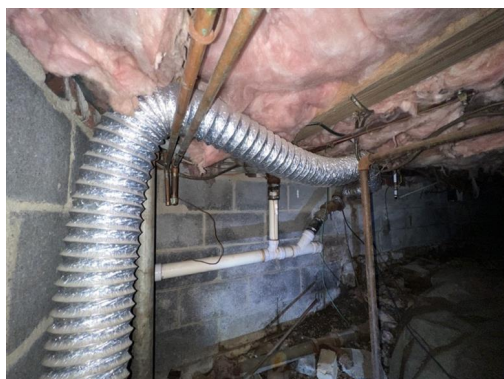
| ISSUE | The dryer ducting is made of improper materials. Dryer ducting in concealed areas is required to be a smooth, hard walled, metal duct. Replace the ducting as required. |

| RECOMMENDATION | Replace the ducting as required. |
