## INSPECTION INSIGHTS

| DATE | 09/15/23 |
| ADDRESS | 16730 Sayley Drive,<br>Chesterfield, VA |

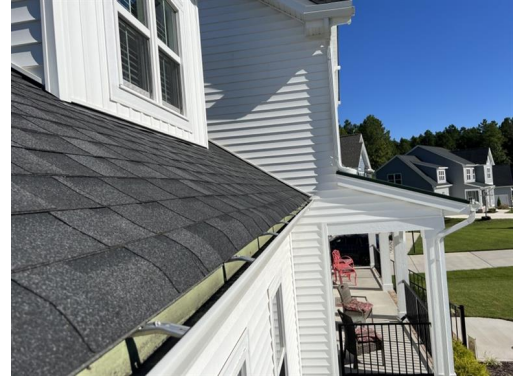
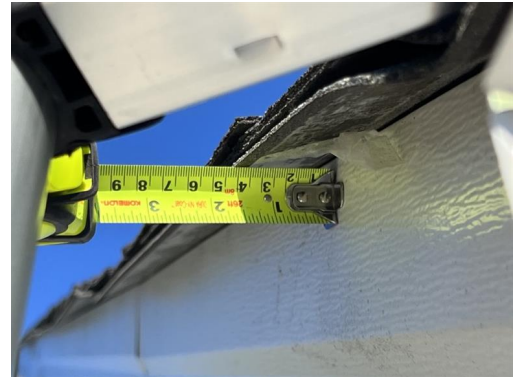
## ROOF/ROOFING

| 1. | <b>Roof/Roofing</b> The shingle overhang is excessive at the rakes and eaves. Engage a roofing contractor to determine proper corrective actions and repair as required. LOCATION: Front. Estimated cost to remedy: \$1,000 to \$1,200. | 13 | |

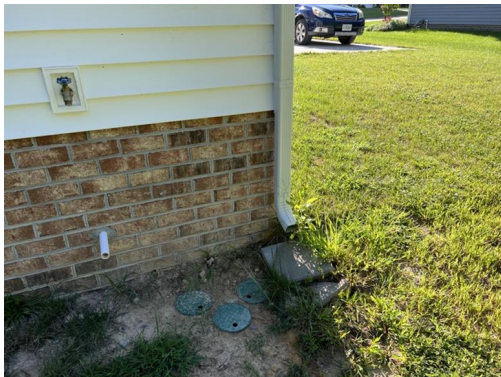
## WATER CONTROL/GUTTERS/DOWNSPOUTS

| ISSUE | The downspout extension is missing. Install downspout extensions. |
| LOCATION | Multiple Locations |
| IMPLICATION | May permit water to accumulate at the structure; water may penetrate the structure. |

| RECOMMENDATION | Install downspout extensions. |

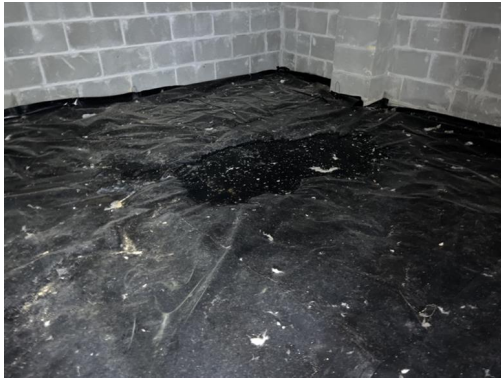
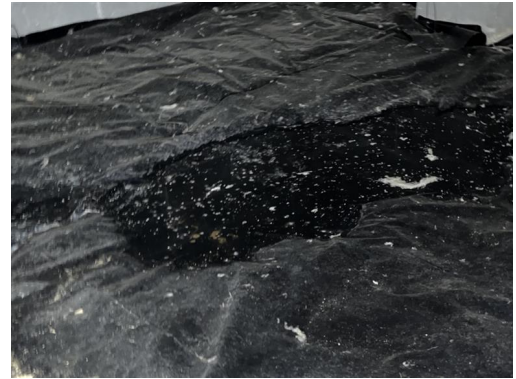
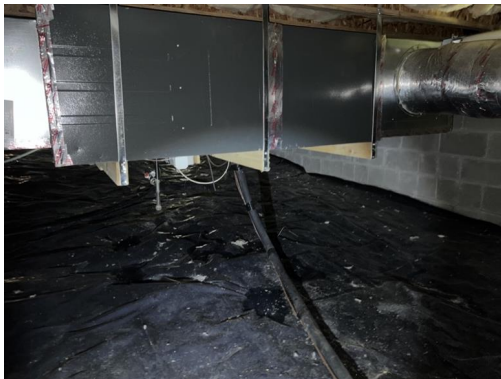
## R STRUCTURE/CRAWL SPACE

| ISSUE | There is standing water at the rear right of the the crawl space. This appears to be a collection of water from the non functioning condensation pump. Have all of the water removed from the vapor barrier following correction of the faulty pump. |
| IMPLICATION | Standing water may leak to excess humidity and moisture related problems. |

| RECOMMENDATION | Have all of the water removed from the vapor barrier following correction of the faulty pump. |

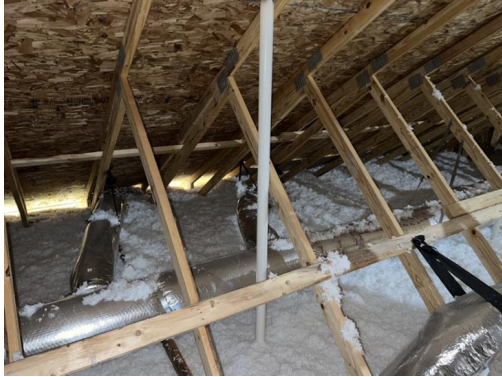
## INSULATION AND VENTILATION/EXHAUST VENTILATION

Not visible due to insulation.

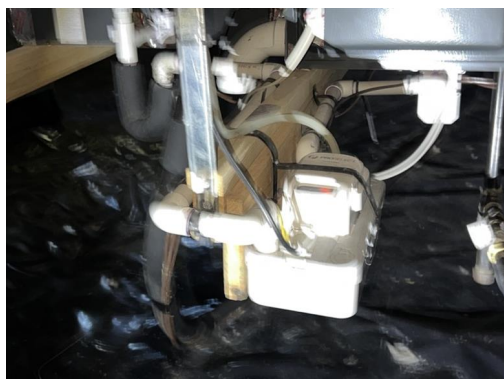
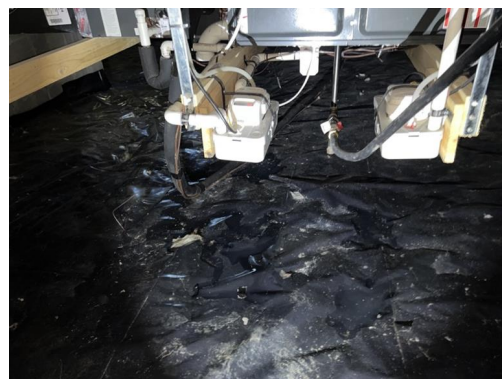
## R HVAC/COOLING SYSTEM 1

| ISSUE | The condensate pump is not functioning and leaks, water found pooling on the vapor barrier below. Engage an HVAC contractor to repair or replace the pump. |
| LOCATION | Crawl Space |
| IMPLICATION | Water may penetrate and damage the structure; there may be hidden damage. |

| RECOMMENDATION | Engage an HVAC contractor to repair or replace the pump. |
