| DATE | 08/16/24 |

| ADDRESS | 8 Polly Court,<br>Hampton, VA |

# PROPERTY AND INSPECTION INFO

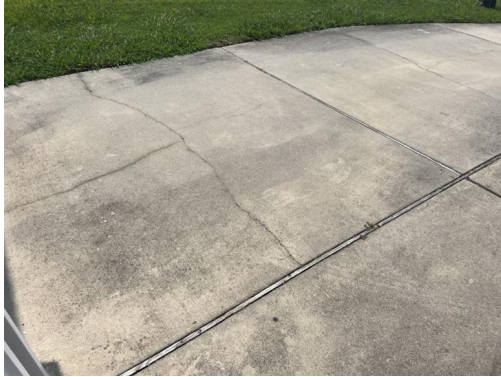
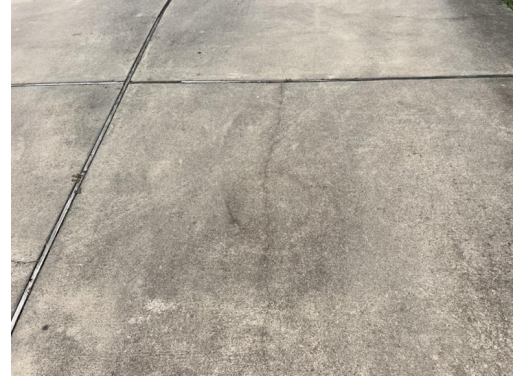
| 22. | <b>Exterior/Driveway</b> There are minor cracks in the driveway. Repair and seal cracks. LOCATION: Multiple Locations. | 13 |

| ISSUE | There are minor cracks in the driveway. |
| LOCATION | Multiple Locations |
| IMPLICATION | May permit water to penetrate the driveway, which may cause further damage. |

| RECOMMENDATION | Repair and seal cracks. |

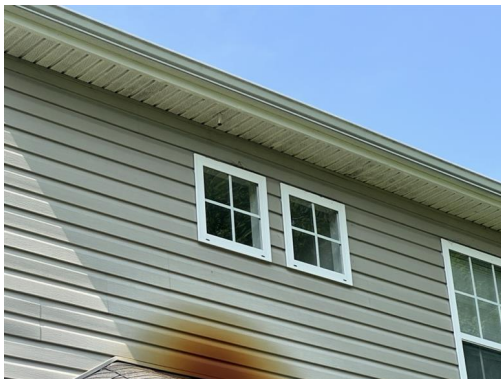
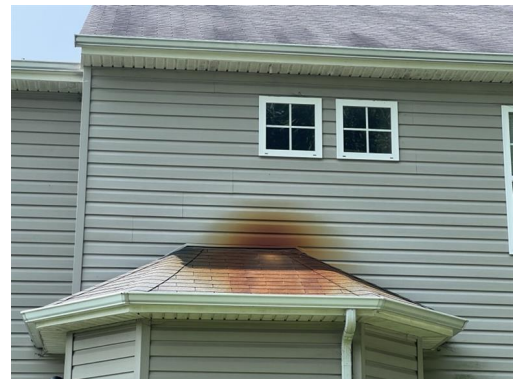
| 15. | <b>Exterior/Exterior Walls</b> The siding is stained orange. This appears to have been caused by a A/C condensation overflow pan. Ensure the Air Handler has been repaired and clean the panels as required. LOCATION: Rear above the bump out roof. | 13 |

| ISSUE | The siding is stained orange. This appears to have been caused by a A/C condensation overflow pan. |
| LOCATION | Rear above the bump out roof. |
| IMPLICATION | This indicates a problem with the HVAC system. |

| RECOMMENDATION | Ensure the Air Handler has been repaired and clean the panels as required. |

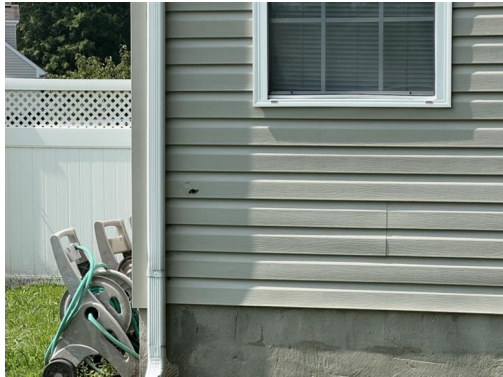
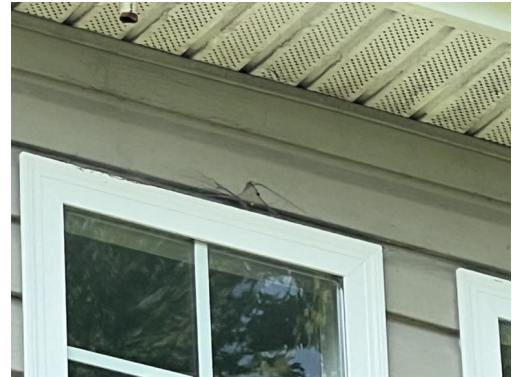
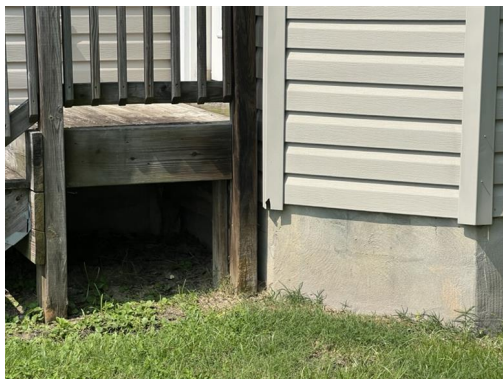
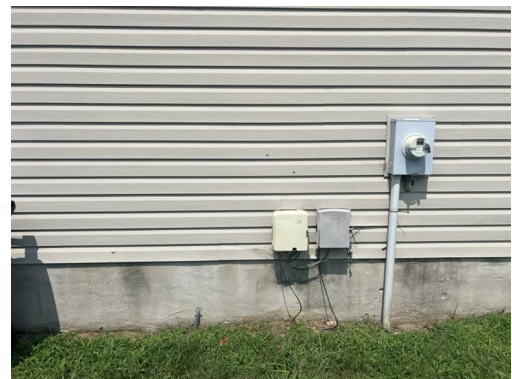
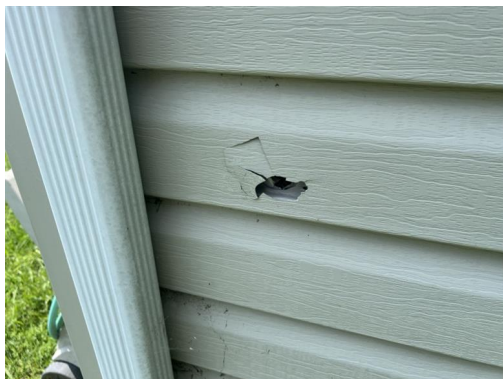
| 1. | <b>Exterior/Exterior Walls</b> There is damaged siding. Replace the siding and repair any damage which may be revealed. LOCATION: Multiple Locations: The rear lower right of the house. The panel above the second floor center window. The lower right side center panels. Estimated cost to remedy: \$600 to \$700. | 14 |

| ISSUE | There is damaged siding. |
| LOCATION | Multiple Locations: The rear lower right of the house. The panel above the second floor center window. The lower right side center panels. |
| IMPLICATION | May permit water to penetrate the structure. |

| RECOMMENDATION | Replace the siding and repair any damage which may be revealed. |
| COST TO REMEDY | \$600 to \$700 |

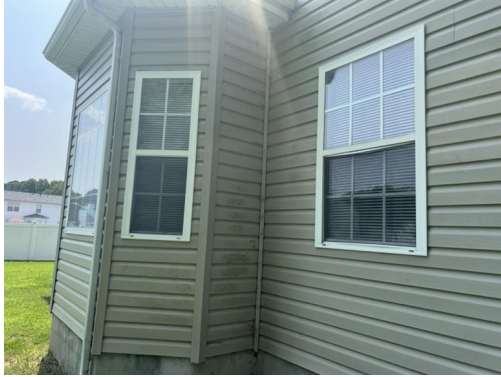
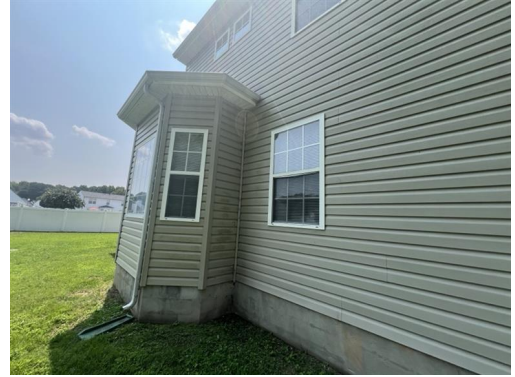
| 16. | <b>Exterior/Exterior Walls</b> There is moss, microbial growth, and/or other biological build-up on the exterior walls. Clean the siding. LOCATION: Multiple Locations. | 15 |

| ISSUE | There is moss, microbial growth, and/or other biological build-up on the exterior walls. |
| LOCATION | Multiple Locations |
| IMPLICATION | Causes damage and premature deterioration of the siding. |

| RECOMMENDATION | Clean the siding. |

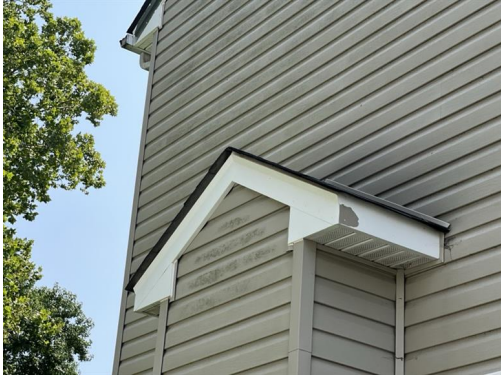
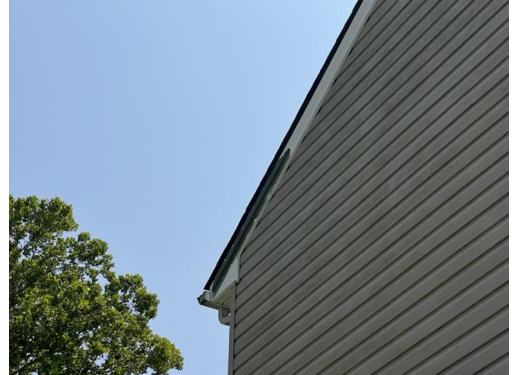
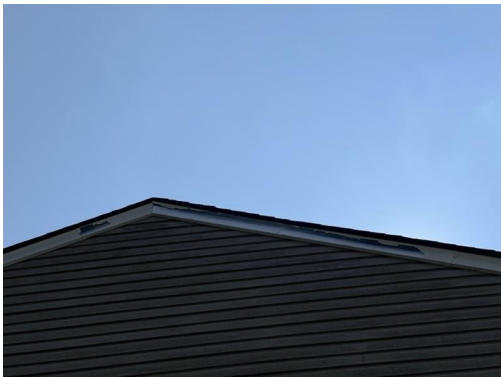
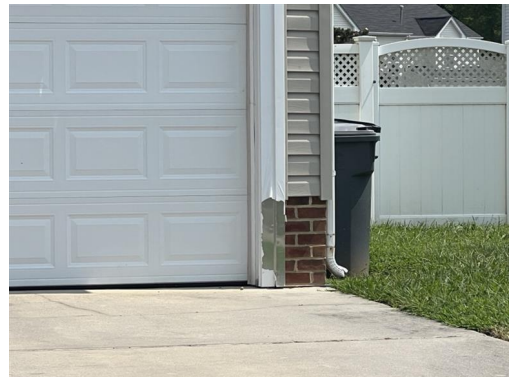
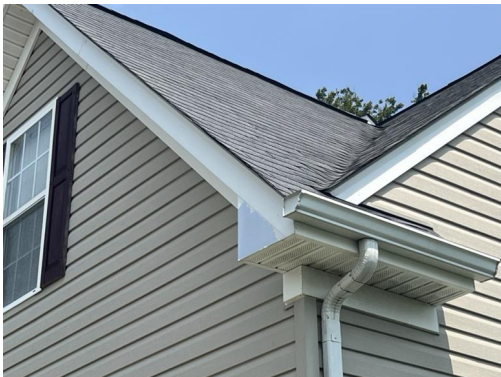
| 17. | <b>Exterior/Exterior Trim</b> The covering is peeling off of the metal trim wrap. Replace covering as required. LOCATION: Multiple Locations: left side and center rakes. Right side of the garage vehicle door. | 16 |

| ISSUE | The covering is peeling off of the metal trim wrap. |
| LOCATION | Multiple Locations: left side and center rakes. Right side of the garage vehicle door. |
| IMPLICATION | This is mostly cosmetic, however, the metal is exposed to moisture. |

| RECOMMENDATION | Replace covering as required. |

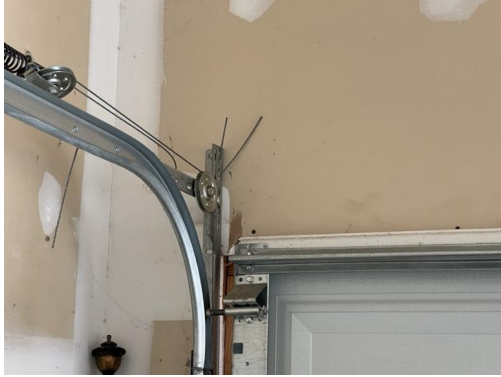
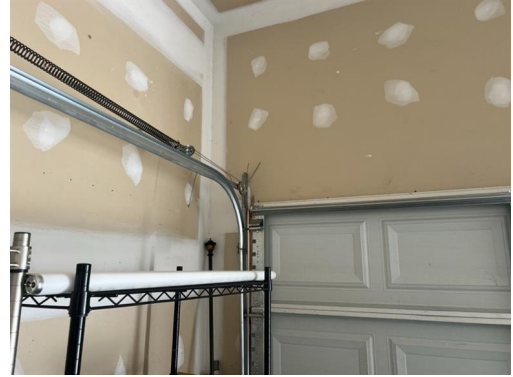
| 2. | <b>Exterior/Garage Door and Opener</b> The right garage door get caught on the right side track. Have the rollers and tracks adjusted to restore proper function. LOCATION: Attached Garage. Estimated cost to remedy: \$100 to \$150. | 17 |

| ISSUE | The right garage door get caught on the right side track. |
| LOCATION | Attached Garage |

| RECOMMENDATION | Have the rollers and tracks adjusted to restore proper function. |

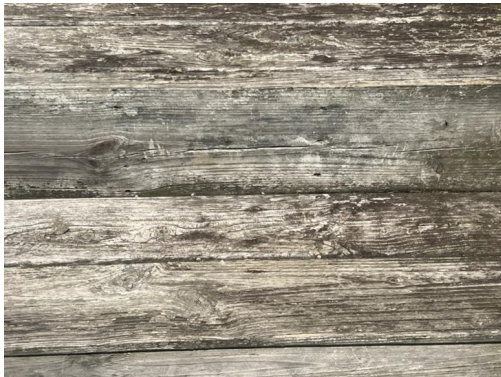
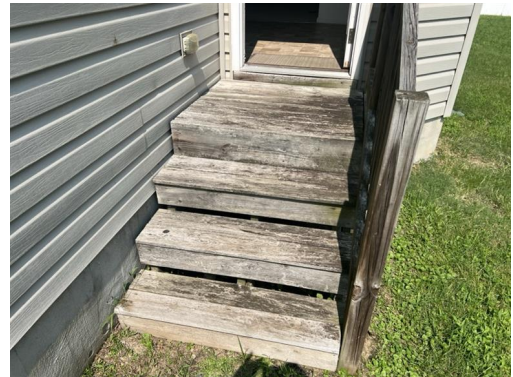
| 18. | <b>Exterior/Exterior Stairs/Steps</b> The wood is aged and cracked. Maintain and replace as required. LOCATION: Rear. | 17 |

| ISSUE | The wood is aged and cracked. |
| LOCATION | Rear |

| RECOMMENDATION | Maintain and replace as required. |

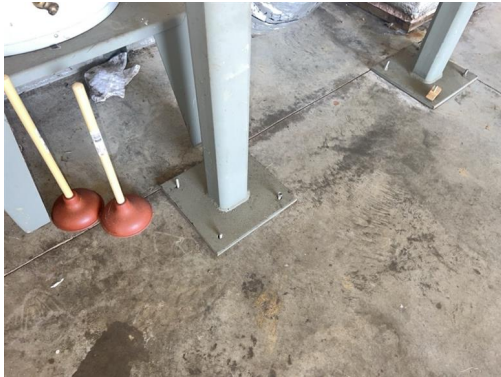
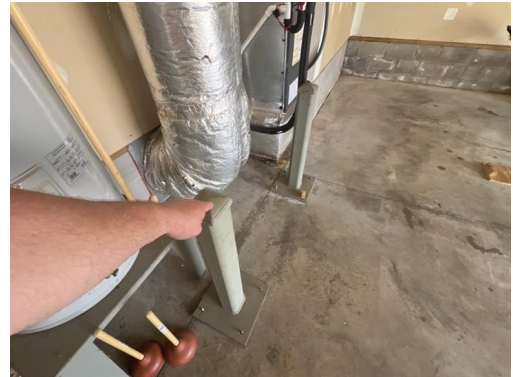
| 3. | <b>Exterior/Exterior Other</b> The protective bollards have missing / loose bolts. The Ballard are loose and move. Secure to the ground as required. LOCATION: Attached Garage. Estimated cost to remedy: \$100 to \$150. | 18 |

| ISSUE | The protective bollards have missing / loose bolts. The Ballard are loose and move. |
| LOCATION | Attached Garage |

| RECOMMENDATION | Secure to the ground as required. |

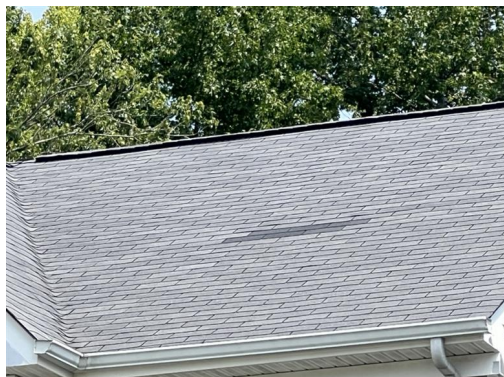
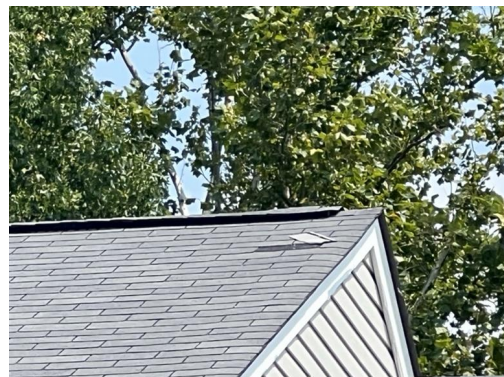
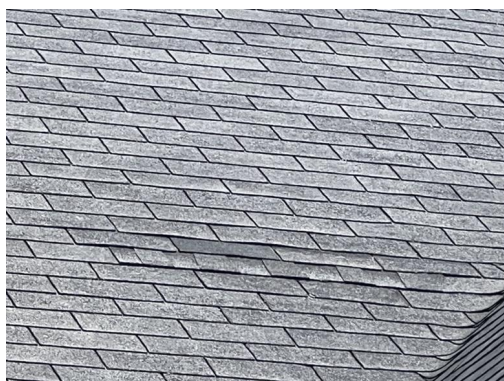
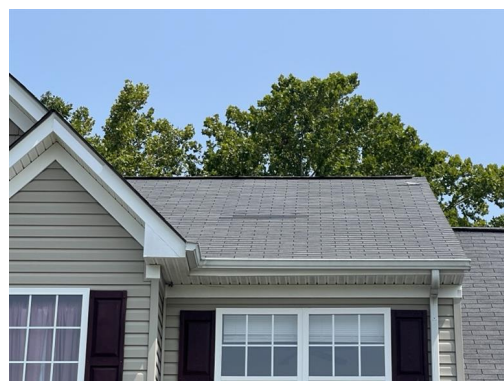
| 4. | <b>Roof/Roofing</b> The roof appears to be at the end of its economic service life. Granular loss, missing, and damaged shingles noted. Engage a roofer to evaluate and replace as required. Obtain an accurate estimate. LOCATION: Multiple Locations. | 20 |

| ISSUE | The roof appears to be at the end of its economic service life. Granular loss, missing, and damaged shingles noted. |
| LOCATION | Multiple Locations |
| IMPLICATION | The roof may not be able to be repaired due to its age and condition. |

| RECOMMENDATION | Engage a roofer to evaluate and replace as required. Obtain an accurate estimate. |

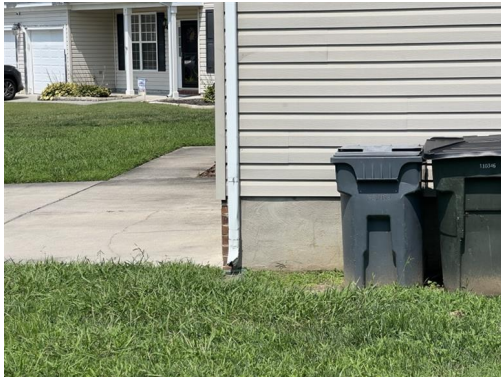
| 5. | <b>Water Control/Gutters/Downspouts</b> The downspout elbow is damaged or deteriorated. Repair or replace the downspout. LOCATION: Right Side. Estimated cost to remedy: \$100 to \$150. | 23 |

| ISSUE | The downspout elbow is damaged or deteriorated. |
| LOCATION | Right Side |

| RECOMMENDATION | Repair or replace the downspout. |

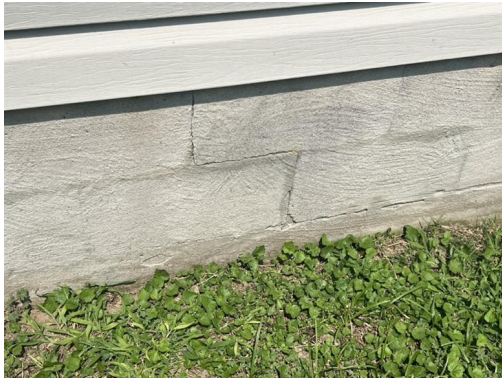
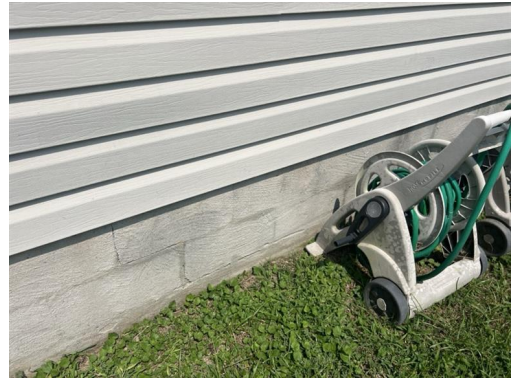
| 19. | <b>Structure/Foundation</b> The foundation's concrete parge coat shows hairline cracks.. Seal and maintain the parging; engage a contractor to evaluate and to make repairs, as required. LOCATION: Right Side Exterior. | 25 |

| ISSUE | The foundation's concrete parge coat shows hairline cracks.. |
| LOCATION | Right Side Exterior |

| RECOMMENDATION | Seal and maintain the parging; engage a contractor to evaluate and to make repairs, as required. |

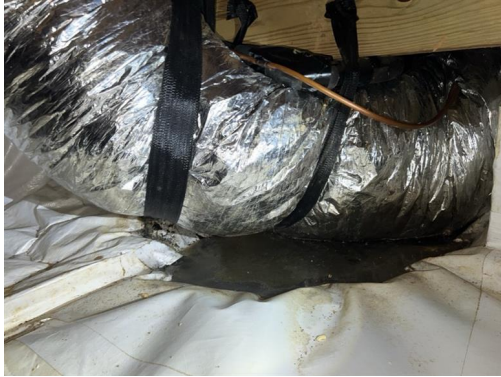
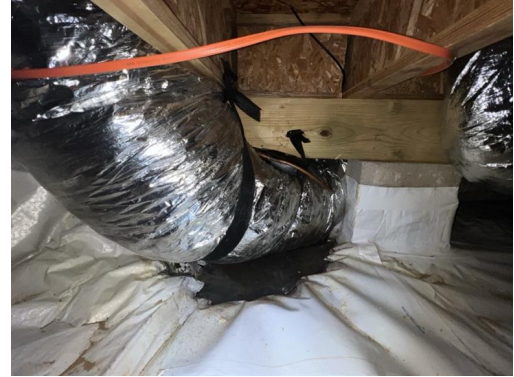
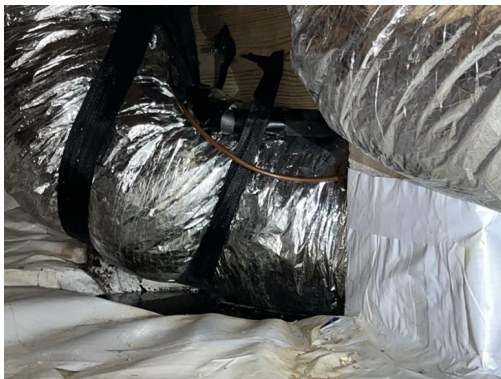
| 6. | <b>Structure/Crawl Space</b> There is standing water in the crawl space below the return duct. Identify and mitigate the source of water penetration. LOCATION: Left Side. Estimated cost to remedy: \$450 to \$550. | 26 |

| ISSUE | There is standing water in the crawl space below the return duct. |
| LOCATION | Left Side |
| IMPLICATION | Conducive to microbial growth and related deterioration. |

| RECOMMENDATION | Identify and mitigate the source of water penetration. |

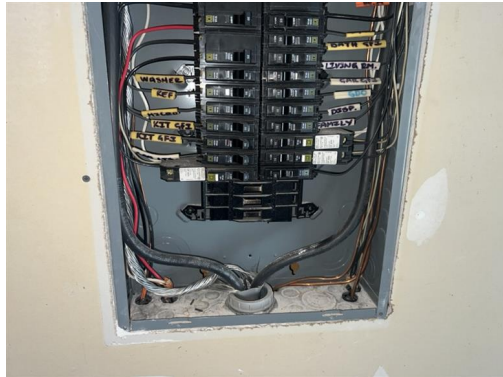
ISSUE The grounding/bonding location can't be identified.

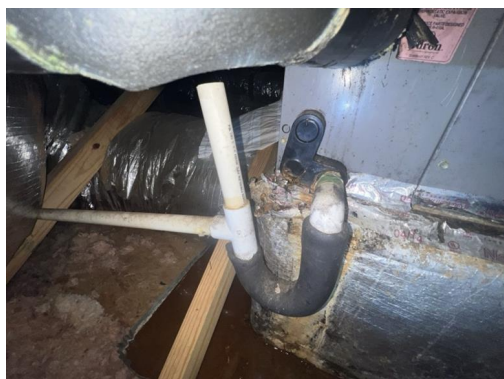
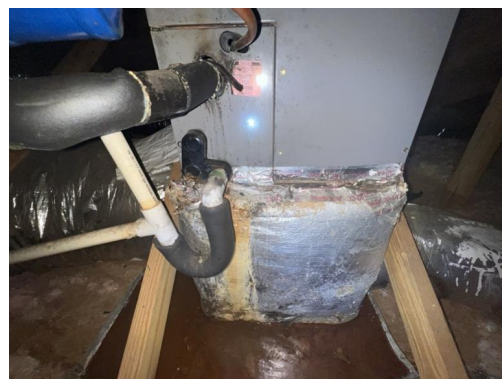
| 7. | <b>HVAC/Cooling System 2</b> The condensate auxiliary overflow drain isn't installed. Engage an HVAC contractor to make repairs, as required. LOCATION: Attic. Estimated cost to remedy: \$150 to \$200. | 32 |

| ISSUE | The condensate auxiliary overflow drain isn't installed. |
| LOCATION | Attic |
| IMPLICATION | If the main condensate line is clogged, the overflow may flow into the appliance, causing water damage to the system and the property. |

| RECOMMENDATION | Engage an HVAC contractor to make repairs, as required. |
| COST TO REMEDY | \$150 to \$200 |

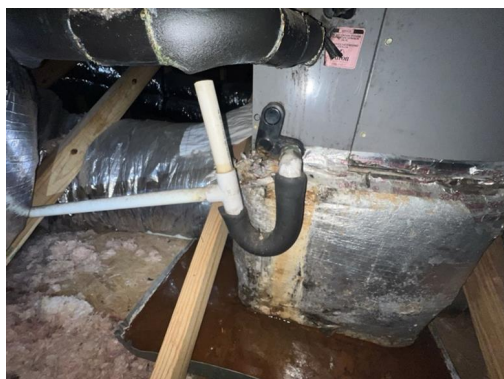
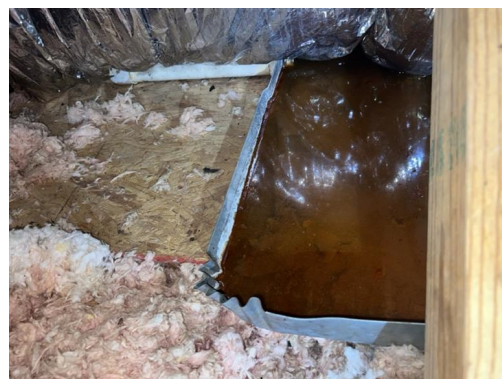
| 9. | <b>HVAC/Cooling System 2</b> The condensate discharge line is blocked or clogged. Clean the discharge line. LOCATION: Attic. Estimated cost to remedy: \$200 to \$300. | 32 |

| ISSUE | The condensate discharge line is blocked or clogged. |
| LOCATION | Attic |
| IMPLICATION | Blocks in the line may cause leaks. |

| RECOMMENDATION | Clean the discharge line. |
| COST TO REMEDY | \$200 to \$300 |

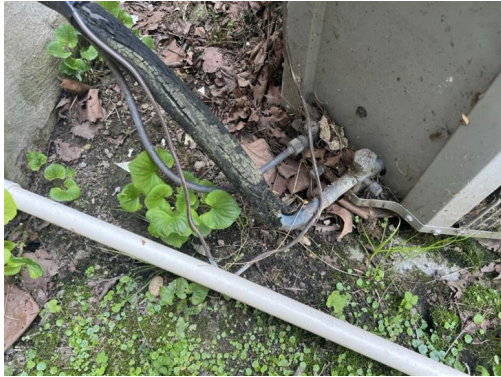
| 8. | <b>HVAC/Cooling System 2</b> The suction line insulation is damaged. Install an exterior-grade pipe insulation on the suction line. LOCATION: Left Side Exterior. Estimated cost to remedy: \$50 to \$100. | 33 |

| ISSUE | The suction line insulation is damaged. |
| LOCATION | Left Side Exterior |

| RECOMMENDATION | Install an exterior-grade pipe insulation on the suction line. |
| COST TO REMEDY | \$50 to \$100 |

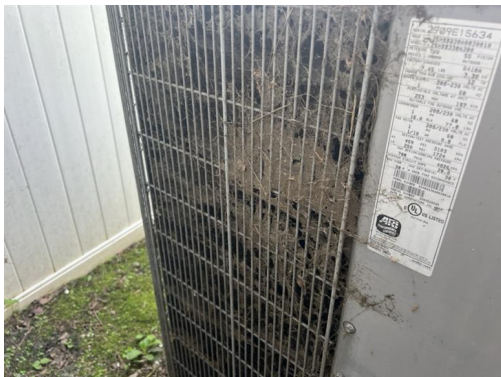
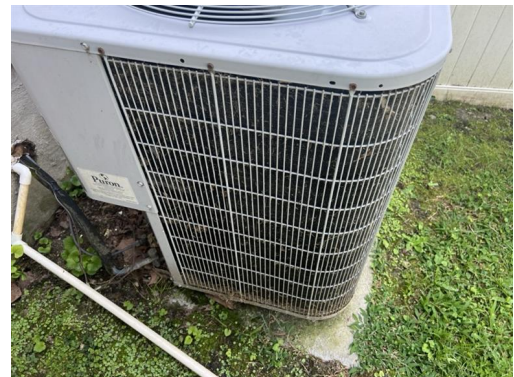
| 20. | <b>HVAC/Cooling System 2</b> The compressor coils are dirty. Clean the coils. LOCATION: Left Side Exterior. | 33 |

| ISSUE | The compressor coils are dirty. |
| LOCATION | Left Side Exterior |

| RECOMMENDATION | Clean the coils. |

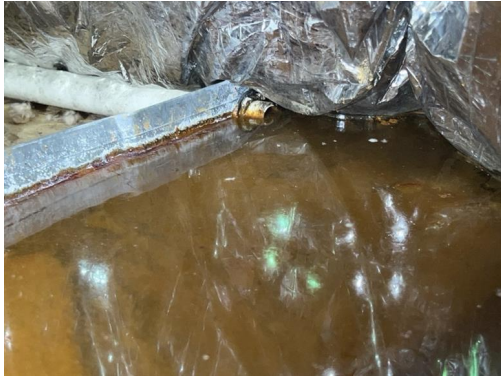
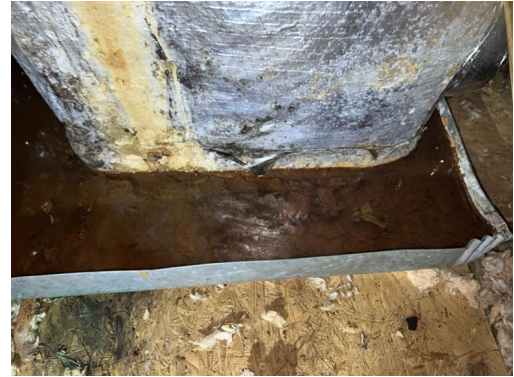
| 10. | <b>HVAC/Cooling System 2</b> The condensate pan isn't draining properly and is retaining water. Engage an HVAC contractor to make repairs, as required. LOCATION: Attic. Estimated cost to remedy: \$150 to \$250. | 34 |

| ISSUE | The condensate pan isn't draining properly and is retaining water. |
| LOCATION | Attic |
| IMPLICATION | Promotes corrosion and creates conditions conducive to mold formation. |

| RECOMMENDATION | Engage an HVAC contractor to make repairs, as required. |
| COST TO REMEDY | \$150 to \$250 |

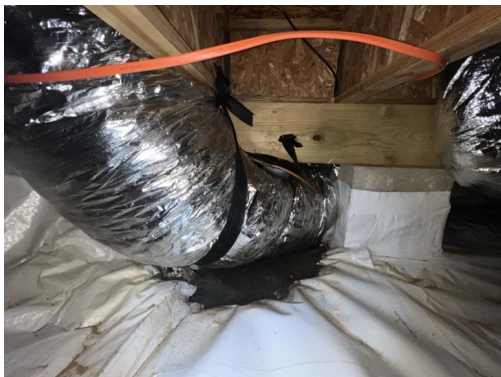
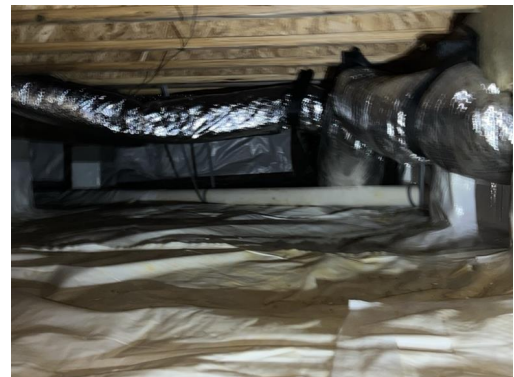
| 11. | <b>HVAC/Distribution</b> The return duct is saturated and sitting in water. Engage a HVAC contractor to replace the damaged duct as required. LOCATION: Left side of the Crawl Space. Estimated cost to remedy: \$350 to \$450. | 34 |

| ISSUE | The return duct is saturated and sitting in water. |
| LOCATION | Left side of the Crawl Space |
| IMPLICATION | The ducting is damaged and non usable. |

| RECOMMENDATION | Engage a HVAC contractor to replace the damaged duct as required. |
| COST TO REMEDY | \$350 to \$450 |

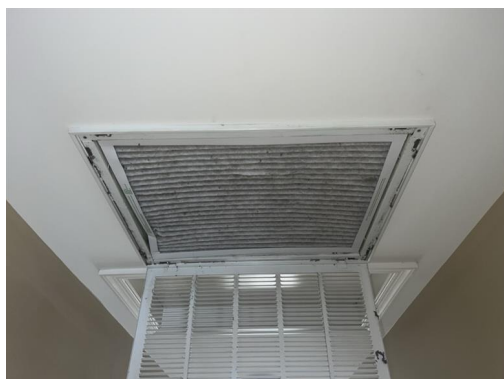
| 21. | <b>HVAC/Distribution</b> The air filter is dirty. Replace the filter. LOCATION: Hallway. | 35 |

| ISSUE | The air filter is dirty. |
| LOCATION | Hallway |

| RECOMMENDATION | Replace the filter. |

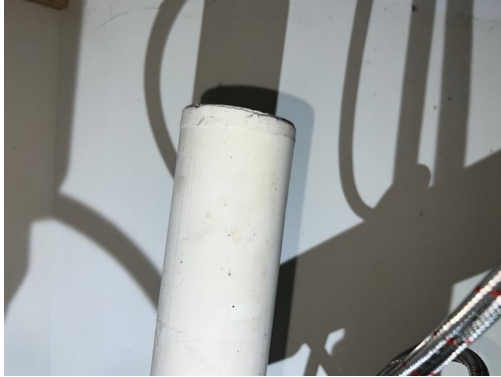
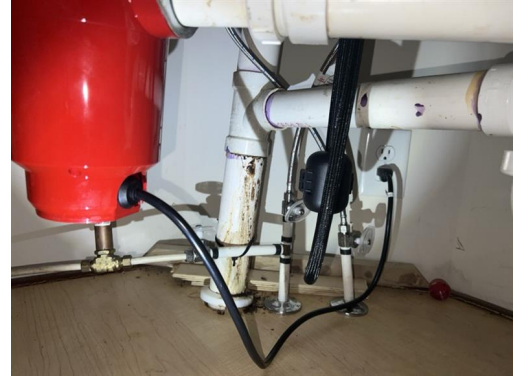
| 12. | <b>Plumbing/Drain, Waste, Vents</b> The top of the drain is open, the air admittance valve is missing. Engage a plumbing contractor to install an AAV as required. LOCATION: Kitchen. Estimated cost to remedy: \$200 to \$250. | 37 |

| ISSUE | The top of the drain is open, the air admittance valve is missing. |
| LOCATION | Kitchen |

| RECOMMENDATION | Engage a plumbing contractor to install an AAV as required. |

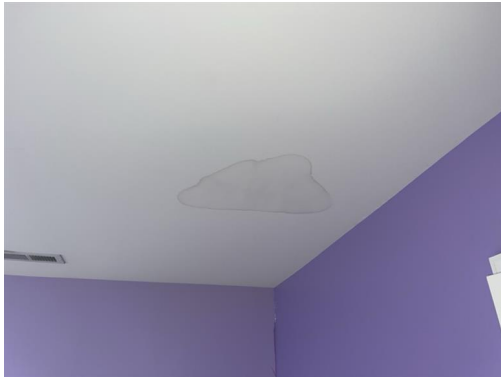
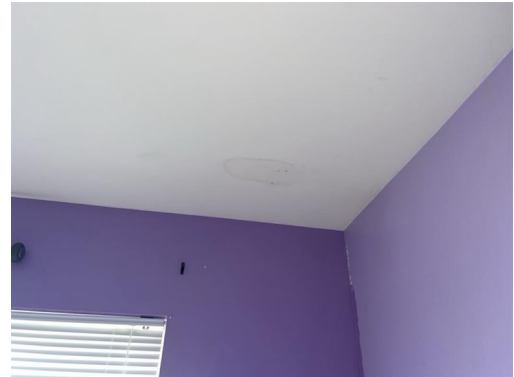
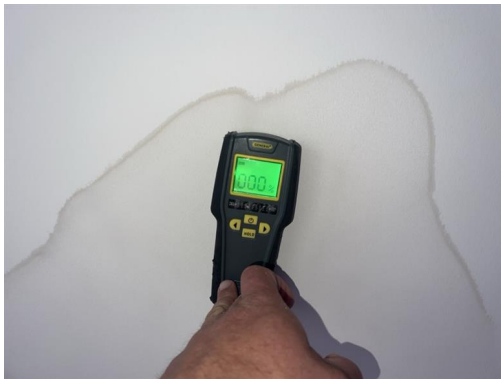
| 24. | <b>Interior/Interior Ceilings</b> | The ceiling is water-stained or damaged; testing with a moisture meter confirms no/low moisture content. Engage a contractor to evaluate and to make repairs, as required. LOCATION: Front Left Bedroom. | 39 |

| ISSUE | The ceiling is water-stained or damaged; testing with a moisture meter confirms no/low moisture content. |
| LOCATION | Front Left Bedroom |

| RECOMMENDATION | Engage a contractor to evaluate and to make repairs, as required. |

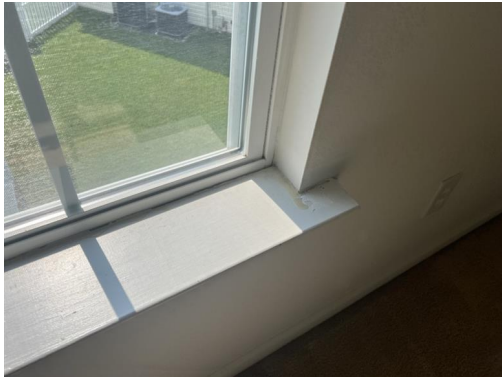
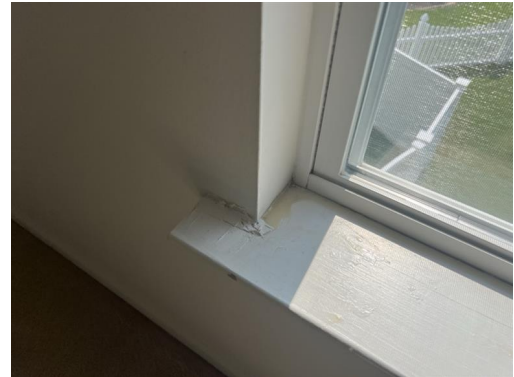
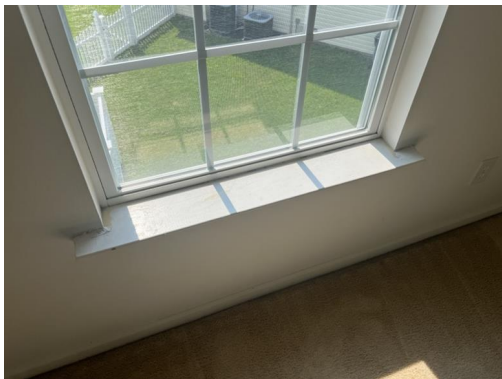
| 25. | <b>Interior/Windows</b> | Previous repairs to the window sill noted. Monitor and maintain as required. LOCATION: Multiple Locations: right front window in the primary bedroom. | 40 |

| ISSUE | Previous repairs to the window sill noted. |
| LOCATION | Multiple Locations: right front window in the primary bedroom. |

| RECOMMENDATION | Monitor and maintain as required. |

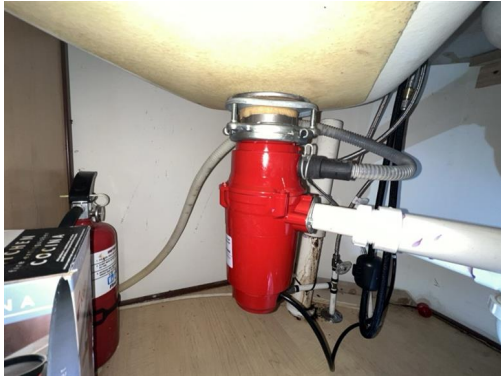
| 13. | <b>Appliances/Dishwasher</b> The dishwasher is missing an anti-siphon device on the drain line. Install a "high loop" or an anti-siphon device. LOCATION: Kitchen. Estimated cost to remedy: \$50 to \$100. | 43 |

| ISSUE | The dishwasher is missing an anti-siphon device on the drain line. |
| LOCATION | Kitchen |

| RECOMMENDATION | Install a "high loop" or an anti-siphon device. |
| COST TO REMEDY | \$50 to \$100 |

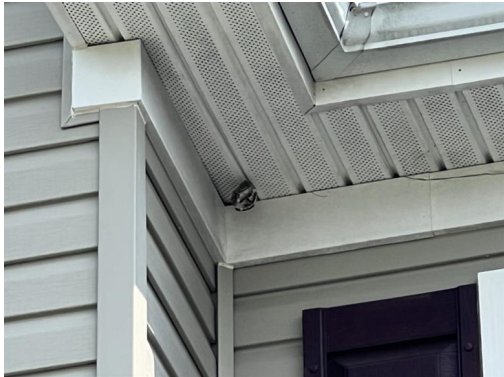
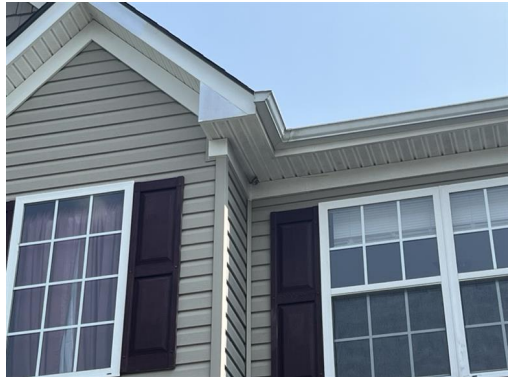
| 14. | <b>Environmental/Environmental Other</b> There wasps nesting on the house. Engage a pest control contractor to clear nests and to make repairs, as required. LOCATION: Front Center Soffit. Estimated cost to remedy: \$100 to \$200. | 46 |

| ISSUE | There wasps nesting on the house. |
| LOCATION | Front Center Soffit |
| IMPLICATION | Bees or wasps may cause personal injury. |

| RECOMMENDATION | Engage a pest control contractor to clear nests and to make repairs, as required. |
