| DATE | 07/15/25 |
| ADDRESS | 13125 Greenwood Creek Drive,<br>Ashland, VA |

# TABLE OF CONTENTS

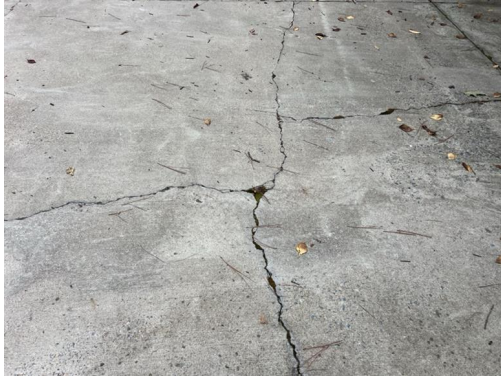
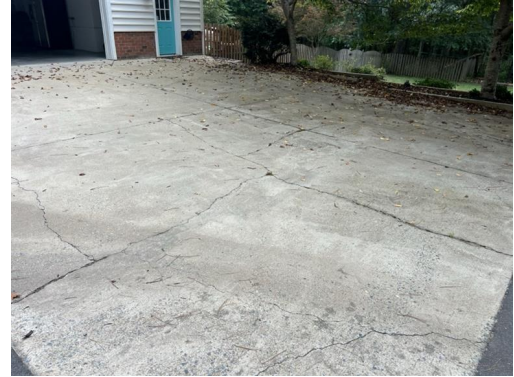
| 8. | <b>Exterior/Driveway</b> There are hairline cracks in the driveway. Repair and seal cracks. LOCATION: Multiple Locations. | 14 | |

| ISSUE | There are hairline cracks in the driveway. |
| LOCATION | Multiple Locations |
| IMPLICATION | May permit water to penetrate the driveway, which may cause further damage. |

| RECOMMENDATION | Repair and seal cracks. |

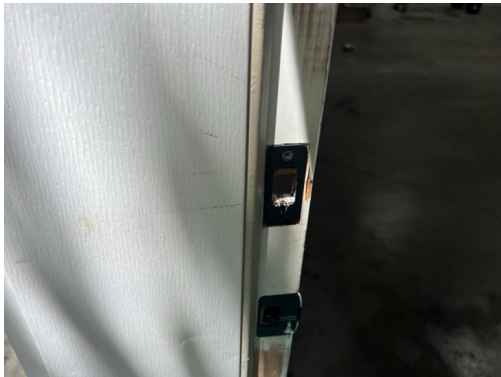
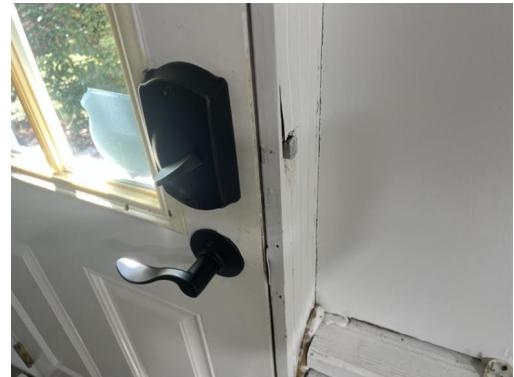
| 1. | <b>Exterior/Exterior Doors</b> The framing for the garage pedestrian door is not adequately for security. Reinforce the framing. LOCATION: Attached Garage. Estimated cost to remedy: \$250 to \$350. | 14 | |

| ISSUE | The framing for the garage pedestrian door is not adequately for security. |
| LOCATION | Attached Garage |
| IMPLICATION | The door can be easily forced open. |

| RECOMMENDATION | Reinforce the framing. |

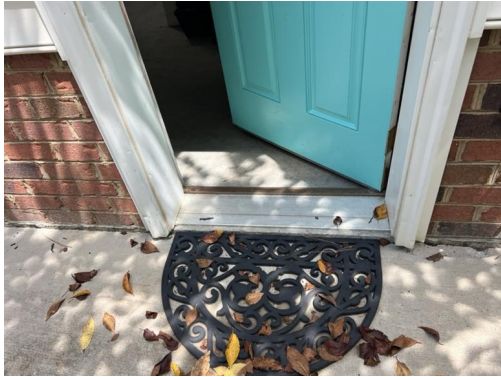
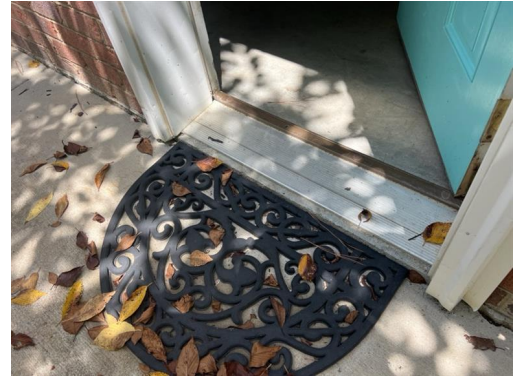
| 7. | <b>Exterior/Exterior Doors</b> The threshold is loose or flexes under foot. Secure and seal the threshold. LOCATION: Garage pedestrian door. | 15 | |

| ISSUE | The threshold is loose or flexes under foot. |
| LOCATION | Garage pedestrian door |
| IMPLICATION | Someone may trip and fall; may promote water intrusion. |

| RECOMMENDATION | Secure and seal the threshold. |

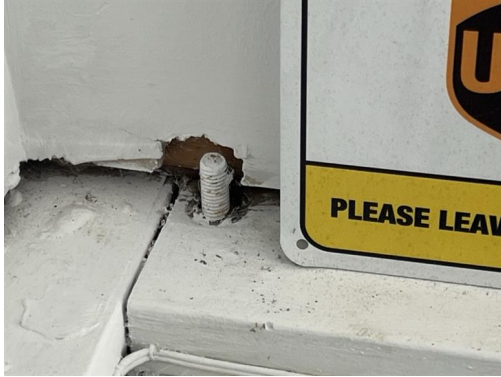
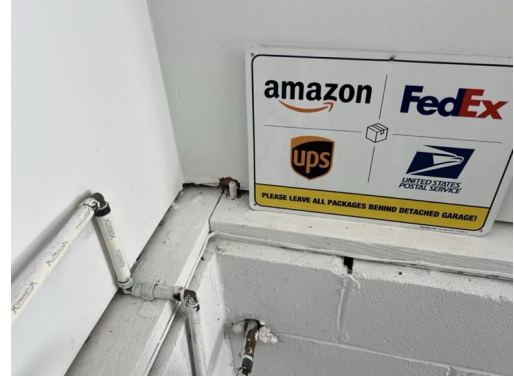
| 2. | <b>Structure/Floor Structure</b> There is a missing sill bolt next to the garage entry door. Install and maintain as required. LOCATION: Rear right of the attached garage. Estimated cost to remedy: \$100 to \$300. | 22 | |

| ISSUE | There is a missing sill bolt next to the garage entry door. |
| LOCATION | Rear right of the attached garage. |
| IMPLICATION | This may allow moment or shifting. |

| RECOMMENDATION | Install and maintain as required. |

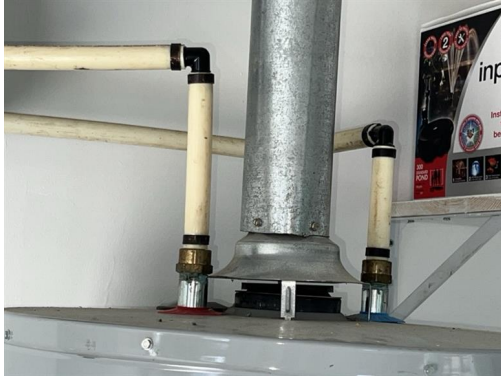
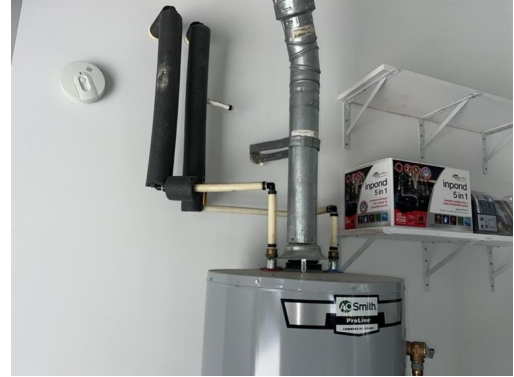
| 3. | <b>Plumbing/Supply Pipes</b> There is plastic water supply pipe connected closer than 18" at the water heater. Engage a plumbing contractor to make repairs, as required. LOCATION: Attached Garage. Estimated cost to remedy: \$350 to \$450. | 30 | |

| ISSUE | There is plastic water supply pipe connected closer than 18" at the water heater. |
| LOCATION | Attached Garage |
| IMPLICATION | Contrary to accepted practice. |

| RECOMMENDATION | Engage a plumbing contractor to make repairs, as required. |

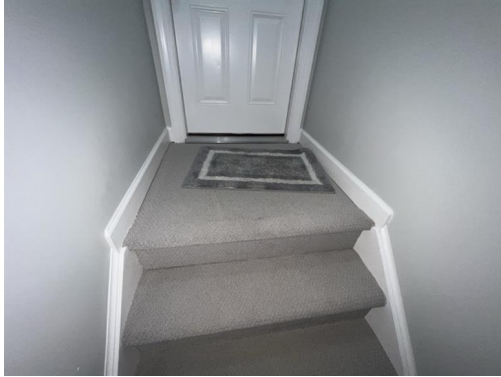
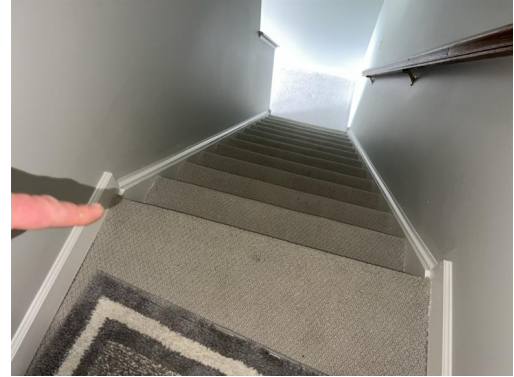
| 4. | <b>Interior/Interior Stairs/Steps</b> There is a lip behind the top tread bullnose. Lever the lip as required for safety. LOCATION: Attic. Estimated cost to remedy: \$250 to \$350. | 32 | |

| ISSUE | There is a lip behind the top tread bullnose. |
| LOCATION | Attic |
| IMPLICATION | This may pose a safety / tripping hazard. |

| RECOMMENDATION | Lever the lip as required for safety. |

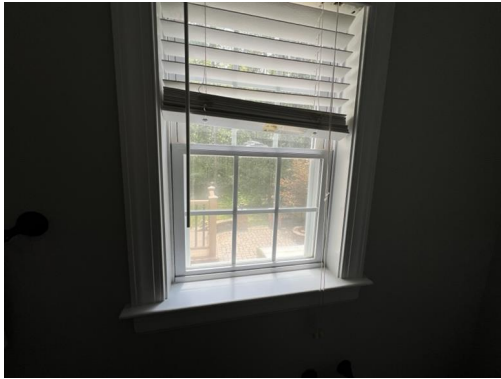
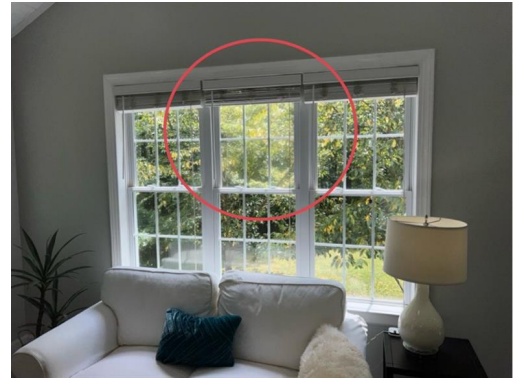
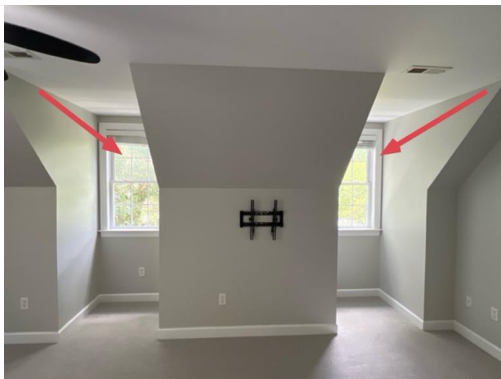
| 5. | <b>Interior/Windows</b> The window has a failed insulated glass seal. Replace the insulated glass unit or the window. LOCATION: Multiple Locations: The lower sash in the half bathroom. The upper sash in the center window of the rear left window bay of the sunroom. Both upper sash's in the front windows of the front right bedroom. Estimated cost to remedy: \$6 to \$1,200. | 33 | |

| ISSUE | The window has a failed insulated glass seal. |
| LOCATION | Multiple Locations: The lower sash in the half bathroom. The upper sash in the center window of the rear left window bay of the sunroom. Both upper sash's in the front windows of the front right bedroom. |
| IMPLICATION | Condensation develops on inside of glass and may affect visibility and appearance. |

| RECOMMENDATION | Replace the insulated glass unit or the window. |

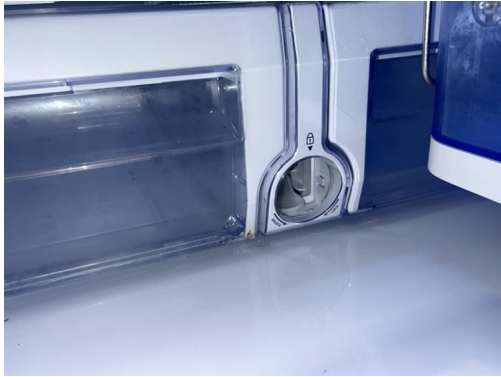
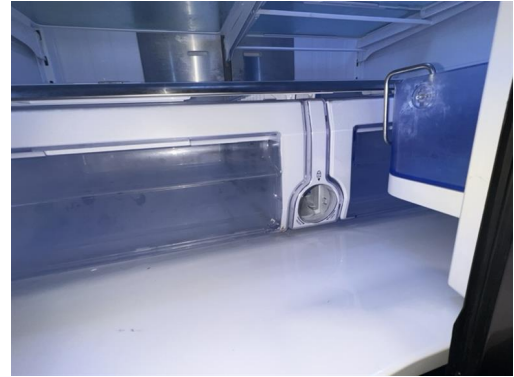
| 6. | <b>Appliances/Refrigerator/Freezer</b> The refrigerator is missing the water filter. Replace the filter. LOCATION: Kitchen. Estimated cost to remedy: \$100 to \$200. | 36 | |

| ISSUE | The refrigerator is missing the water filter. |
| LOCATION | Kitchen |
| IMPLICATION | This may allow water to leak into the unit if not replaced. |

| RECOMMENDATION | Replace the filter. |
