## INSPECTION INSIGHTS

| DATE | 02/23/24 |
| ADDRESS | 1903 Maddox Street,<br>Richmond, VA |

# TABLE OF CONTENTS

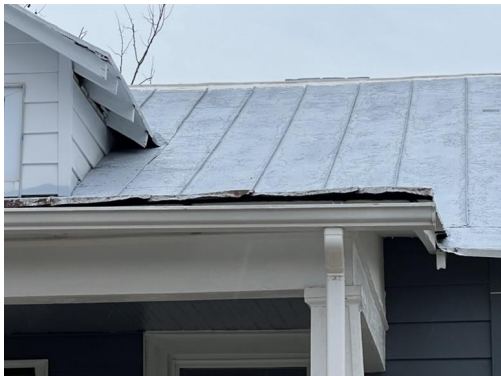
## ROOF/ROOFING

| 10. | <b>Roof/Roofing</b> The metal is lifting away from the rafters tails at the eaves. Engage a roofing contractor to make repairs or replace the roofing. LOCATION: Front. Estimated cost to remedy: \$400 to \$500. | 20 |

| ISSUE | The metal is lifting away from the rafters tails at the eaves. |
| LOCATION | Front |

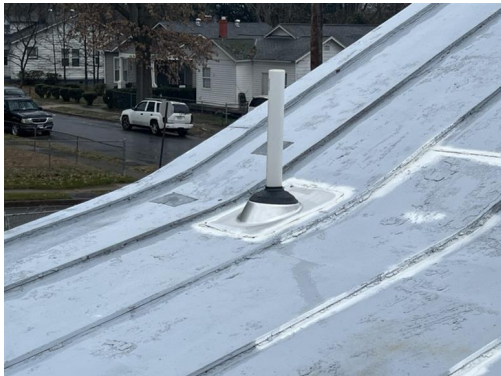
## ROOF/FLASHING

| 11. | <b>Roof/Flashing</b> The vent boot does not appear to be adequately attached to the roof. Replace the vent boot and repair any damage which may be revealed. LOCATION: Rear roof. Estimated cost to remedy: \$200 to \$300. | 21 |

| ISSUE | The vent boot does not appear to be adequately attached to the roof. |
| LOCATION | Rear roof |

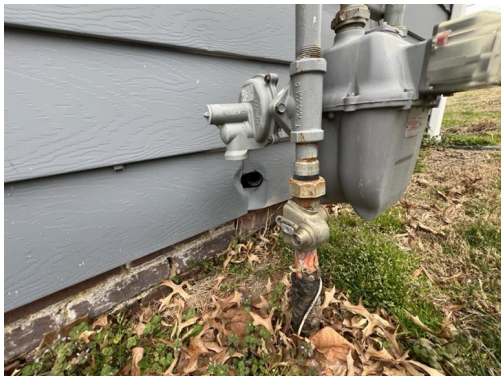
## FUEL SERVICES/FUEL METER

ISSUE

The fuel meter is locked out, no service to the property.
