## INSPECTION INSIGHTS

| DATE | 01/29/24 |
| ADDRESS | 110 North Harrison Street,<br>Richmond, VA |

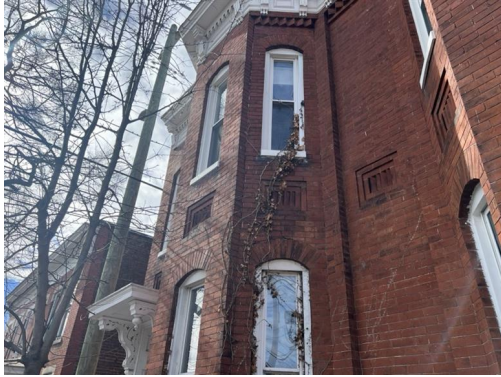
## EXTERIOR/EXTERIOR WALLS

| ISSUE | There is vegetation in contact with the exterior wall. |
| LOCATION | Multiple Locations |

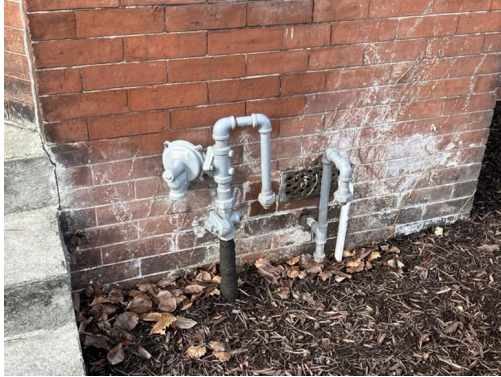
## FUEL SERVICES/FUEL METER

No fuel meter present.

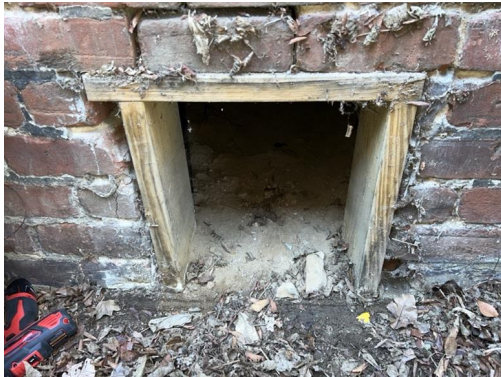
**R** STRUCTURE/CRAWL SPACE

| ISSUE | The crawlspace access does not meet the minimum size requirements. |
| LOCATION | Left Side |

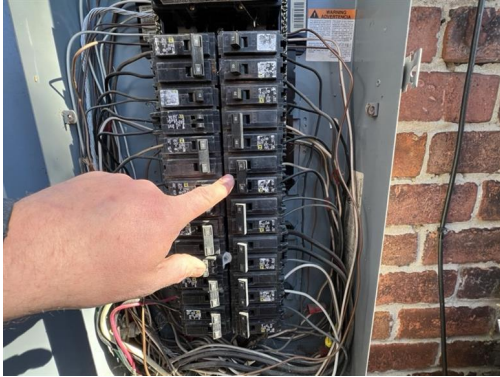
## ELECTRICAL/ELECTRICAL PANEL

| ISSUE | There is a breakers in the off position and will not reset. |
| LOCATION | Rear exterior |

| 17. | <b>Electrical/Electrical Panel</b> There is a breakers in the off position and will not reset. Engage an electrical contractor to evaluate and to make repairs, as required. LOCATION: Rear exterior. Estimated cost to remedy: \$200 to \$300. | 34 |

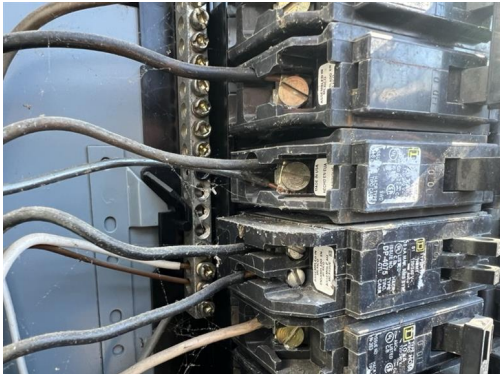
## ELECTRICAL/ELECTRICAL PANEL

| ISSUE | There are double-tapped breakers. |
| LOCATION | Rear exterior. |

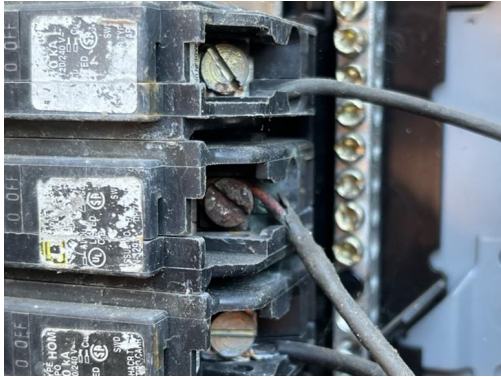
## ELECTRICAL/ELECTRICAL PANEL

| ISSUE | The wires are overheated at the right side of the panel. |
| LOCATION | Rear exterior |

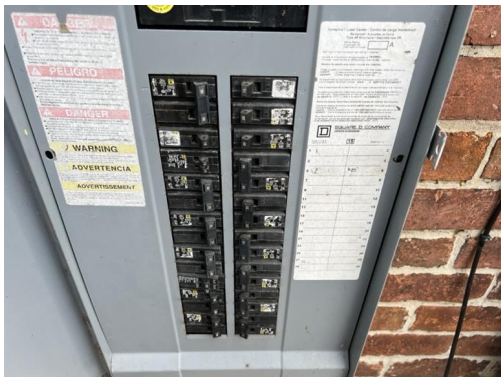
## ELECTRICAL/ELECTRICAL PANEL

| ISSUE | The electrical panel isn't labeled. |
| LOCATION | Rear exterior. |

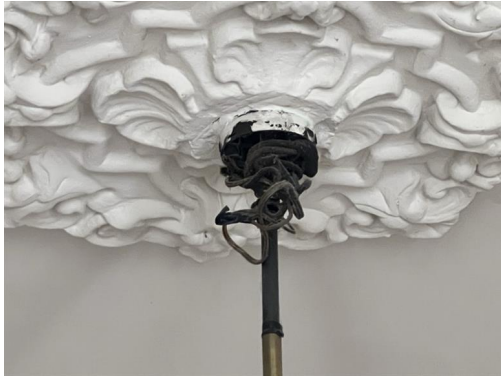
ELECTRICAL/BRANCH CIRCUITS

| ISSUE | There is exposed and unprotected wiring above the ceiling light. |
| LOCATION | The living room. |

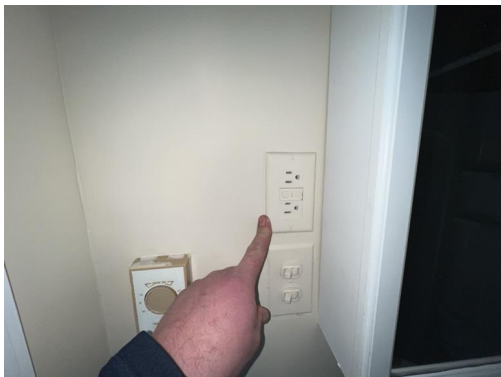
**R** ELECTRICAL/RECEPTACLES

| ISSUE | The GFCI receptacle is painted over and doesn't trip/reset. |
| LOCATION | Second floor hall bathroom. |

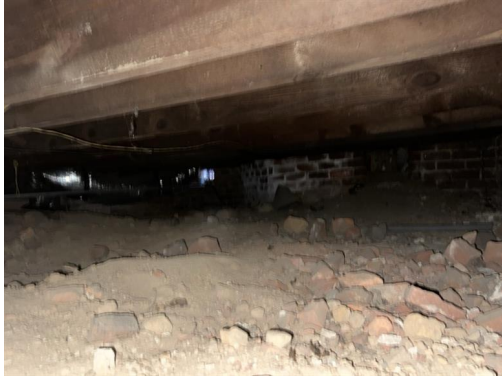
## ● PLUMBING/WATER SERVICE LINE

ISSUE                      The water service line is not accessible.

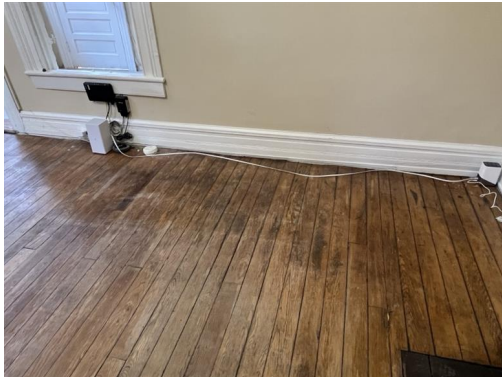
## R INTERIOR/INTERIOR FLOORS

| ISSUE | The floorboards sag at the rear of the dining room. |
| LOCATION | Rear wall of the family room. |

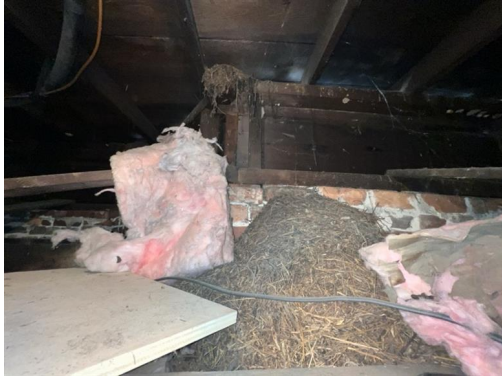
**R** ENVIRONMENTAL/ENVIRONMENTAL OTHER

| ISSUE | There is evidence of nesting at the front of the attic. |
| LOCATION | Attic |
