## INSPECTION INSIGHTS

| DATE | 06/29/23 |
| ADDRESS | 1910 Windsordale Drive,<br>Richmond, VA |

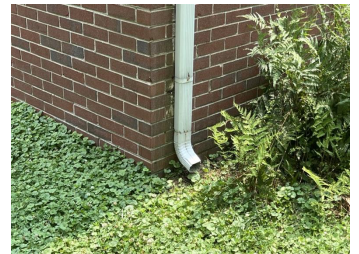
## WATER CONTROL/GUTTERS/DOWNSPOUTS

| 7. | <b>Water Control/Gutters/Downspouts</b> The gutters are dented, also the trough is not properly pitched due to damage. Repair or replace the gutters to carry water away from the structure. LOCATION: Front. Estimated cost to remedy: \$400 to \$500. | 20 |
