## INSPECTION INSIGHTS

| DATE | 09/15/23 |
| ADDRESS | 16730 Sayley Drive,<br>Chesterfield, VA |

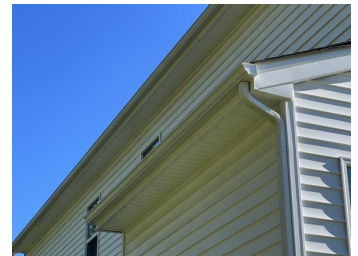
## WATER CONTROL/GUTTERS/DOWNSPOUTS

| ISSUE | The downspout extension is missing. Install downspout extensions. |

| RECOMMENDATION | Install downspout extensions. |
