| DATE | 08/16/24 |

| ADDRESS | 8 Polly Court,<br>Hampton, VA |

# PROPERTY AND INSPECTION INFO

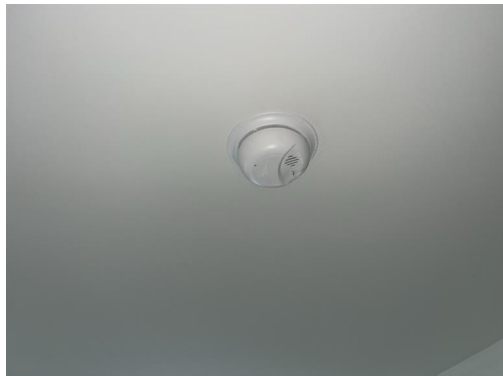
## ELECTRICAL/SMOKE DETECTORS

| ISSUE | The smoke detectors are in good working conition. |
| LOCATION | Multiple Locations |
