## INSPECTION INSIGHTS

DATE	04/22/24
ADDRESS	608 Mayfair Ave, Richmond, VA
NAME	Lee Henry

TYPE	Single family
YEAR BUILT	1968
APPROXIMATE SQUARE FOOTAGE	5,379
DIRECTION FRONT OF HOUSE FACES	Southeast

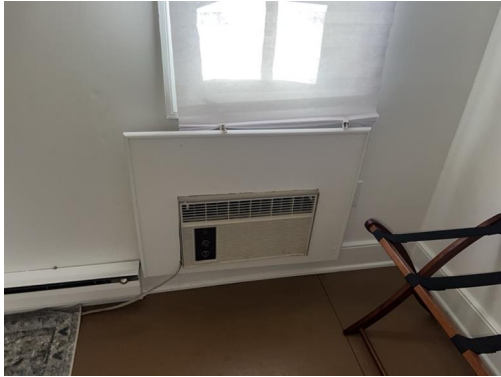
● HVAC/HVAC OTHER

ISSUE      The wall units are not longer in use.

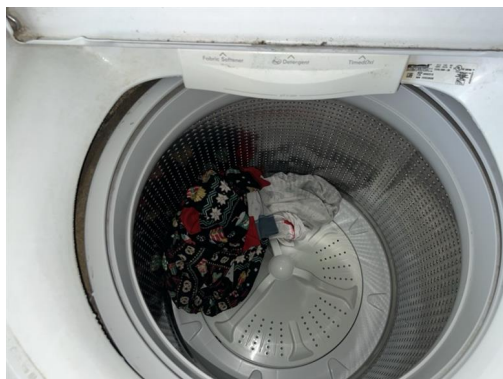
## APPLIANCES/WASHER

ISSUE

The unit contains clothes.

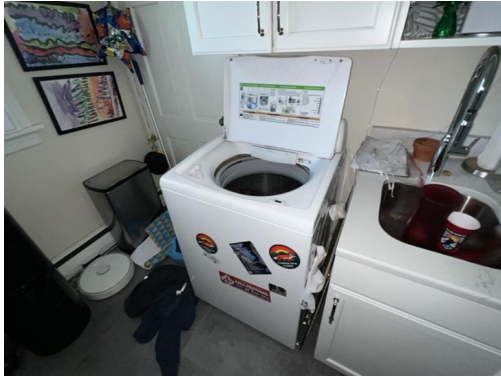
● APPLIANCES/WASHER

ISSUE The unit contains clothes.

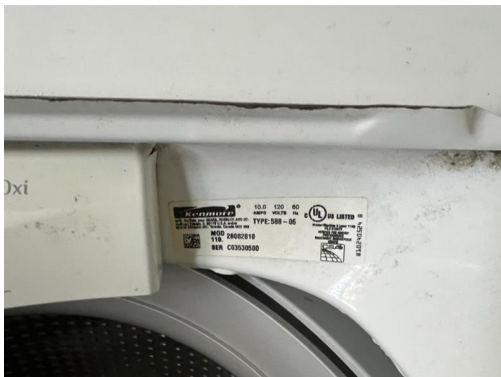
● APPLIANCES/WASHER

ISSUE The unit contains clothes.

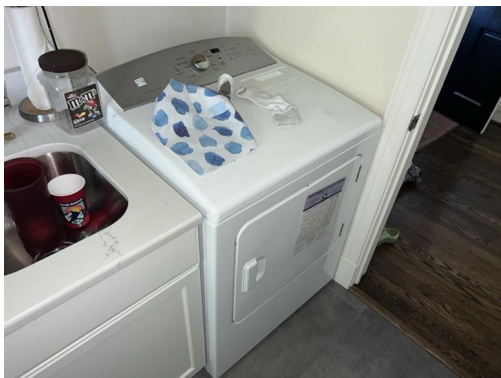
● APPLIANCES/DRYER

ISSUE The unit contains clothes.

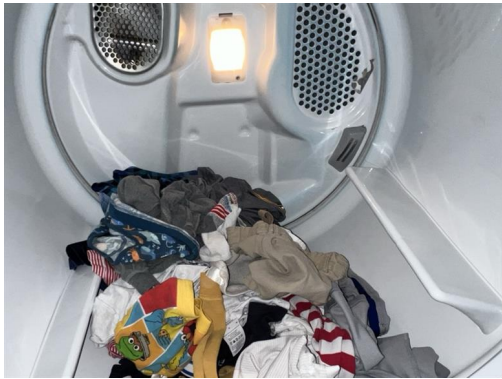
● APPLIANCES/DRYER

ISSUE                      The unit contains clothes.

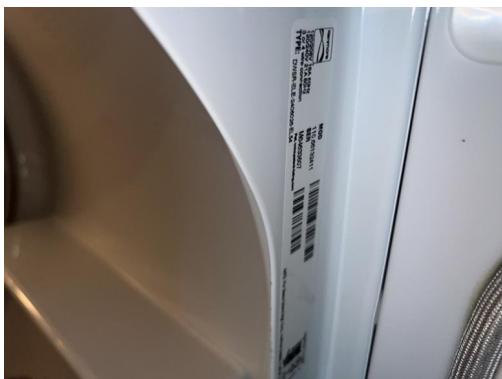
● APPLIANCES/DRYER

ISSUE                      The unit contains clothes.
